Re: FOI request IE_FOI_377

Report of Investigation:

**Train A708 collided with cattle on approach to the 55 MP
Portarlinton/Tullamore, near Level Crossing XA043,
28th of June 2018**

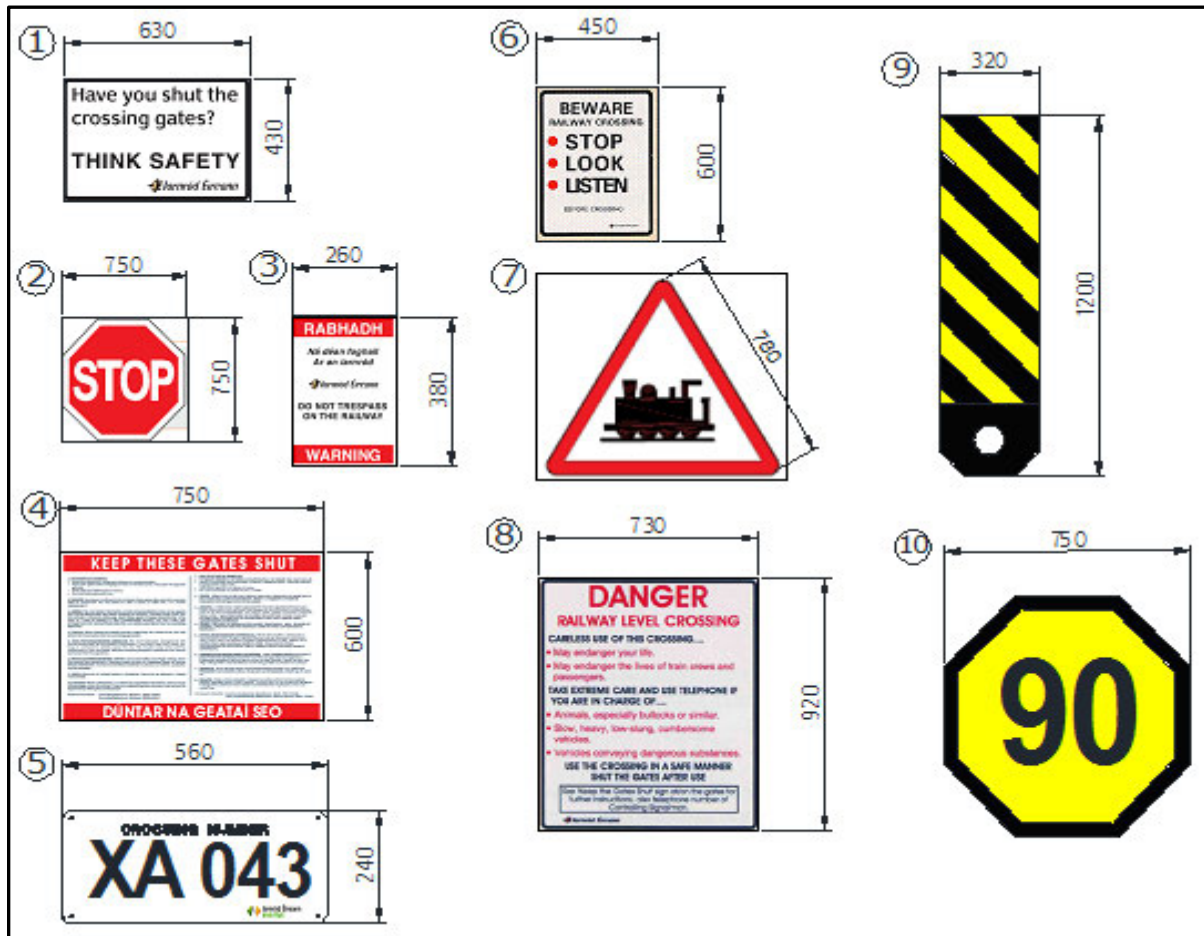
Figure 3: Passive signage details for level crossing XA043.

6.2.6 The signage at level crossing XA043 was in compliance with the Technical Management Standard CCE-TMS-380, 'Technical Standard for the Management of User Worked Unattended Level Crossings'.

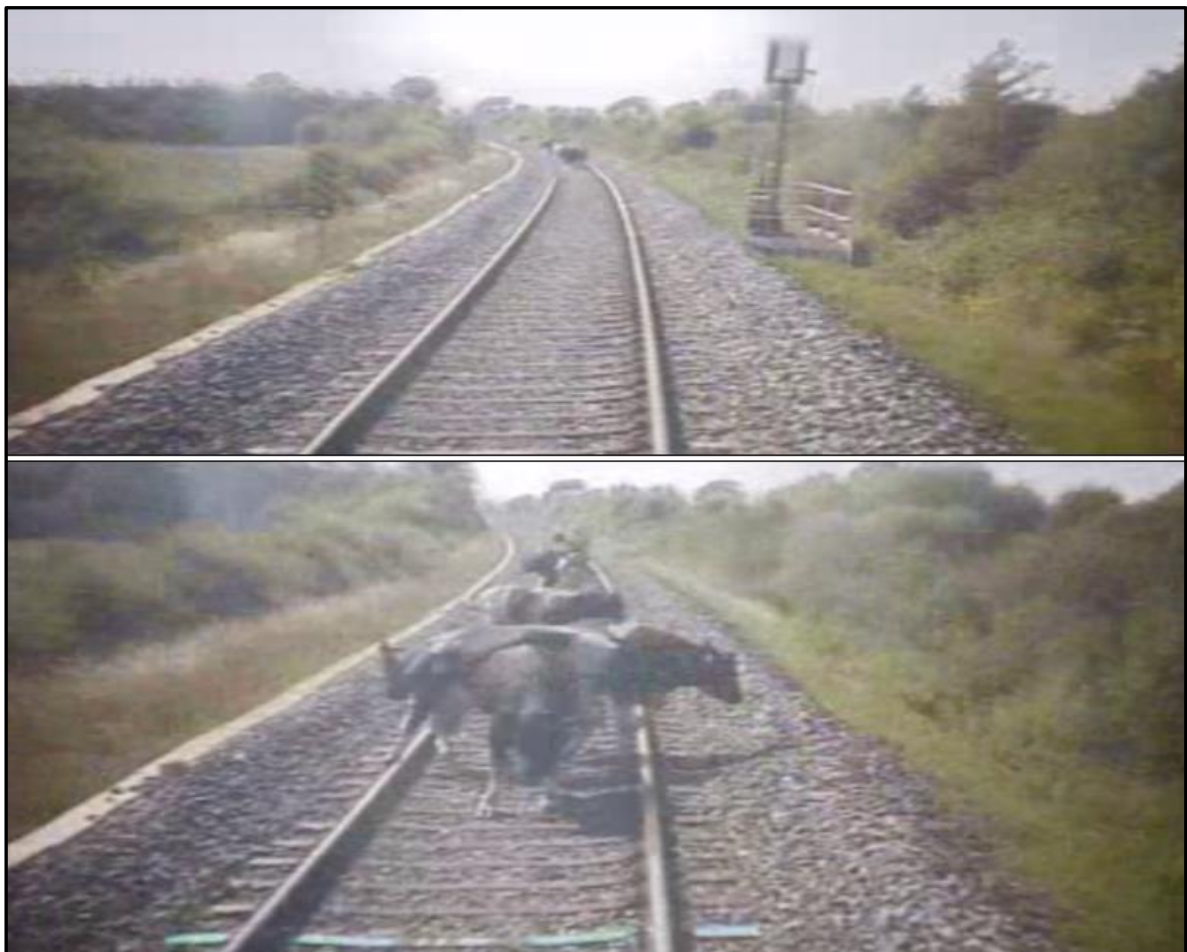
- 9.1.7 The Driver of train A708 then observed a number of cattle on the line in the path of the train.

Figures 5 & 6: Images from the front CCTV cameras on train A708 coming to the end of the curvature and moments prior to the collision with the cattle at the 54 miles 1545 yards.

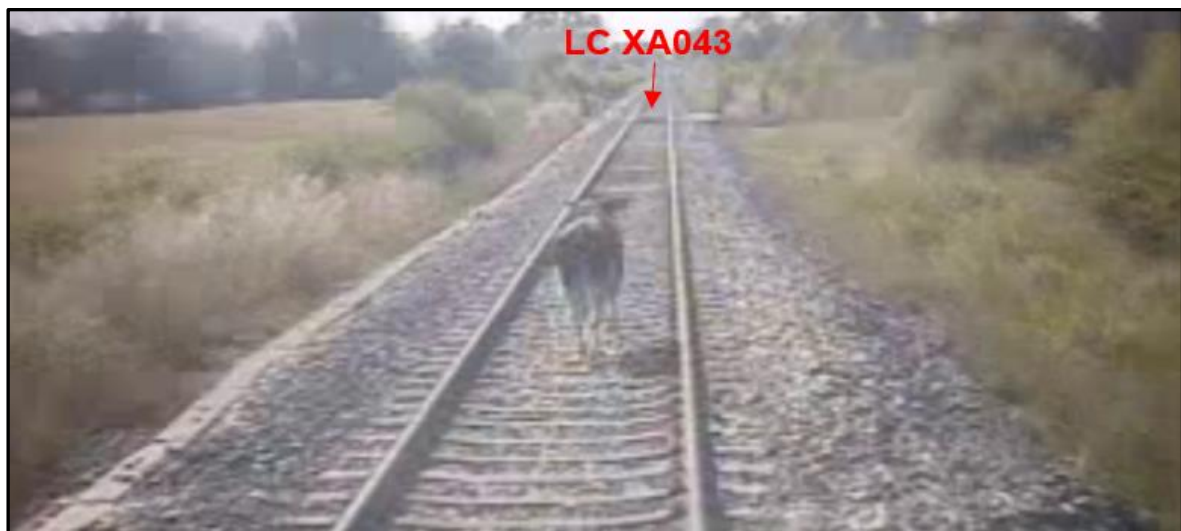
9.2.2 CCTV footage from the train showed that, following the collision, the train stopped before reaching level crossing XA043 which was at 55 miles 0442 yards.

Figure 7: Image from the front CCTV camera after train A708 had stopped, with XA043 in the foreground.

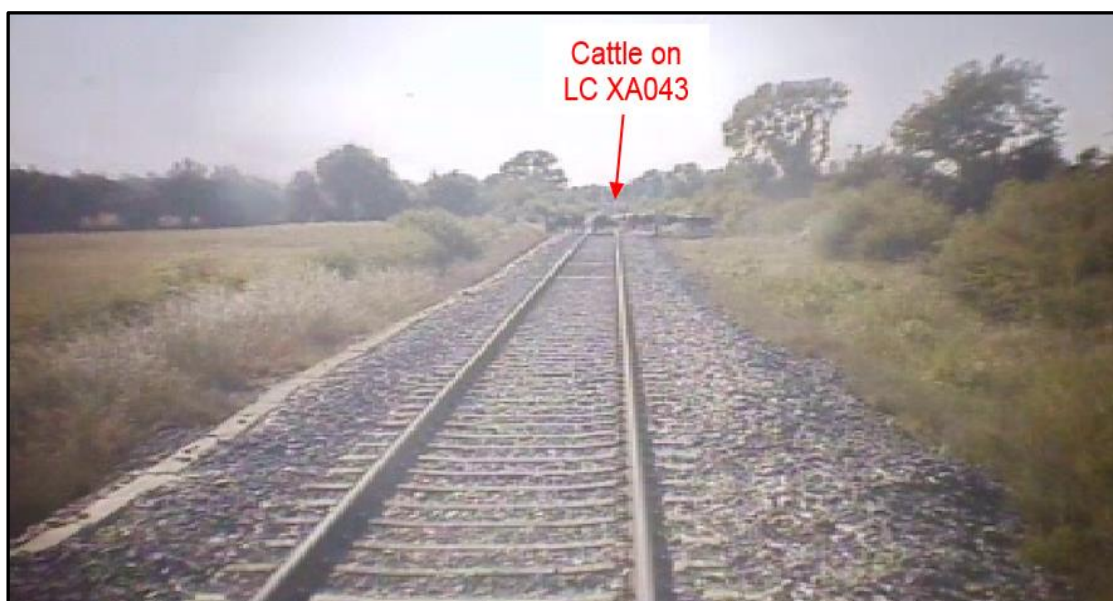
- 9.4.2 At 16:49:08, almost 20 minutes after the train stopped, the forward facing CCTV camera of train A708 showed a number of cattle enter onto Level Crossing XA043 from the Down Side. The cattle remained on the crossing for a further few minutes. This evidence indicated that the Down side gate of Level Crossing XA043 was not secured and cattle could access the level crossing. The cattle remained on the crossing facing the (opposite) Up side gate, indicating the Upside gate was closed as the cattle did not continue over the crossing.

Figure 8: Image from the forward facing CCTV camera after train A708 had stopped. At 16:49:50 it shows cattle have entered level crossing XA043 from the Down side and are held at the crossing by the Up side gate.

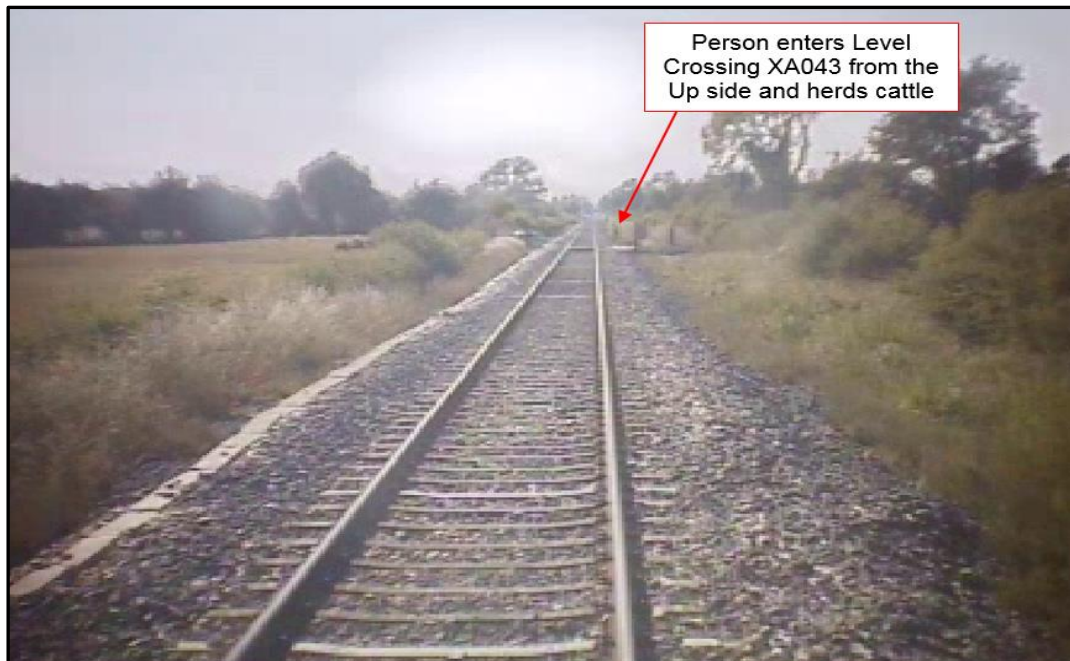
- 9.4.3 At 16:51:28 the CCTV camera of train A708 showed a person wearing shorts arriving at Level Crossing XA043 from the Up side. This person herded the cattle off the crossing and back to the field on the Down side. The person then walked along the line towards the train.

Figure 9: Image from the front CCTV camera after train A708 had stopped. At 16:51:28 it shows a person enter level crossing XA043 from the Up side and herd the cattle off the crossing through the Down side gate.

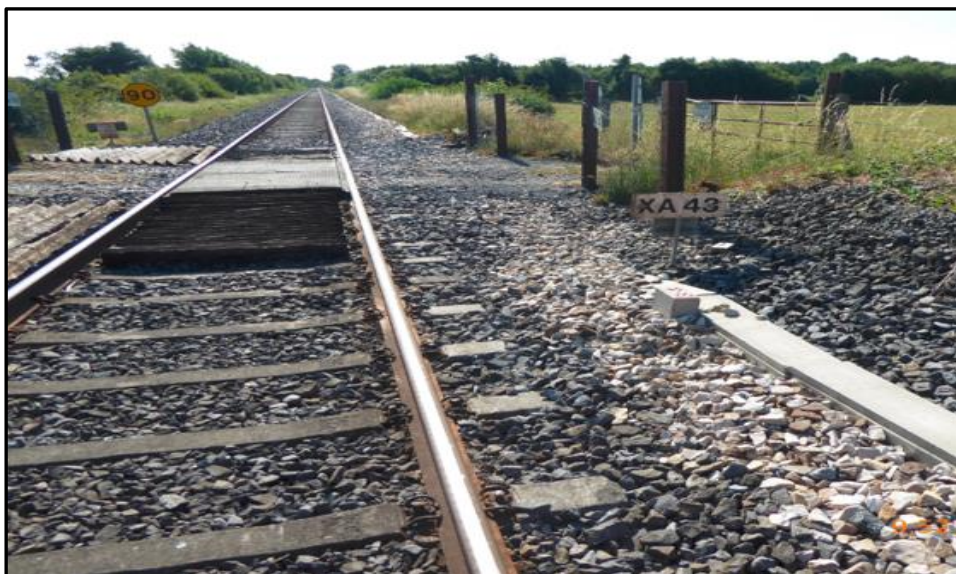
- 9.4.4 The Driver stated during formal interview that he saw the cattle standing on crossing XA043 after the occurrence and the person putting them back into the field on the Down side.
- 9.4.5 A CCE member of staff (Mobile Ganger) who attended at the scene stated, during the post incident review, that the person in shorts (the person in figure 9 above) told him the cattle got out at the gate of crossing XA043.
- 9.4.6 It was also observed by the CCE member of staff that the cattle grids on the Down side cess of XA043 were missing at the time of the occurrence.

Figure 10: Post-incident image of LC XA043 showing missing Down side cess cattle grid. This view is looking towards Portarlinton. Note; the newly installed cable ducting.

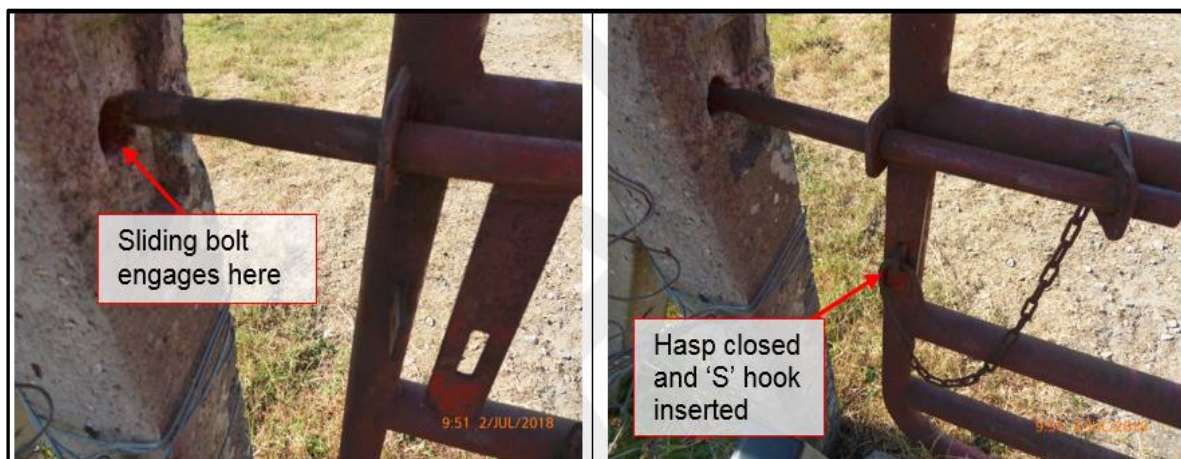
- 10.1.3 The post-incident inspection of the sliding bolt and hasp fastening arrangement of the Down side gate found there was no damage to the hasp or to the chained 'S' securing hook. The end of the sliding steel bolt slotted 70mm into the concrete slapping post which provided good engagement.

Figure 11: Post-incident images of the sliding bolt and hasp fastening arrangement of Down side gate at XA043.

- 10.1.4 There have been no changes or adjustments made to this fastening arrangement since the occurrence and it continues to provide a secure fastened gate when used correctly. When the hasp is closed and the 'S' hook is inserted through the hole, the gate is secure and cannot be opened by cattle either scratching or pushing against it.

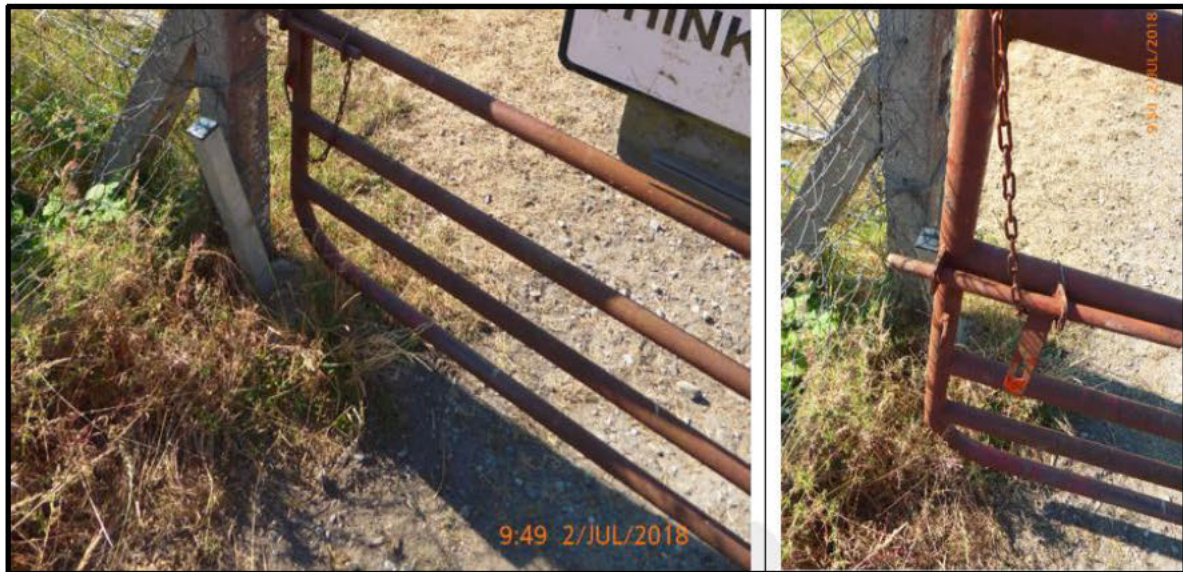
- 10.1.7 It was also observed that the gate stop post, which is an independent post fitted to block the gate from opening towards the railway, was found to be loose in the post-incident inspection. This allowed the gate open towards the railway once it was unfastened. The records showed that the stop post was fitted in October 2015. The investigation was unable to determine if the stop post was damaged on the day of the occurrence or before it. However, its purpose is not to secure the gate, but to prevent the user from opening the gate towards the railway line during the opening process.

Figure 12: Post-incident images of the loose gate stop post on the Down side gate at XA043. This allowed the unfastened gate to open towards the railway.
