Cork Line Level Crossings Project –

XC215 Shinanagh, Co. Cork

Targeted Archaeological Test Excavations

18th December 2020

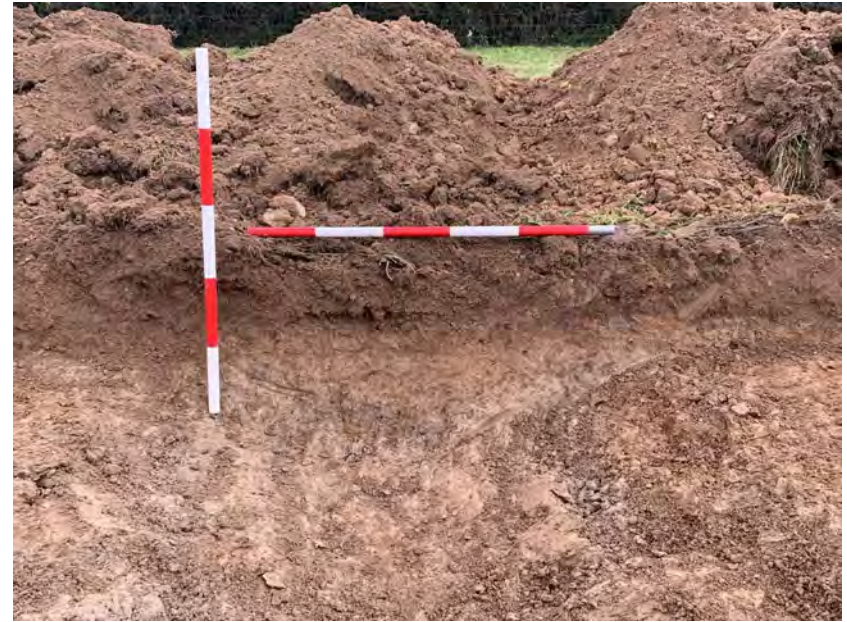
Plate 22: Test Trench 9, ditch C3, facing east

In **Test Trench 9** (Figure 11) an east-west ditch C3 was exposed, and measured 1.2m in width and was 0.25m deep. The ditch was V-shaped, and filled by C92 that consisted of a pale greyish brown sandy clay. Ditch C3 accounts for a trend noted in the geophysical survey. The ditch aligns with a field boundary shown on the 1st Edition Ordnance Survey Map of 1840 (Figure 23a). It is therefore assumed to be of 19th-century date and not of archaeological significance.

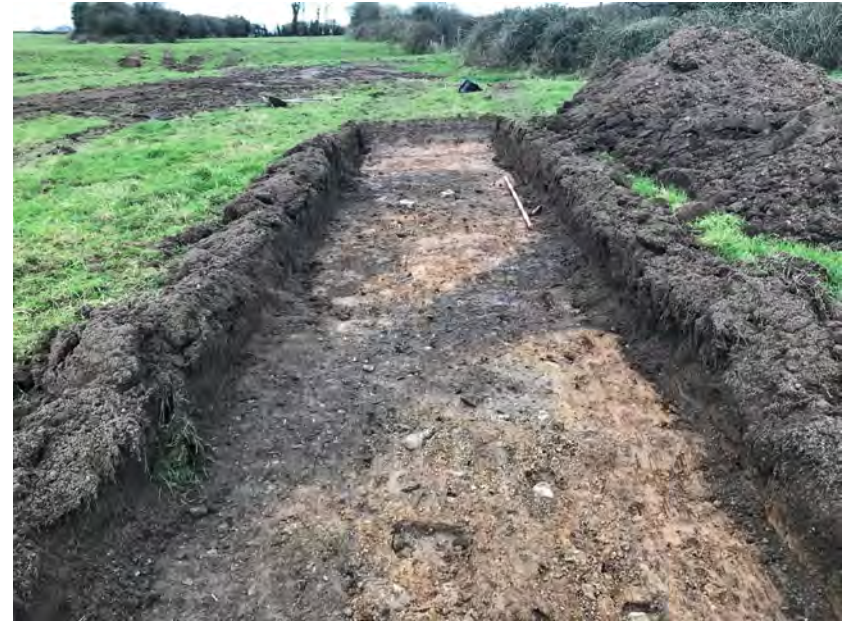
Plate 38: Test Trench 15, ditch C85 and pit C84, facing north

In total one pit was exposed in Field 2, in **Test Trench 15** (C84). C84 was partially exposed, oval in shape, measured 1.4m in length, 1.1m in width and was 0.15m deep (Figure 15, 21, Plate 38, 40). The south side was steep while the north was more gradual, and it was filled by C90 that consisted of a brownish-grey sandy clay with inclusions of charcoal, small to medium stones and decaying stones. Pit C84 accounts for Anomaly 15, which represented a series of anomalies interpreted as a probable burnt/fired deposit by Target.
