Iarnród Éireann  
 Cork Line Level Crossings  
 XC211 (19-135-2)

## Cork Line Level Crossings – XC212 Ground Investigation

Report No.: OCB19-135-3

## Cork Line Level Crossings – XC215 Ground Investigation

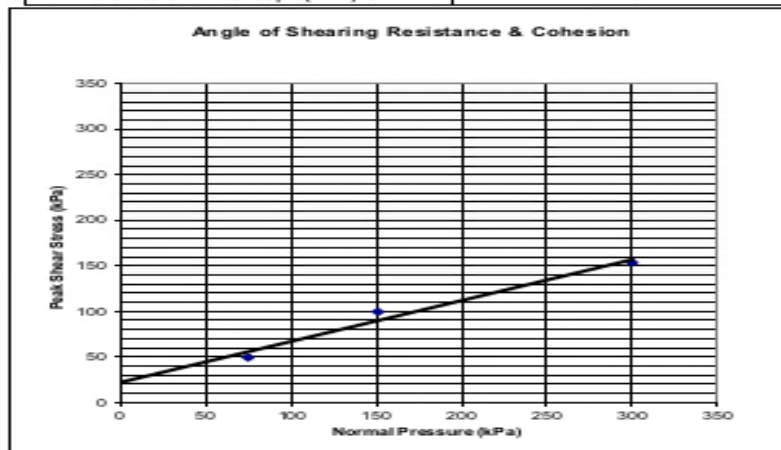
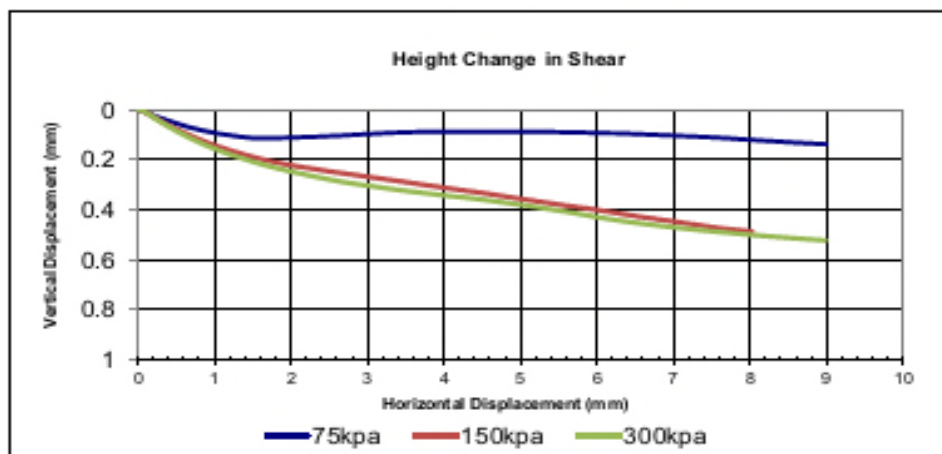
Sample Condition: Submerged  
 Particle Density: 2.65 (Mg/m<sup>3</sup>) Assumed  
 Sample Preparation: Remoulded (Hand Tamped)  
 Material tested passing 2mm sieve

Initial Condition		
	1	2	3
Normal Pressure (kPa)	75	150	300
Height (mm)	20.39	20.20	20.37
Width (mm)	59.9	59.9	59.9
Bulk Density (Mg/m <sup>3</sup> )	2.07	2.09	2.07
Dry Density (Mg/m <sup>3</sup> )	1.80	1.82	1.80
Moisture Content (%)	15	15	15
Voids Ratio	0.469	0.457	0.475
Degree of Saturation	84.8	87.0	83.7
Shearing Stage			
Rate of Displacement (mm/min)	0.03	0.03	0.03
Peak Shear Stress (kPa)	49.4	99.6	153.5
Displacement at Peak Stress (mm)	8.9	7.6	8.1
Final Condition			
Bulk Density (Mg/m <sup>3</sup> )	2.28	2.40	2.42
Dry Density (Mg/m <sup>3</sup> )	1.90	2.03	2.09
Moisture Content (%)	20	18	16
Angle of Shearing Resistance ( $^{\circ}$ ) $\phi'$	24.0		
Cohesion Intercept (kPa) $c'$	22.0

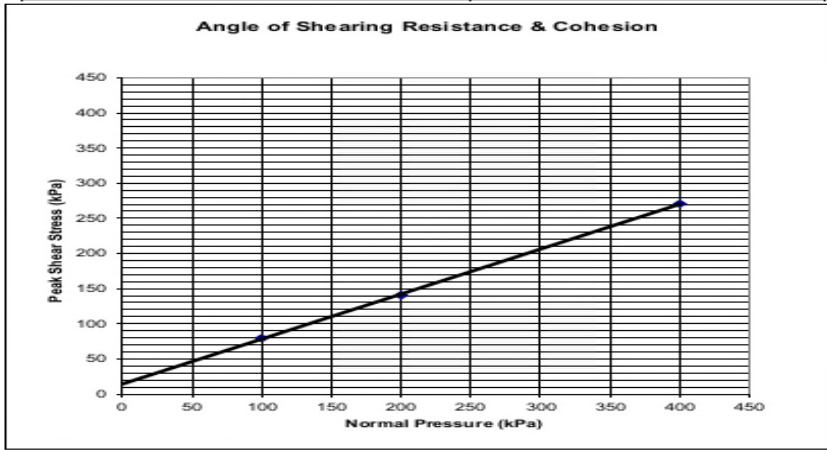
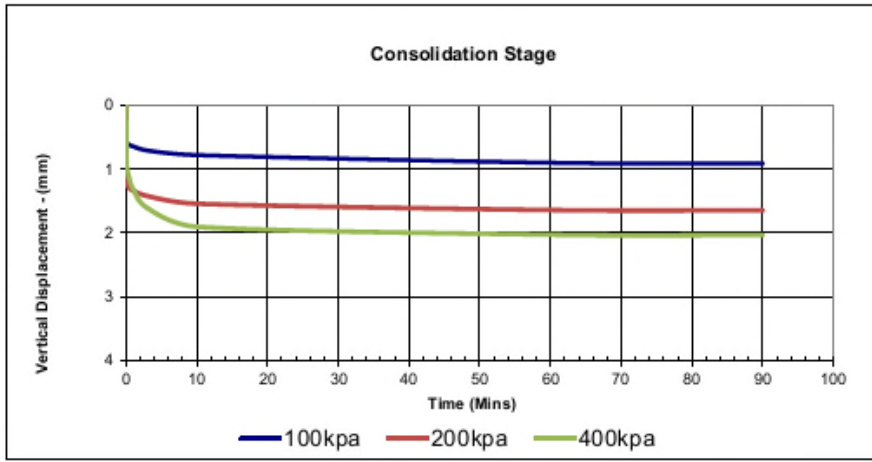
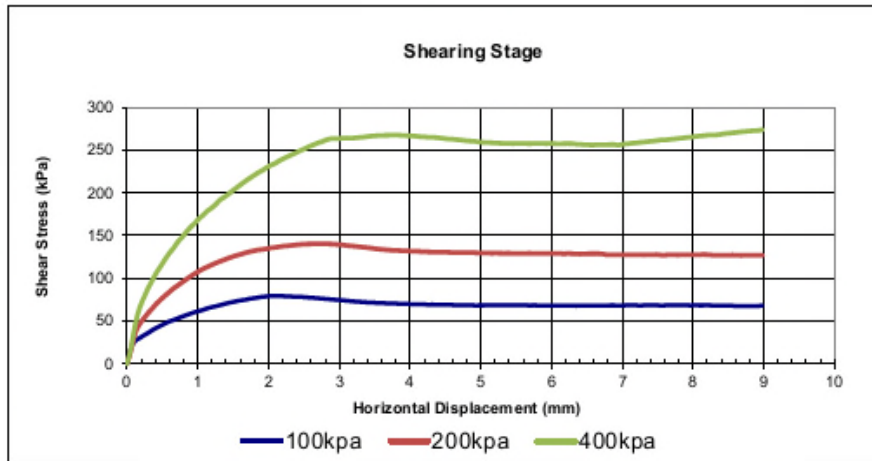
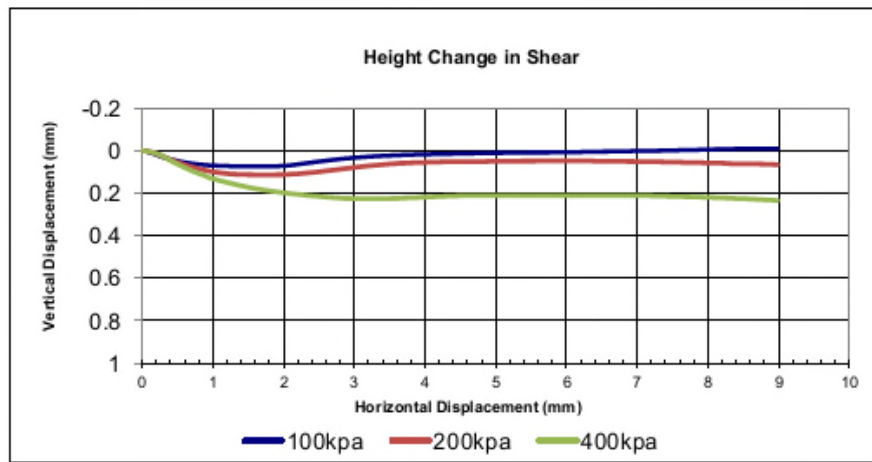
Sample Condition: Submerged  
 Particle Density: 2.65(Mg/m<sup>3</sup>) Assumed  
 Sample Preparation: Remoulded (Hand Tamped)  
 Material tested passing 2mm sieve

Initial Condition		
	Stage		
	1	2	3
Normal Pressure (kPa)	100	200	400
Height (mm)	20.60	20.23	20.77
Width (mm)	59.9	59.9	59.9
Bulk Density (Mg/m <sup>3</sup> )	2.24	2.26	2.21
Dry Density (Mg/m <sup>3</sup> )	2.03	2.04	1.99
Moisture Content (%)	10	11	11
Voids Ratio	0.303	0.301	0.329
Degree of Saturation	87.3	96.8	88.5
Shearing Stage			
Rate of Displacement (mm/min)	0.03	0.03	0.03
Peak Shear Stress (kPa)	79.4	140.4	270.7
Displacement at Peak Stress (mm)	2.0	2.7	9.0
Final Condition			
Bulk Density (Mg/m <sup>3</sup> )	2.40	2.49	2.44
Dry Density (Mg/m <sup>3</sup> )	2.13	2.23	2.24
Moisture Content (%)	13	12	9
Angle of Shearing Resistance ( $^{\circ}$ ) $\phi'$	32.5		
Cohesion Intercept (kPa) $c'$	14.0

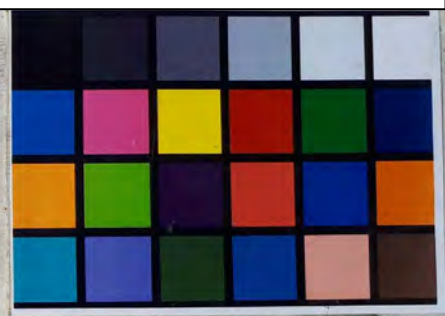
C.P/R.C01
	Rock Core Photographs
Client:	Iarnród Éireann
Engineer:	Jacob's
Date:	May - July 2020

**Job Name:** IARNÓD ÉIREANN  
 CORK LINE  
**Job No.:** 19-135  
**BH:** XC215-CP/R001  
**Depth:** 12.6 to 14.1 m  
**Box:** 3 OF 3  
**Date:** 18/8/20  
**Depth To:** 14.1 m

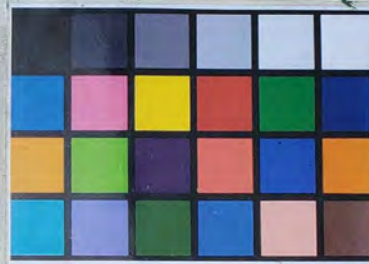
C.P/R.C02

**Date:** 07/8/20

**Depth To:** 8.1m
