Iarnród Éireann
Cork Line Level Crossings
XC215 (19-135-4)

T.PIT5
	Trial Pit Photographs
Client:	Iarnród Éireann
Engineer:	Jacob's
Date:	February 2020

Appendix F

Indirect CBR Test Results

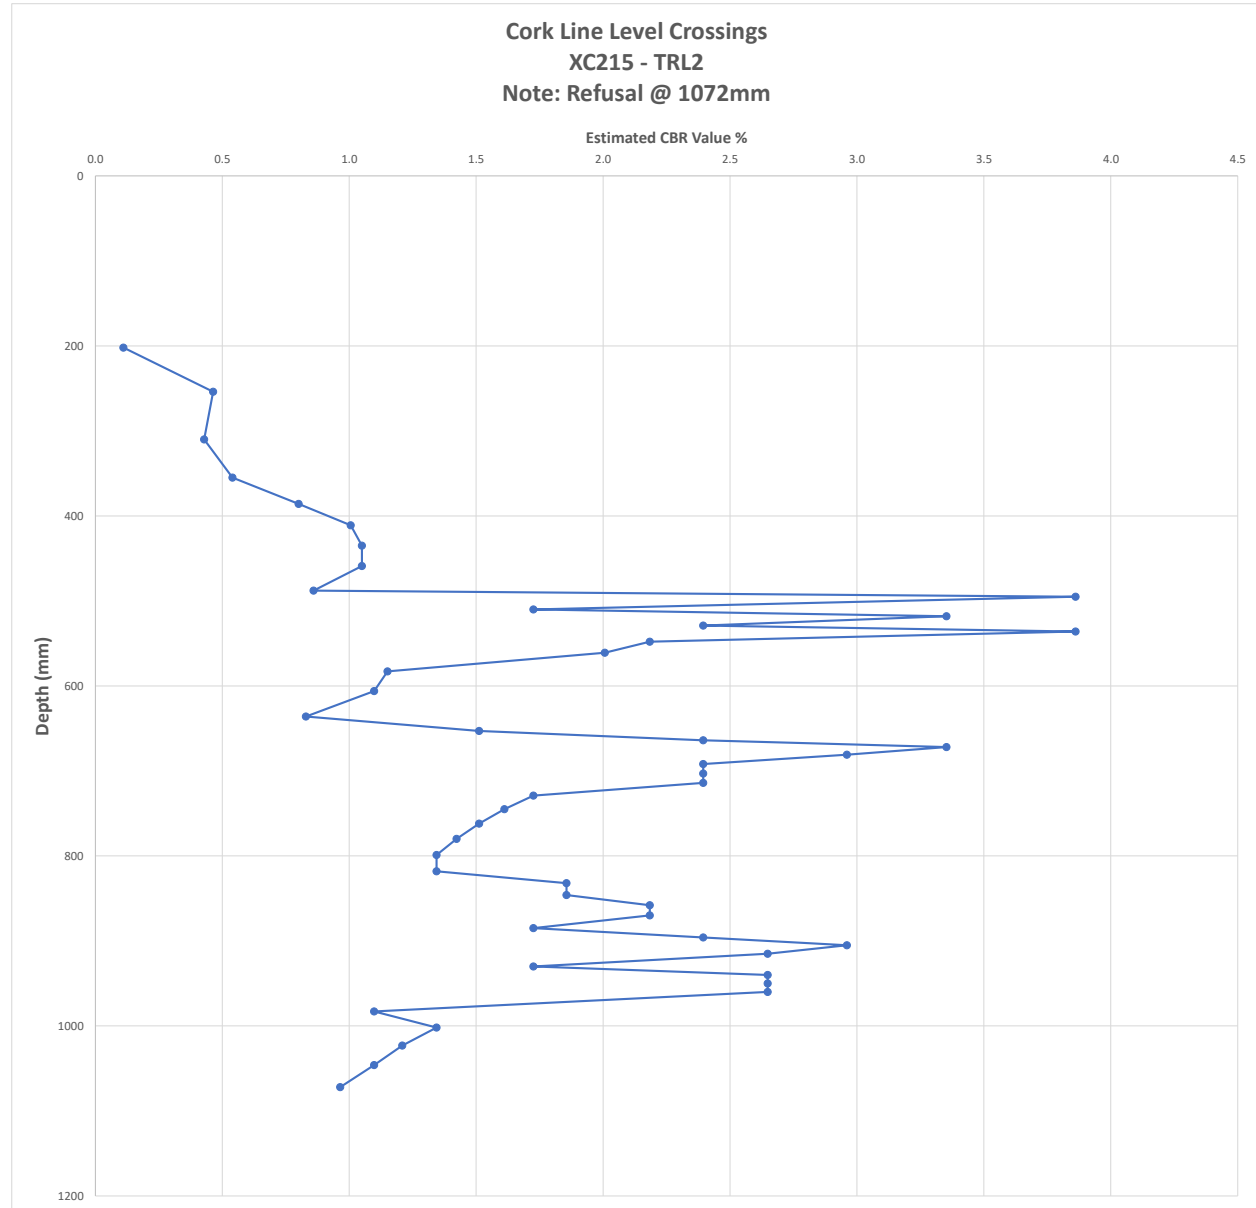
Location	XC215 - TRL2	Job No	19-135
----------	--------------	--------	--------

Cork Line Level Crossings - Irish Rail
 Transport Research Laboratory - Dynamic Cone Penetrometer Data

No. of Blows	READING (mm)	Penetration/blow (mm)	DEPTH	CBR %
1	948	202	202	0.1
2	896	52	254	0.5
3	840	56	310	0.4
4	795	45	355	0.5
5	764	31	386	0.8
6	739	25	411	1.0
7	715	24	435	1.0
8	691	24	459	1.0
9	662	29	488	0.9
10	655	7	495	3.9
11	640	15	510	1.7
12	632	8	518	3.4
13	621	11	529	2.4
14	614	7	536	3.9
15	602	12	548	2.2
16	589	13	561	2.0
17	567	22	583	1.2
18	544	23	606	1.1
19	514	30	636	0.8
20	497	17	653	1.5
21	486	11	664	2.4
22	478	8	672	3.4
23	469	9	681	3.0
24	458	11	692	2.4
25	447	11	703	2.4
26	436	11	714	2.4
27	421	15	729	1.7
28	405	16	745	1.6
29	388	17	762	1.5
30	370	18	780	1.4
31	351	19	799	1.3
32	332	19	818	1.3
33	318	14	832	1.9
34	304	14	846	1.9
35	292	12	858	2.2
36	280	12	870	2.2
37	265	15	885	1.7
38	254	11	896	2.4
39	245	9	905	3.0
40	235	10	915	2.6
41	220	15	930	1.7
42	210	10	940	2.6
43	200	10	950	2.6
44	190	10	960	2.6
45	167	23	983	1.1
46	148	19	1002	1.3
47	127	21	1023	1.2
48	104	23	1046	1.1
49	78	26	1072	1.0
50

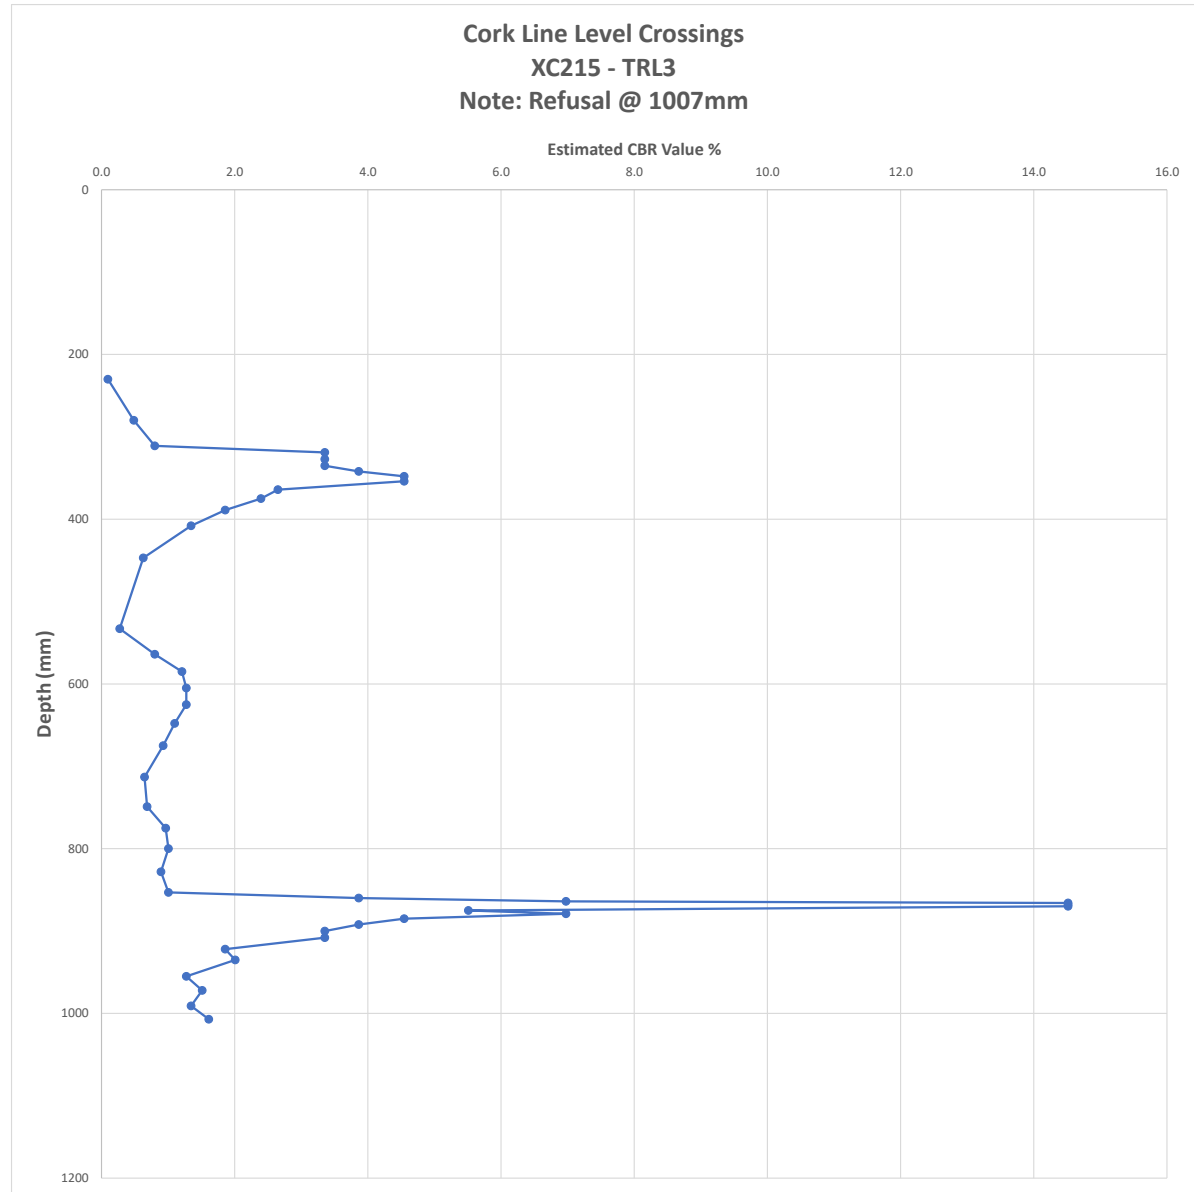
Location	XC215 - TRL3	Job No	19-135
----------	--------------	--------	--------

Cork Line Level Crossings - Irish Rail
 Transport Research Laboratory - Dynamic Cone Penetrometer Data

No. of Blows	READING (mm)	Penetration/blow (mm)	DEPTH	CBR %
1	920	230	230	0.1
2	870	50	280	0.5
3	839	31	311	0.8
4	831	8	319	3.4
5	823	8	327	3.4
6	815	8	335	3.4
7	808	7	342	3.9
8	802	6	348	4.5
9	796	6	354	4.5
10	786	10	364	2.6
11	775	11	375	2.4
12	761	14	389	1.9
13	742	19	408	1.3
14	703	39	447	0.6
15	617	86	533	0.3
16	586	31	564	0.8
17	565	21	585	1.2
18	545	20	605	1.3
19	525	20	625	1.3
20	502	23	648	1.1
21	475	27	675	0.9
22	437	38	713	0.6
23	401	36	749	0.7
24	375	26	775	1.0
25	350	25	800	1.0
26	322	28	828	0.9
27	297	25	853	1.0
28	290	7	860	3.9
29	286	4	864	7.0
30	284	2	866	14.5
31	282	2	868	14.5
32	280	2	870	14.5
33	275	5	875	5.5
34	271	4	879	7.0
35	265	6	885	4.5
36	258	7	892	3.9
37	250	8	900	3.4
38	242	8	908	3.4
39	228	14	922	1.9
40	215	13	935	2.0
41	195	20	955	1.3
42	178	17	972	1.5
43	159	19	991	1.3
44	143	16	1007	1.6
45

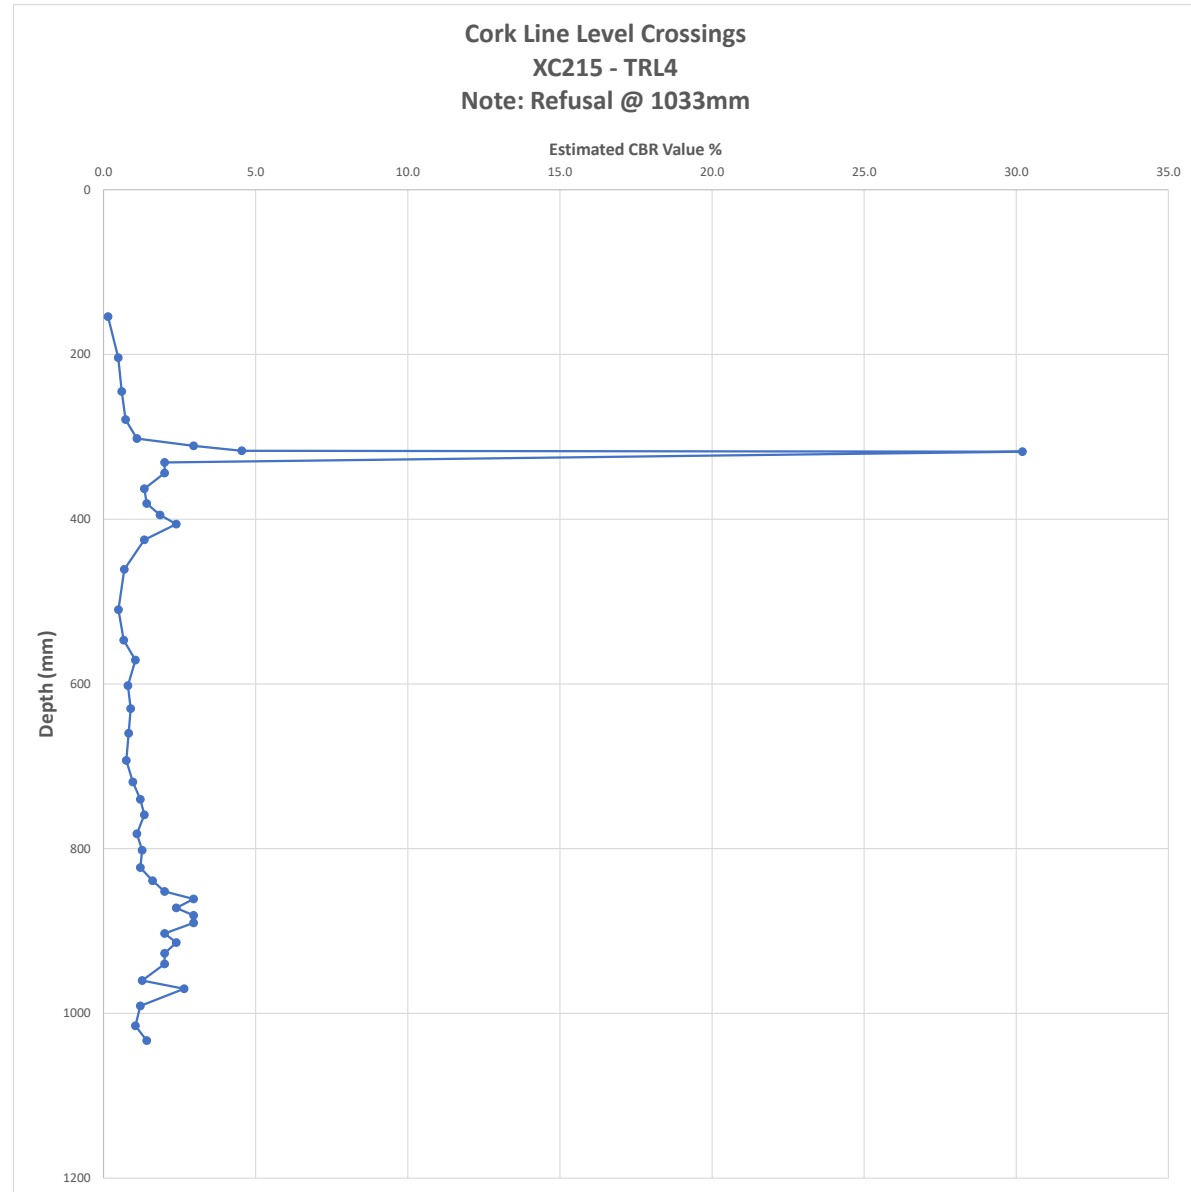
Location	XC215 - TRL4	Job No	19-135
----------	--------------	--------	--------

Cork Line Level Crossings - Irish Rail
 Transport Research Laboratory - Dynamic Cone Penetrometer Data

No. of Blows	READING (mm)	Penetration/blow (mm)	DEPTH	CBR %
1	996	154	154	0.1
2	946	50	204	0.5
3	905	41	245	0.6
4	871	34	279	0.7
5	848	23	302	1.1
6	839	9	311	3.0
7	833	6	317	4.5
8	832	1	318	30.2
9	819	13	331	2.0
10	806	13	344	2.0
11	787	19	363	1.3
12	769	18	381	1.4
13	755	14	395	1.9
14	744	11	406	2.4
15	725	19	425	1.3
16	689	36	461	0.7
17	640	49	510	0.5
18	603	37	547	0.7
19	579	24	571	1.0
20	548	31	602	0.8
21	520	28	630	0.9
22	490	30	660	0.8
23	457	33	693	0.7
24	431	26	719	1.0
25	410	21	740	1.2
26	391	19	759	1.3
27	368	23	782	1.1
28	348	20	802	1.3
29	327	21	823	1.2
30	311	16	839	1.6
31	298	13	852	2.0
32	289	9	861	3.0
33	278	11	872	2.4
34	269	9	881	3.0
35	260	9	890	3.0
36	247	13	903	2.0
37	236	11	914	2.4
38	223	13	927	2.0
39	210	13	940	2.0
40	190	20	960	1.3
41	180	10	970	2.6
42	159	21	991	1.2
43	135	24	1015	1.0
44	117	18	1033	1.4
45

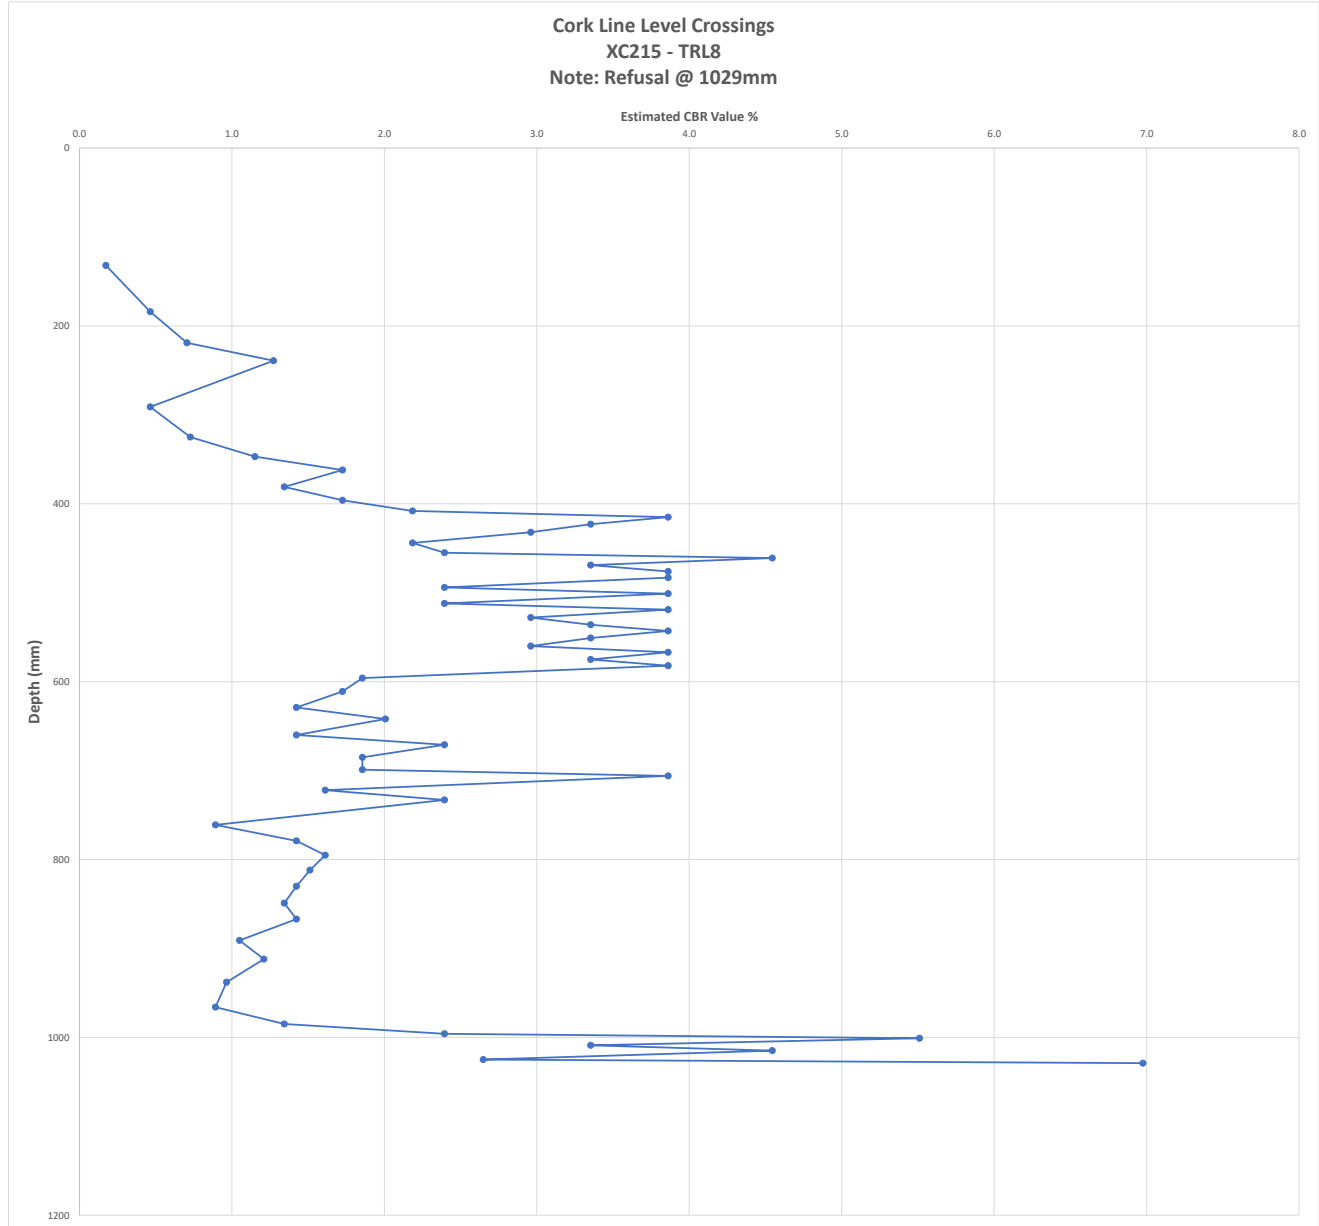
Location	XC215 - TRL8	Job No	19-135
----------	--------------	--------	--------

Cork Line Level Crossings - Irish Rail
 Transport Research Laboratory - Dynamic Cone Penetrometer Data

No. of Blows	READING (mm)	Penetration/blow (mm)	DEPTH	CBR %
1	1018	132	132	0.2
2	966	52	184	0.5
3	931	35	219	0.7
4	911	20	239	1.3
5	859	52	291	0.5
6	825	34	325	0.7
7	803	22	347	1.2
8	788	15	362	1.7
9	769	19	381	1.3
10	754	15	396	1.7
11	742	12	408	2.2
12	735	7	415	3.9
13	727	8	423	3.4
14	718	9	432	3.0
15	706	12	444	2.2
16	695	11	455	2.4
17	689	6	461	4.5
18	681	8	469	3.4
19	674	7	476	3.9
20	667	7	483	3.9
21	656	11	494	2.4
22	649	7	501	3.9
23	638	11	512	2.4
24	631	7	519	3.9
25	622	9	528	3.0
26	614	8	536	3.4
27	607	7	543	3.9
28	599	8	551	3.4
29	590	9	560	3.0
30	583	7	567	3.9
31	575	8	575	3.4
32	568	7	582	3.9
33	554	14	596	1.9
34	539	15	611	1.7
35	521	18	629	1.4
36	508	13	642	2.0
37	490	18	660	1.4
38	479	11	671	2.4
39	465	14	685	1.9
40	451	14	699	1.9
41	444	7	706	3.9
42	428	16	722	1.6
43	417	11	733	2.4
44	389	28	761	0.9
45	371	18	779	1.4
46	355	16	795	1.6
47	338	17	812	1.5
48	320	18	830	1.4
49	301	19	849	1.3
50	283	18	867	1.4
51	259	24	891	1.0

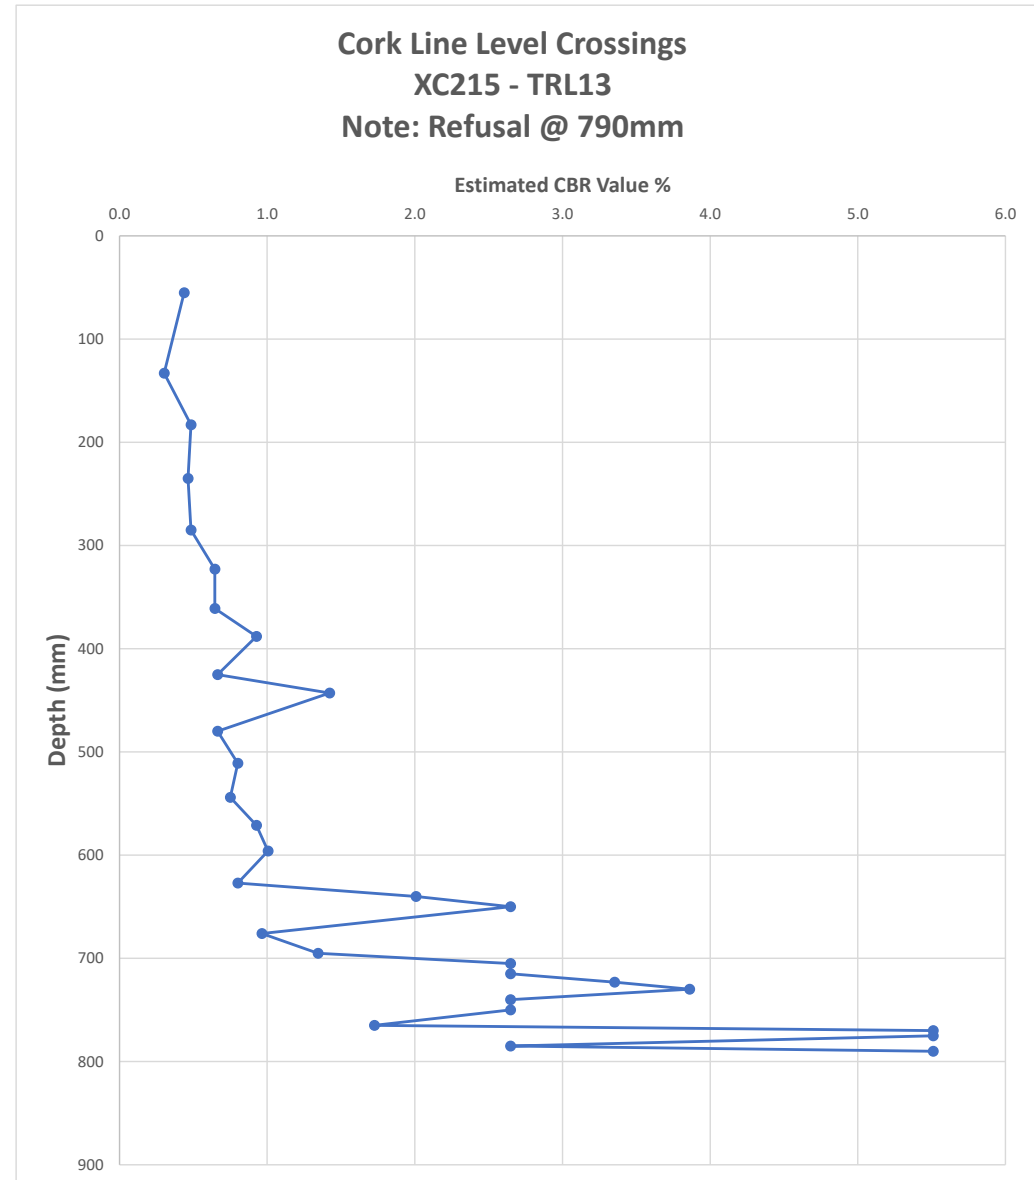
Location	XC215 - TRL13	Job No	19-135
----------	----------------------	--------	--------

Cork Line Level Crossings - Irish Rail
Transport Research Laboratory - Dynamic Cone Penetrometer Data

No. of Blows	READING (mm)	Penetration/blow (mm)	DEPTH	CBR %
1	995	55	55	0.4
2	917	78	133	0.3
3	867	50	183	0.5
4	815	52	235	0.5
5	765	50	285	0.5
6	727	38	323	0.6
7	689	38	361	0.6
8	662	27	388	0.9
9	625	37	425	0.7
10	607	18	443	1.4
11	570	37	480	0.7
12	539	31	511	0.8
13	506	33	544	0.7
14	479	27	571	0.9
15	454	25	596	1.0
16	423	31	627	0.8
17	410	13	640	2.0
18	400	10	650	2.6
19	374	26	676	1.0
20	355	19	695	1.3
21	345	10	705	2.6
22	335	10	715	2.6
23	327	8	723	3.4
24	320	7	730	3.9
25	310	10	740	2.6
26	300	10	750	2.6
27	285	15	765	1.7
28	280	5	770	5.5
29	275	5	775	5.5
30	265	10	785	2.6
31	260	5	790	5.5
32	260	0	790	
33	260	0	790	
34

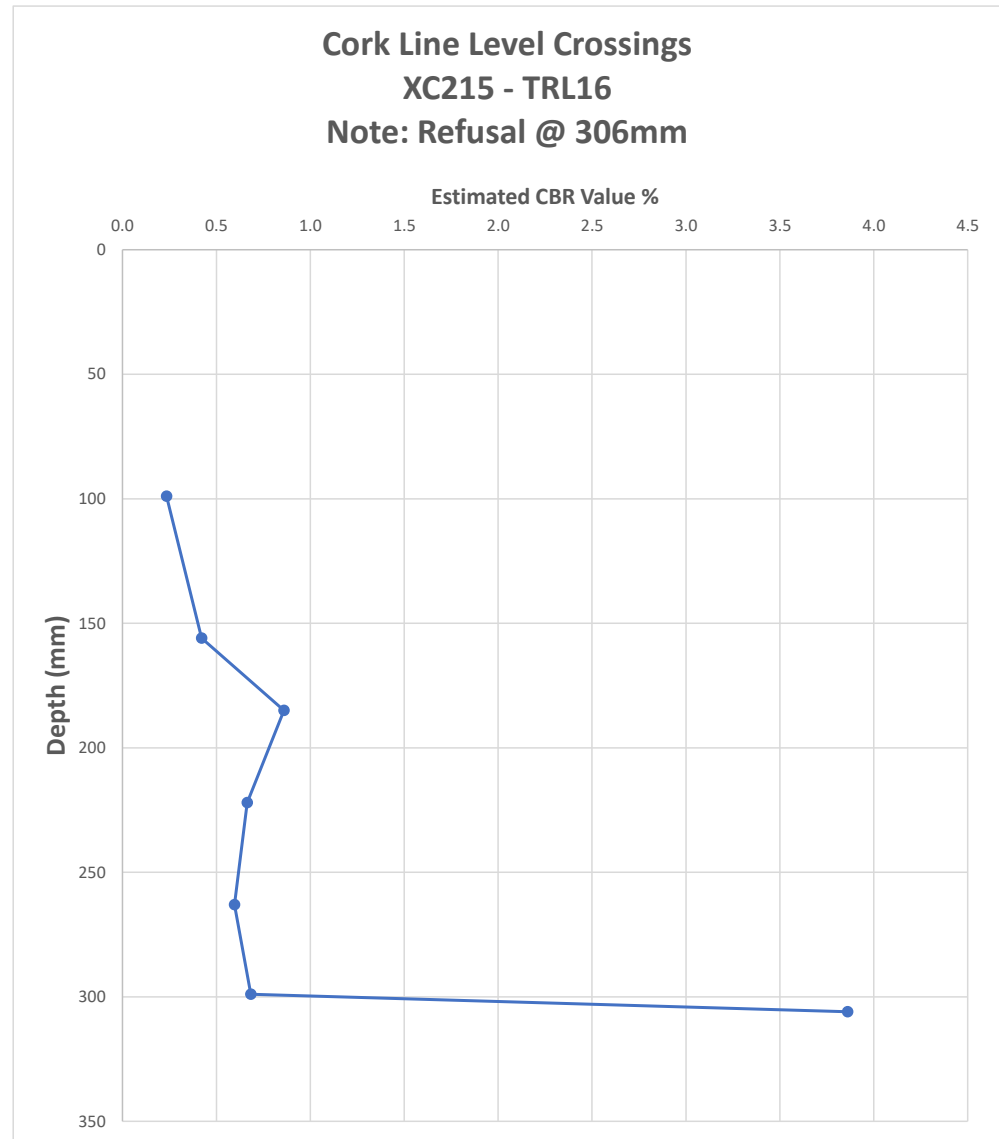
Location	XC215 - TRL16	Job No	19-135
----------	----------------------	--------	--------

Transport Research Laboratory - Dynamic Cone Penetrometer Data

No. of Blows	READING (mm)	Penetration/blow (mm)	DEPTH	CBR %
1	957	99	99	0.2
2	900	57	156	0.4
3	871	29	185	0.9
4	834	37	222	0.7
5	793	41	263	0.6
6	757	36	299	0.7
7	750	7	306	3.9
8	750	0	306	
9	750	0	306	
10

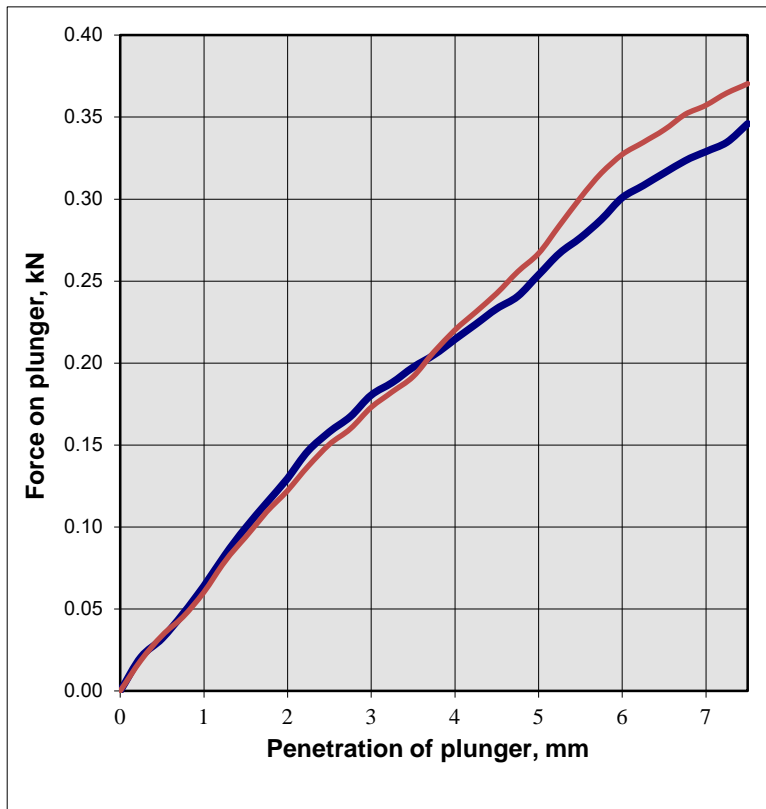
LABORATORY TEST REPORT
 DETERMINATION OF CALIFORNIA BEARING RATIO - BS 1377 : Part 4 : 1990

Penetration (mm)	Force (kN)	Standard Force (kN)	Top CBR (%)
2.5	0.16	13.2	1.2
5.0	0.25	20.0	1.3
Moisture content : %	19.5	Mean CBR value : %	1.2
Penetration (mm)	Force (kN)	Standard Force (kN)	Bottom CBR (%)
2.5	0.15	13.2	1.1
5.0	0.27	20.0	1.3
Moisture content : %	19.5	Mean CBR value : %	1.2

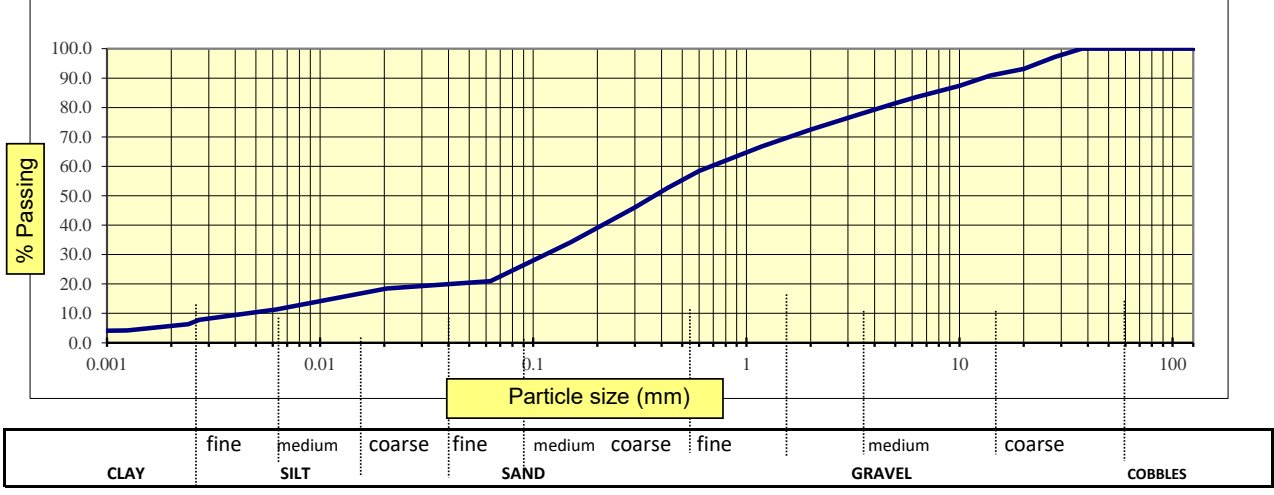
BS Sieve Size	% Passing	Specification
300 mm	100	
125 mm	100	
100 mm	100	
75 mm	100	
63 mm	100	
50 mm	100	
37.5 mm	100	
28 mm	97	
20 mm	93	
14 mm	91	
10 mm	87	
6.3 mm	84	
5 mm	81	
3.35 mm	78	
2 mm	72	
1.18 mm	67	
0.6 mm	58	
0.425 mm	53	
0.3 mm	46	
0.15 mm	34	
0.063 mm	21	
0.020 mm	18	
0.006 mm	11	
0.003 mm	8	
0.002 mm	6	
0.001 mm	4

Tested in accordance with BS 1377: Part 2 : 1990 Clause 9.2 and 9.5

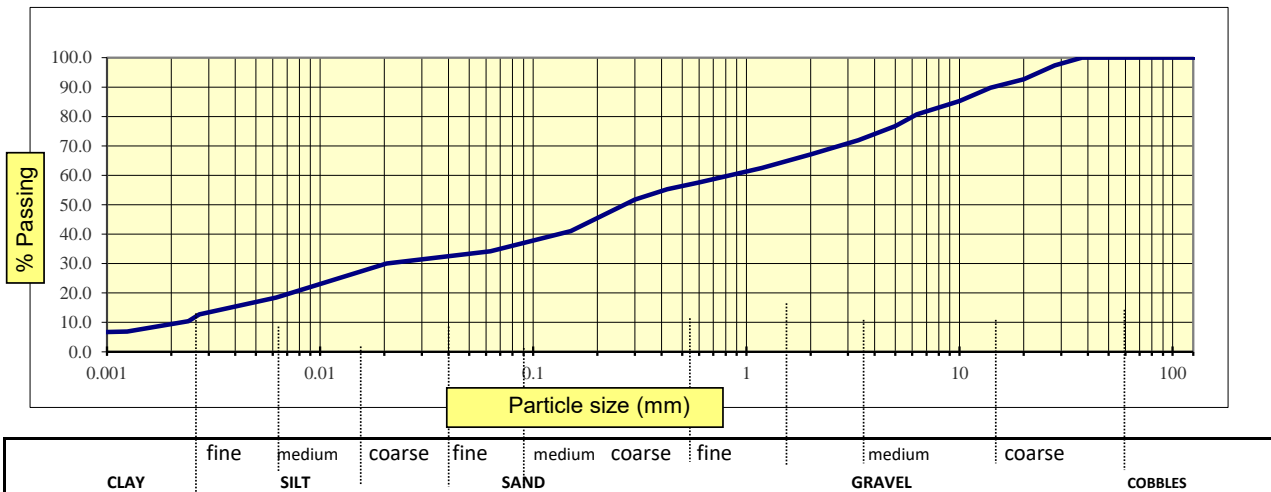
BS Sieve Size	% Passing	Specification
300 mm	100	
125 mm	100	
100 mm	100	
75 mm	100	
63 mm	100	
50 mm	100	
37.5 mm	100	
28 mm	97	
20 mm	93	
14 mm	90	
10 mm	85	
6.3 mm	81	
5 mm	77	
3.35 mm	72	
2 mm	67	
1.18 mm	63	
0.6 mm	58	
0.425 mm	55	
0.3 mm	52	
0.15 mm	41	
0.063 mm	34	
0.020 mm	30	
0.006 mm	19	
0.003 mm	13	
0.002 mm	10	
0.001 mm	7

Tested in accordance with BS 1377: Part 2 : 1990 Clause 9.2 and 9.5
