Iarnród Éireann  
Cork Line Level Crossings  
XC219 (19-135-5)

Rock Core Photographs

## **Trial Pit Logs**

## **Trial Pit Photographs**

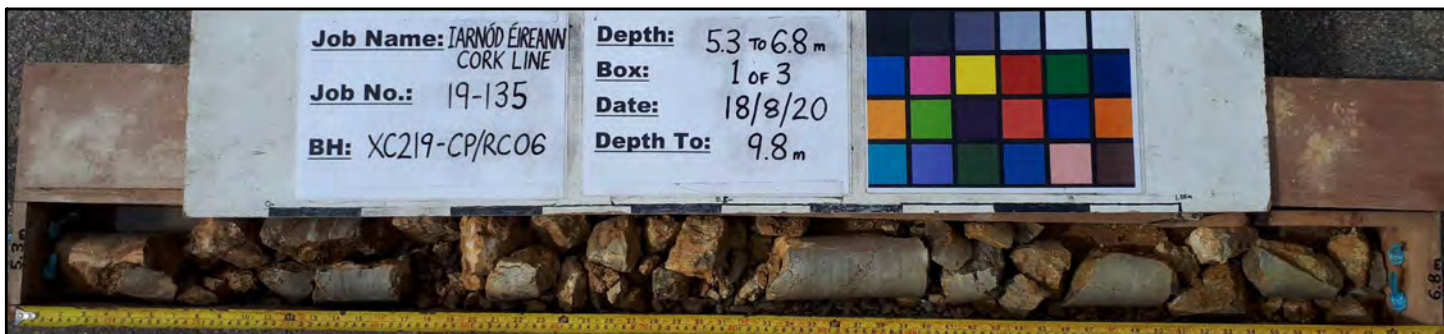
**Job Name:** IARNÓD ÉIREANN  
CORK LINE  
**Job No.:** 19-135  
**BH:** XC219-CP/RC06

**Depth:** 5.3 To 6.8 m  
**Box:** 1 of 3  
**Date:** 18/8/20  
**Depth To:** 9.8 m

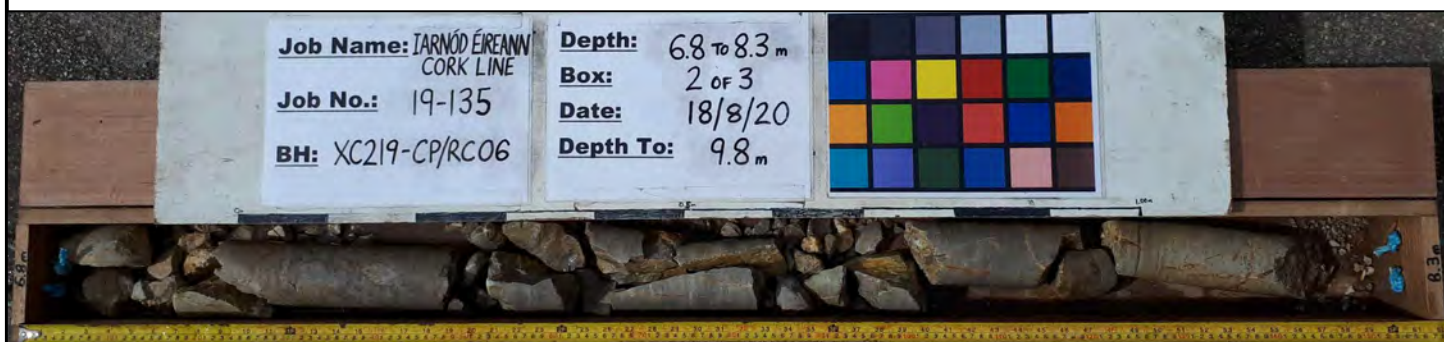
**Job Name:** IARNÓD ÉIREANN  
CORK LINE  
**Job No.:** 19-135  
**BH:** XC219-CP/RC06

**Depth:** 6.8 To 8.3 m  
**Box:** 2 of 3  
**Date:** 18/8/20  
**Depth To:** 9.8 m

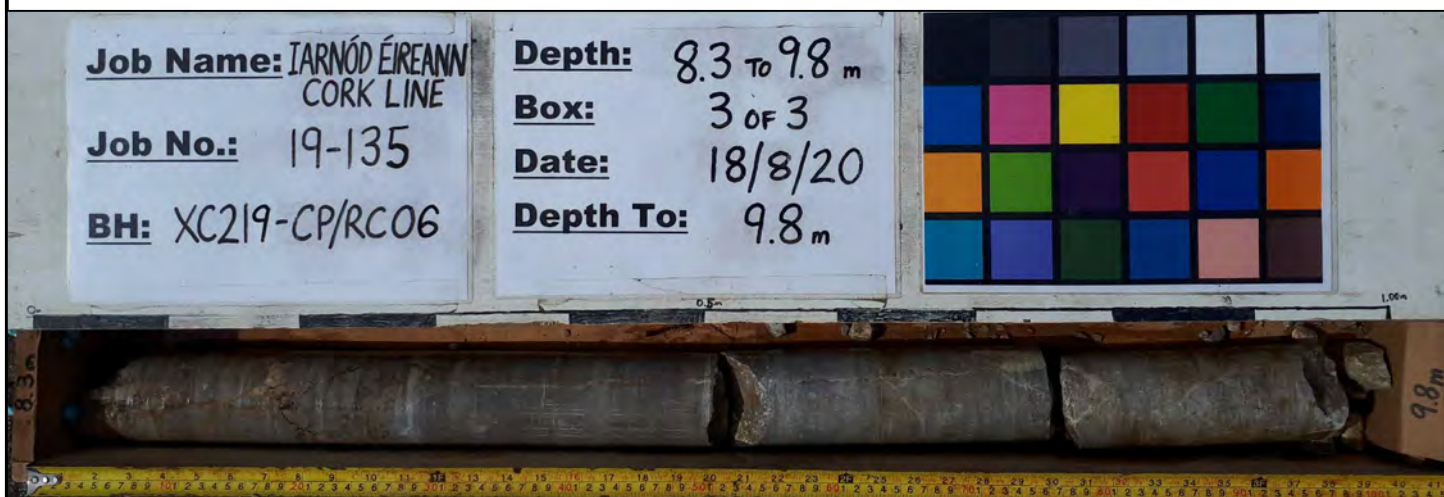
**Job Name:** IARNÓD ÉIREANN  
CORK LINE  
**Job No.:** 19-135  
**BH:** XC219-CP/RC06

**Depth:** 8.3 To 9.8 m  
**Box:** 3 of 3  
**Date:** 18/8/20  
**Depth To:** 9.8 m

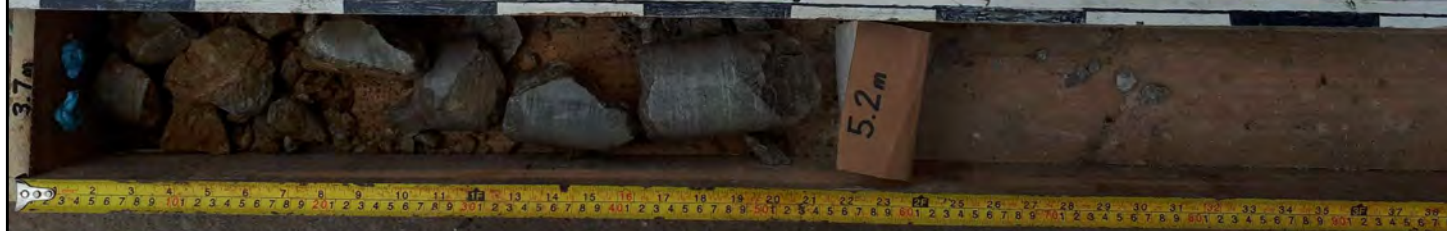
**BH:** XC219-CP/RC07

**Depth:** 3.7 To 5.2 m

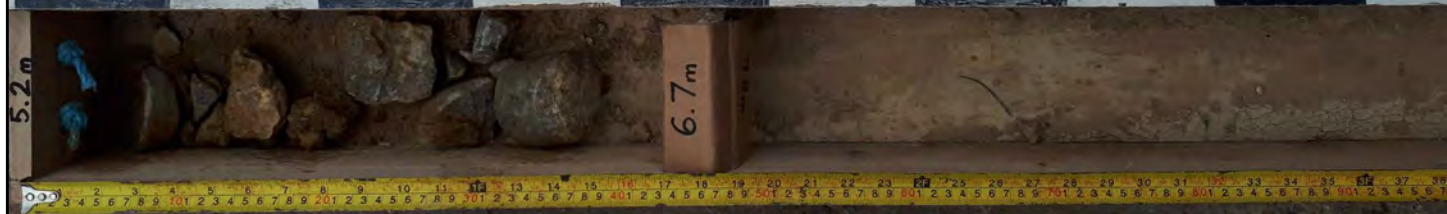
**BH:** XC219-CP/RC07

**Depth:** 5.2 To 6.7 m
