Iarnród Éireann  
Cork Line Level Crossings  
XC201 (19-135-1)

T.PIT4
	Trial Pit Photographs
Client:	Iarnród Éireann
Engineer:	Jacob's
Date:	July 2020

## **Appendix E**

## **Indirect CBR Test Data**

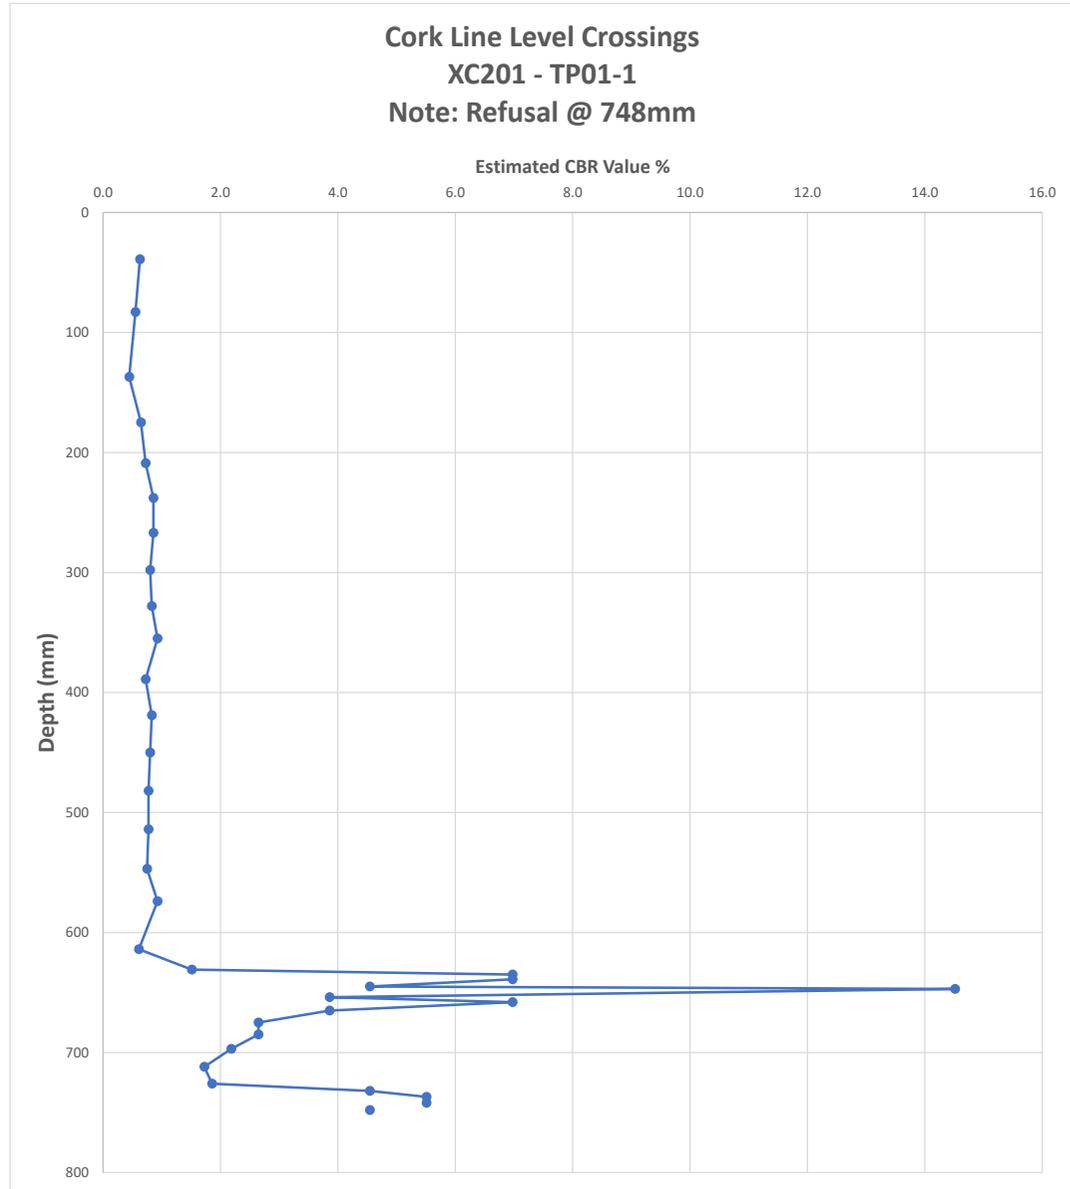
Location	XC201 - TP01-1	Job No	19-135
----------	----------------	--------	--------

Cork Line Level Crossings - Irish Rail  
 Transport Research Laboratory - Dynamic Cone Penetrometer Data

No. of Blows	READING (mm)	Penetration/blow (mm)	DEPTH	CBR %
1	1101	39	39	0.6
2	1057	44	83	0.6
3	1003	54	137	0.4
4	965	38	175	0.6
5	931	34	209	0.7
6	902	29	238	0.9
7	873	29	267	0.9
8	842	31	298	0.8
9	812	30	328	0.8
10	785	27	355	0.9
11	751	34	389	0.7
12	721	30	419	0.8
13	690	31	450	0.8
14	658	32	482	0.8
15	626	32	514	0.8
16	593	33	547	0.7
17	566	27	574	0.9
18	526	40	614	0.6
19	509	17	631	1.5
20	505	4	635	7.0
21	501	4	639	7.0
22	495	6	645	4.5
23	493	2	647	14.5
24	486	7	654	3.9
25	482	4	658	7.0
26	475	7	665	3.9
27	465	10	675	2.6
28	455	10	685	2.6
29	443	12	697	2.2
30	428	15	712	1.7
31	414	14	726	1.9
32	408	6	732	4.5
33	403	5	737	5.5
34	398	5	742	5.5
35	398	0	742	
36	392	6	748	4.5
37	392	0	748	
38	392	0	748

The test results are presented in Appendix E in the form of plots of the variation with depth of the cumulative blow count. Straight lines have been fitted to the plots and the CBR for each depth range estimated using the following relationship, as proposed by DTP Interim Advice Note 73/06 (Design Guidance for Road Pavement Foundations):

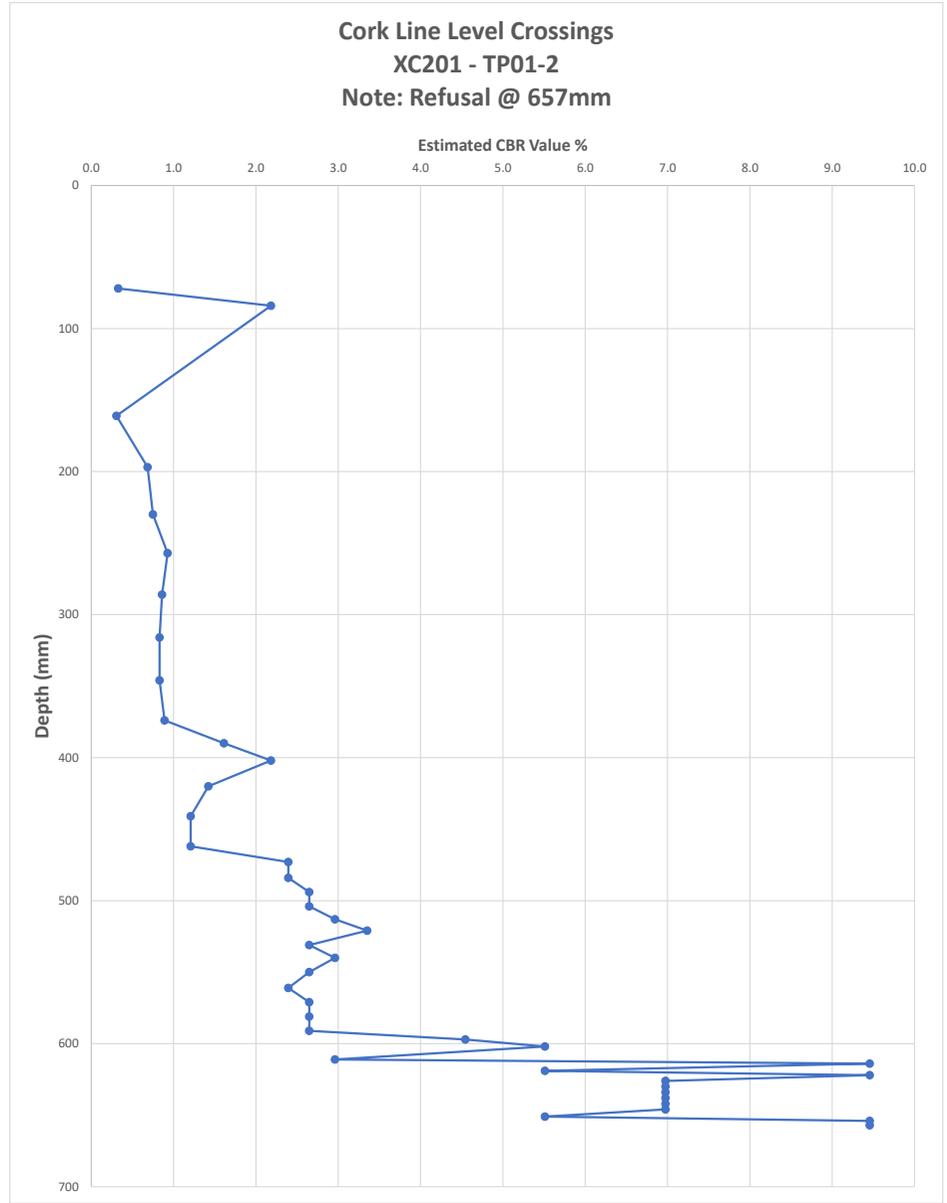
Location	XC201 - TP01-2	Job No	19-135
----------	----------------	--------	--------

Cork Line Level Crossings - Irish Rail  
 Transport Research Laboratory - Dynamic Cone Penetrometer Data

No. of Blows	READING (mm)	Penetration/blow (mm)	DEPTH	CBR %
1	1068	72	72	0.3
2	1056	12	84	2.2
3	979	77	161	0.3
4	943	36	197	0.7
5	910	33	230	0.7
6	883	27	257	0.9
7	854	29	286	0.9
8	824	30	316	0.8
9	794	30	346	0.8
10	766	28	374	0.9
11	750	16	390	1.6
12	738	12	402	2.2
13	720	18	420	1.4
14	699	21	441	1.2
15	678	21	462	1.2
16	667	11	473	2.4
17	656	11	484	2.4
18	646	10	494	2.6
19	636	10	504	2.6
20	627	9	513	3.0
21	619	8	521	3.4
22	609	10	531	2.6
23	600	9	540	3.0
24	590	10	550	2.6
25	579	11	561	2.4
26	569	10	571	2.6
27	559	10	581	2.6
28	549	10	591	2.6
29	543	6	597	4.5
30	538	5	602	5.5
31	529	9	611	3.0
32	526	3	614	9.5
33	521	5	619	5.5
34	518	3	622	9.5
35	514	4	626	7.0
36	510	4	630	7.0
37	506	4	634	7.0
38	502	4	638	7.0
39	498	4	642	7.0
40	494	4	646	7.0
41	489	5	651	5.5
42	486	3	654	9.5
43	483	3	657	9.5
44	483	0	657	
45	483	0	657

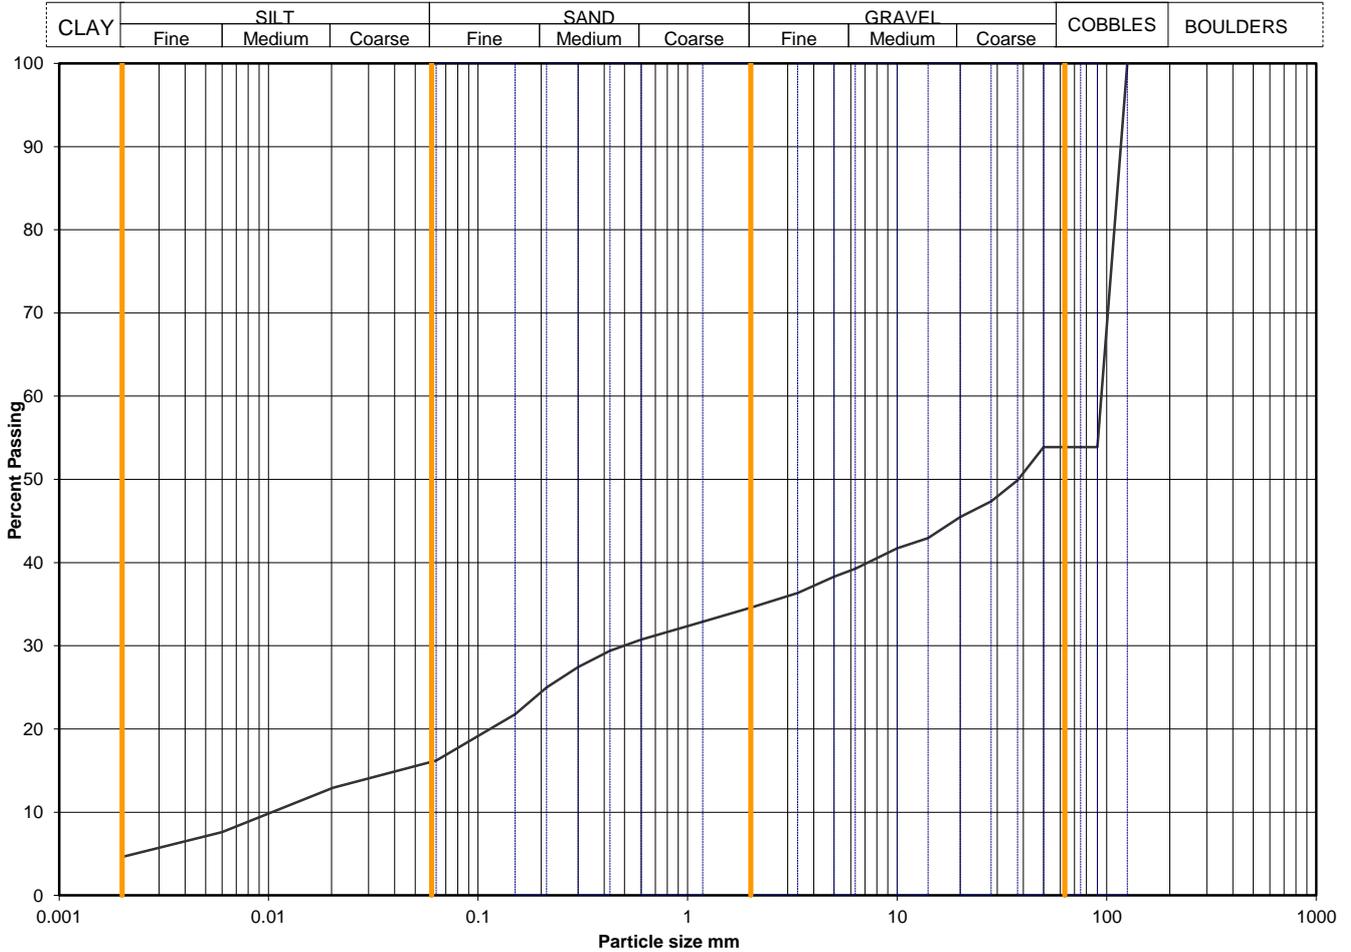
<b>Sample Details:</b>	SAMPLE ID:	Hole No	XC201-CP01
	SOCO202008042	Sample Depth (m BGL)	1.20 - 2.00
		Sample Type and No	B5
		Specimen Ref

Sieving		Sedimentation	
Particle Size mm	% Passing	Particle Size mm	% Passing
125	100	0.0203	13
90	54	0.0060	8
75	54	0.0020	5
63	54		
50	54		
37.5	50		
28	47		
20	45		
14	43		
10	42		
6.3	39		
5.0	38		
3.35	36		
2.00	35		
1.18	33		
0.600	31	Particle density, Mg/m <sup>3</sup>	
0.425	29	2.65	assumed
0.300	27	Dry mass of sample, kg	
0.212	25	7.1	
0.150	22		
0.063	16

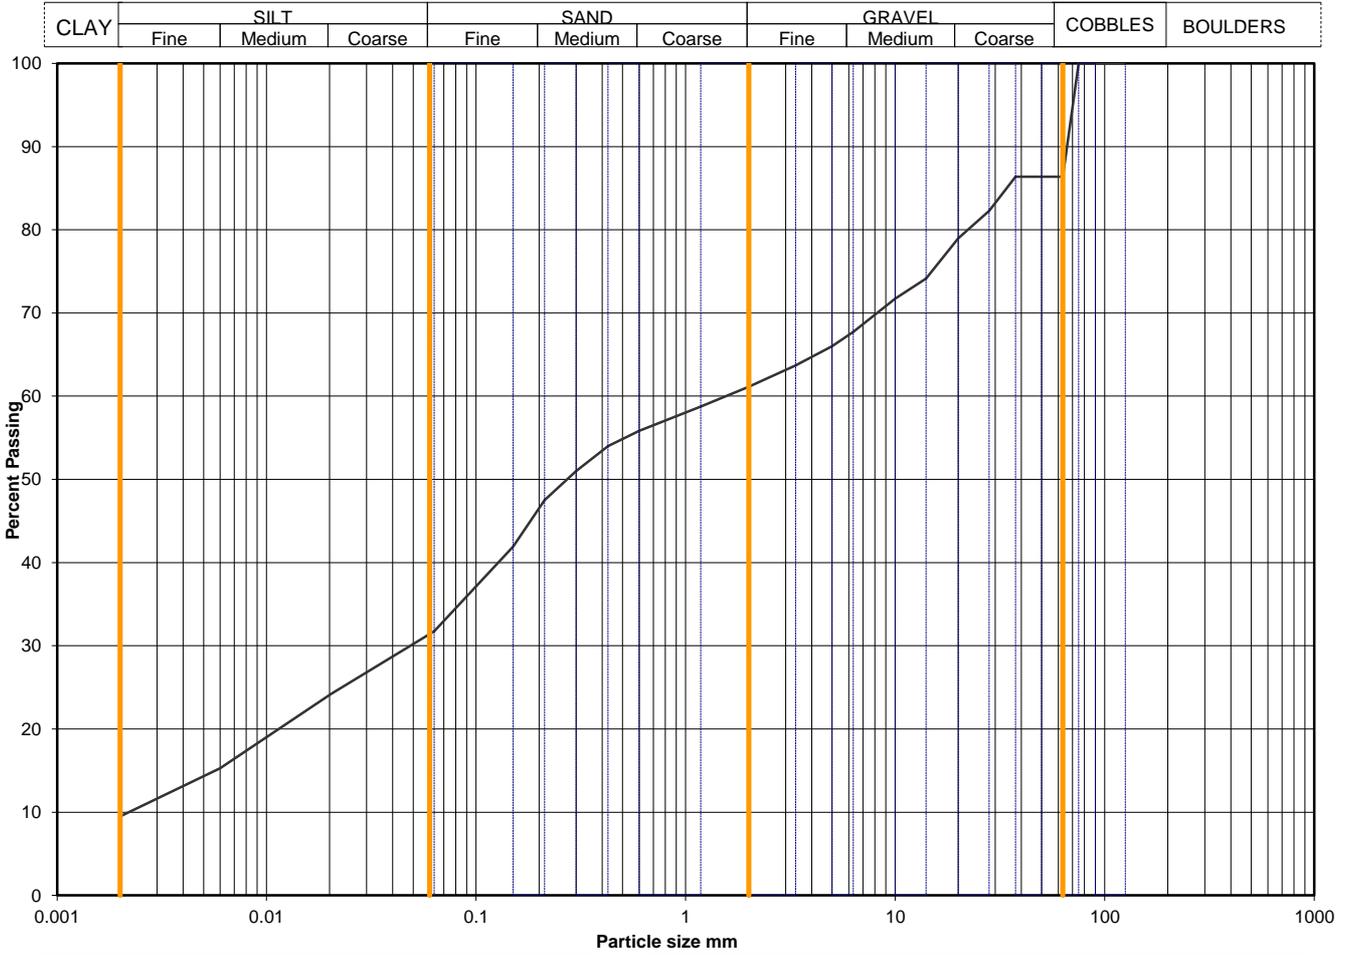
<b>Sample Details:</b>	SAMPLE ID:	Hole No	XC201-CP01A
	SOCO202008044	Sample Depth (m BGL)	2.00 - 3.00
		Sample Type and No	B7
		Specimen Ref

Sieving		Sedimentation	
Particle Size mm	% Passing	Particle Size mm	% Passing
125	100	0.0203	24
90	100	0.0060	15
75	100	0.0020	9
63	86		
50	86		
37.5	86		
28	82		
20	79		
14	74		
10	72		
6.3	68		
5.0	66		
3.35	64		
2.00	61		
1.18	59		
0.600	56	Particle density, Mg/m <sup>3</sup>	
0.425	54	2.65	assumed
0.300	51	Dry mass of sample, kg	
0.212	48	3.0	
0.150	42		
0.063	32

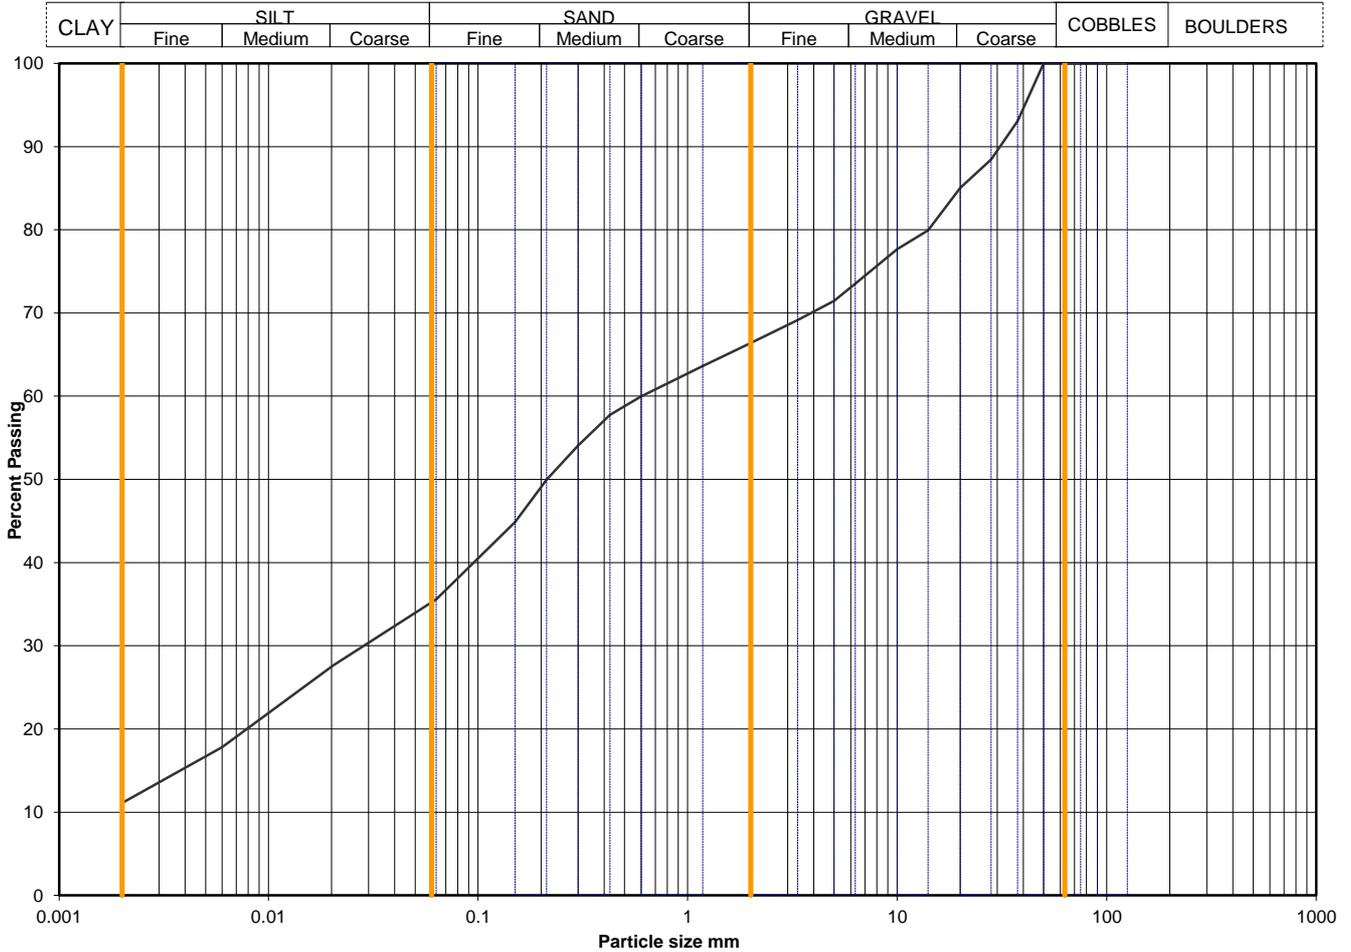
<b>Sample Details:</b>	SAMPLE ID:	Hole No	XC201-CP02
	SOCO202008046	Sample Depth (m BGL)	1.20 - 2.00
		Sample Type and No	B5
		Specimen Ref

Sieving		Sedimentation	
Particle Size mm	% Passing	Particle Size mm	% Passing
125	100	0.0203	28
90	100	0.0060	18
75	100	0.0020	11
63	100		
50	100		
37.5	93		
28	88		
20	85		
14	80		
10	78		
6.3	74		
5.0	71		
3.35	69		
2.00	66		
1.18	64		
0.600	60		
0.425	58		
0.300	54		
0.212	50		
0.150	45		
0.063	36		
		Particle density, Mg/m <sup>3</sup>	
		2.65 assumed	
		Dry mass of sample, kg	
		2.9

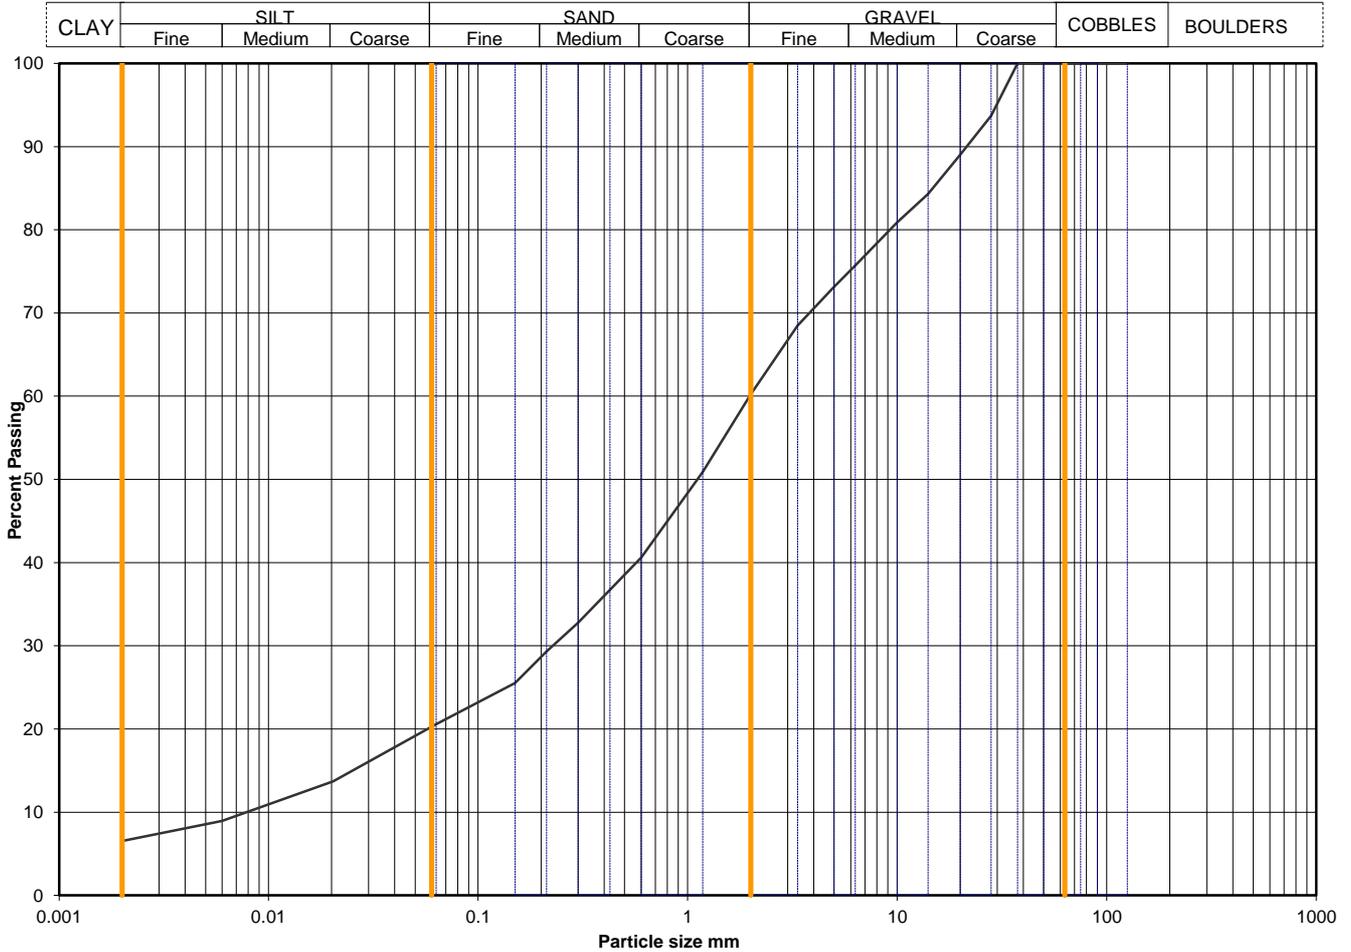
Sample Details:	SAMPLE ID:	Hole No	XC201-CPRC01
	SOCO2020080416	Sample Depth (m BGL)	3.20 - 3.70
		Sample Type and No	B15
		Specimen Ref

Sieving		Sedimentation	
Particle Size mm	% Passing	Particle Size mm	% Passing
125	100	0.0203	14
90	100	0.0060	9
75	100	0.0020	7
63	100		
50	100		
37.5	100		
28	94		
20	89		
14	84		
10	81		
6.3	76		
5.0	73		
3.35	69		
2.00	60		
1.18	51		
0.600	41	Particle density, Mg/m <sup>3</sup>	
0.425	37	2.65	assumed
0.300	33	Dry mass of sample, kg	
0.212	29	2.7	
0.150	26		
0.063	21

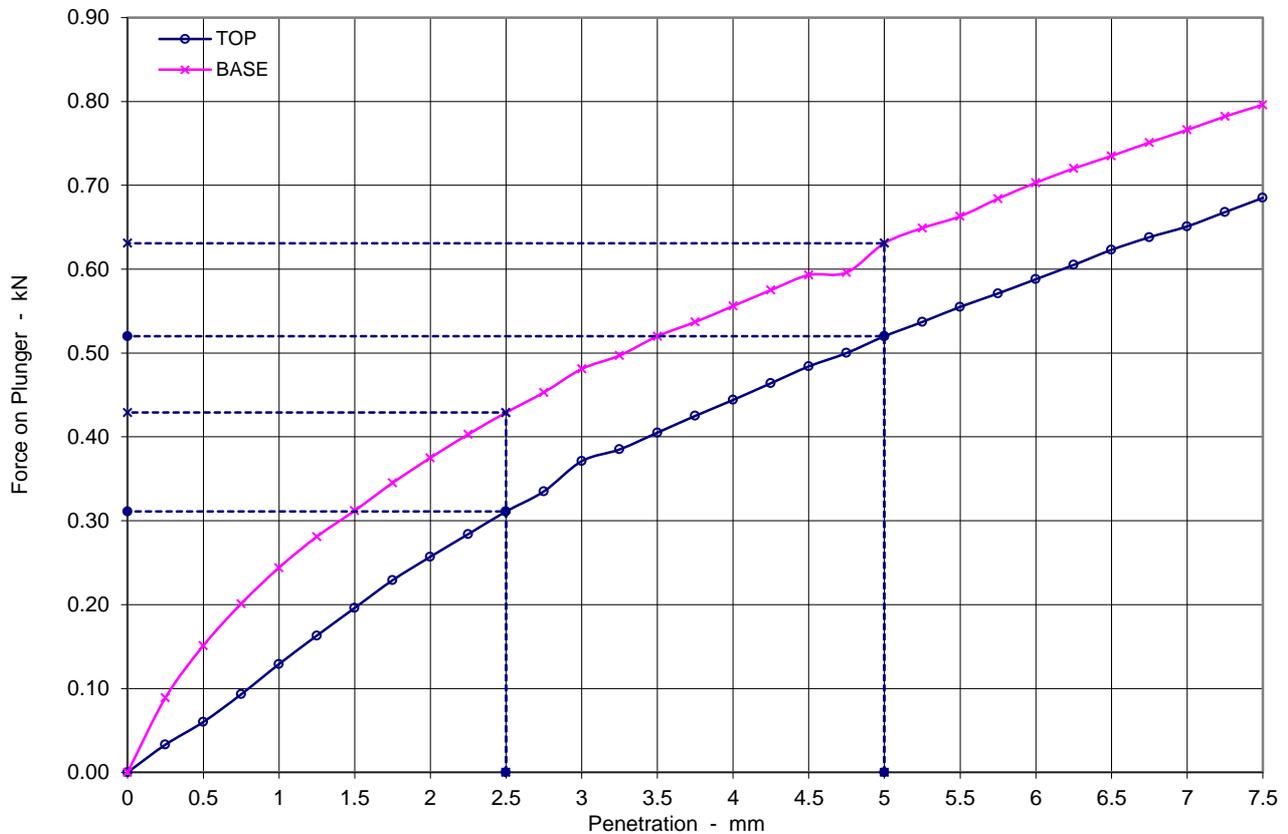
Sample Details:	SAMPLE ID:	Hole No	XC201-TP01
	SOCO202010024	Sample Depth (m)	0.50 - 1.00
		Sample Type and No	D1
		Specimen Ref	1

Soil description	Brown slightly sandy gravelly CLAY.
------------------	-------------------------------------

Test Conditions		
Sample Retained on 20 mm sieve	%	17

Sample Conditions		
Initial Moisture Content	%	12.0
Bulk Density	Mg/m <sup>3</sup>	1.97
Dry Density	Mg/m <sup>3</sup>	1.77
Moisture Content - TOP	%	11.0
Moisture Content - BASE	%	12.0

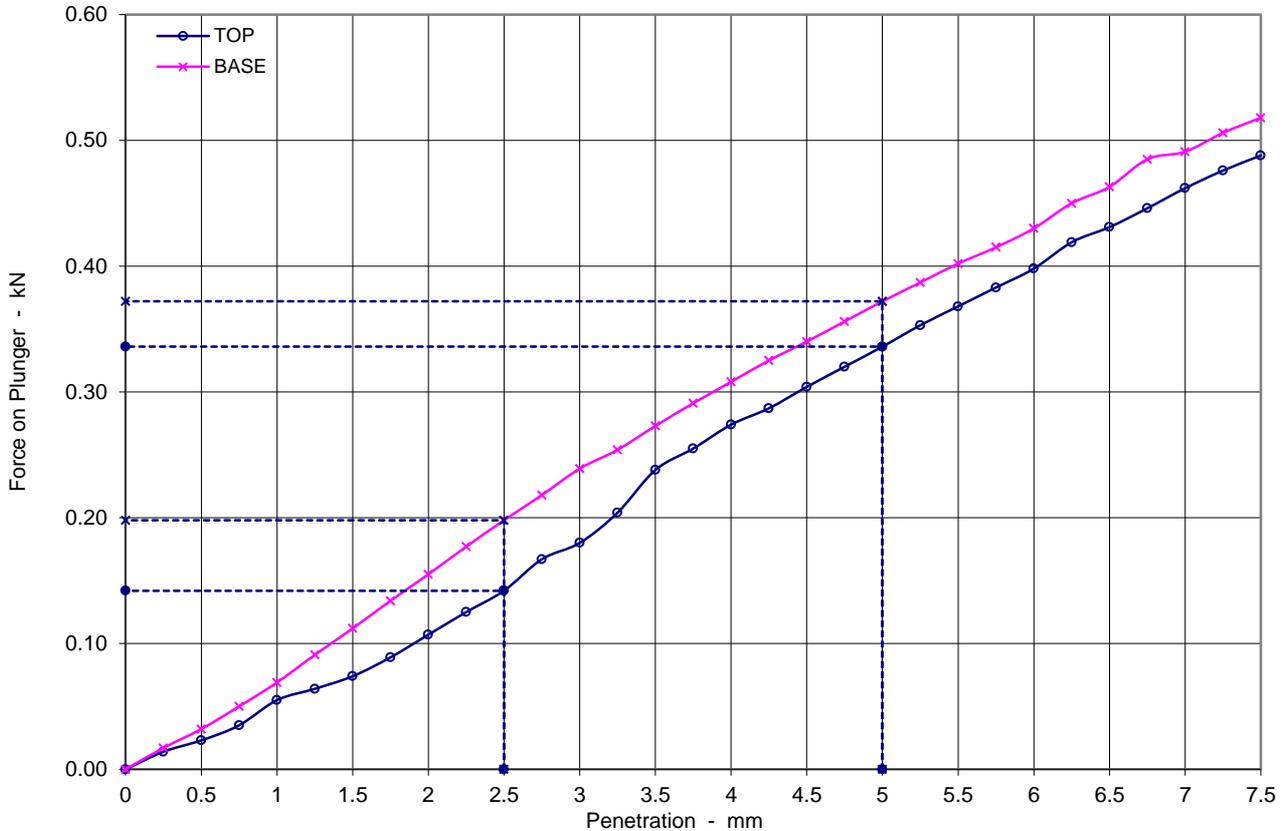
Sample Details:	SAMPLE ID:	Hole No	XC201-TP04
	SOCO2020100233	Sample Depth (m)	2.00 - 2.50
		Sample Type and No	B8
		Specimen Ref	1

Soil description	Brown slightly sandy slightly gravelly CLAY.
------------------	--

Test Conditions		
Sample Retained on 20 mm sieve	%	0

Sample Conditions		
Initial Moisture Content	%	10.0
Bulk Density	Mg/m <sup>3</sup>	2.12
Dry Density	Mg/m <sup>3</sup>	1.92
Moisture Content - TOP	%	10.0
Moisture Content - BASE	%	10.0
