Rosslare ORE Hub

Technical Appendix 16:

Cultural Heritage

Rosslare Europort Archaeological Desktop Assessment

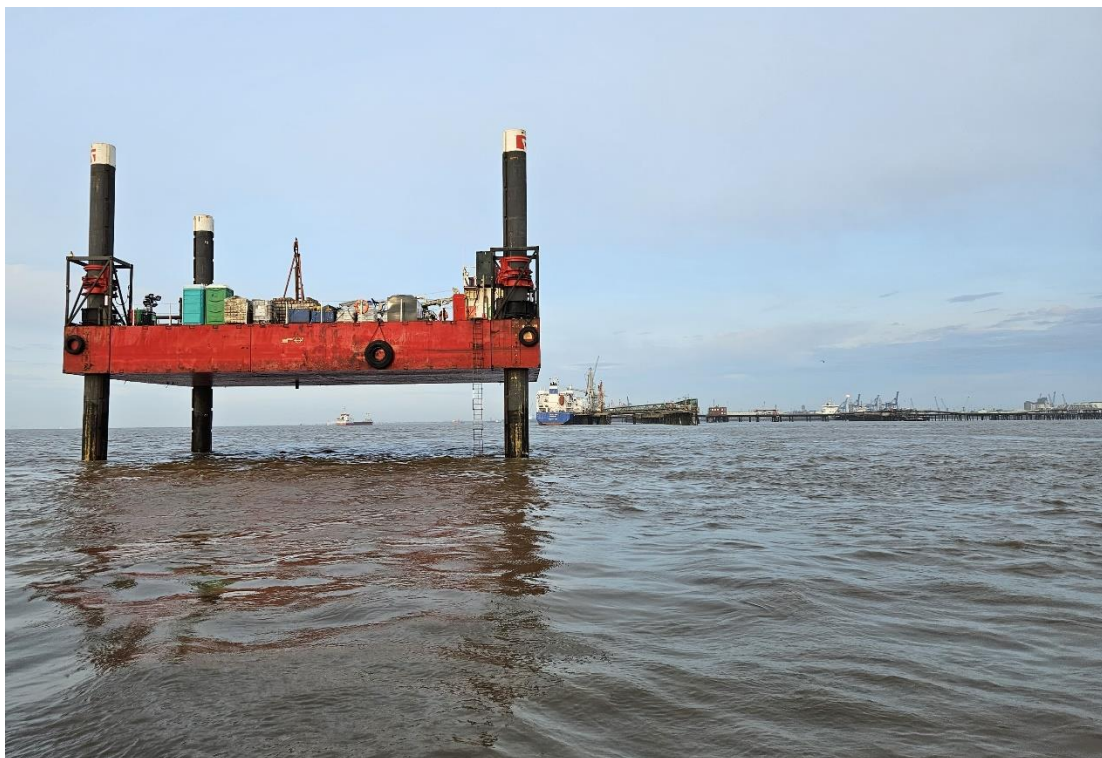
The GI campaign will be carried out by the contractor Causeway Geotech. A jack-up barge will serve as the works platform: *Causeway Giant* (Plate 1). The barge measures 24m by 7m length by width. The four spud legs each measure 1.22m diameter and are 36m long. The campaign is programmed to commence immediately.

Plate 1: Causeway Giant 2. Source: Causeway Geotech.

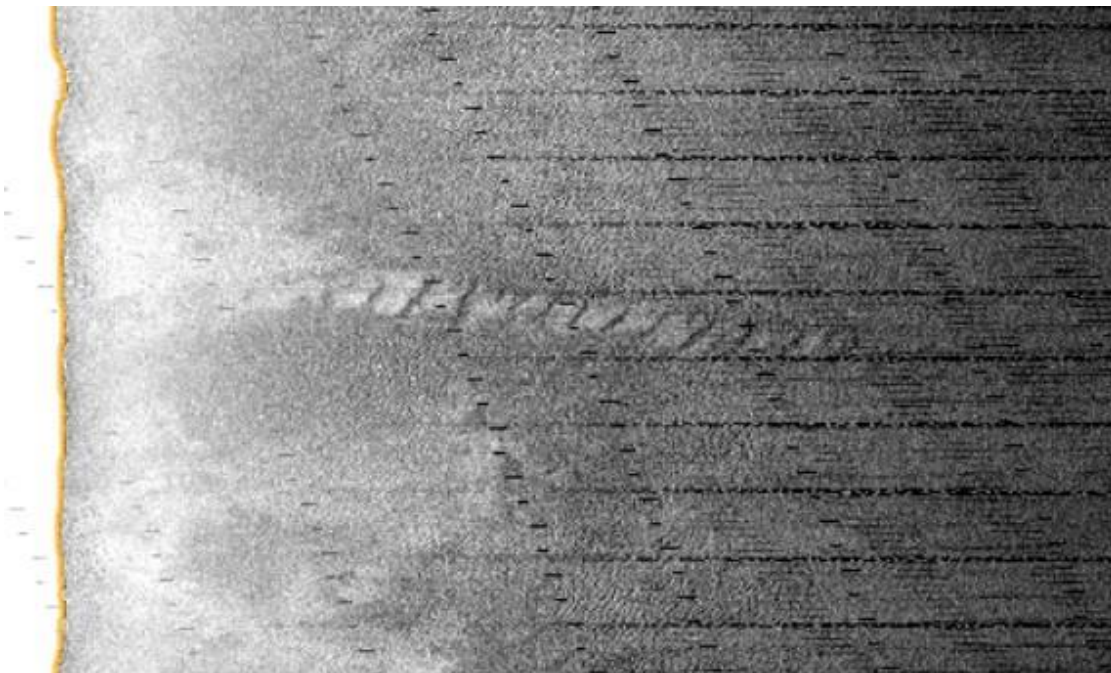
Plate 5: ADCO4. Side scan sonar data trace showing possible line of c. 14 stakes, c. 1m long and c. 1m separations, extending c. 14m in length close inshore in vicinity of and west of

Ballygeary Harbour. Centred on ITM 712114E 612539N, Source file: Survey Line SF173607, also recorded, faintly, on lines SF173245 and SF172947. The image also shows interference lines from other device deployments.

It is recommended that archaeological dive inspection is conducted at the location of ADCO4, to consider whether there is a linear stake feature at this location, and what its function might be if identified.

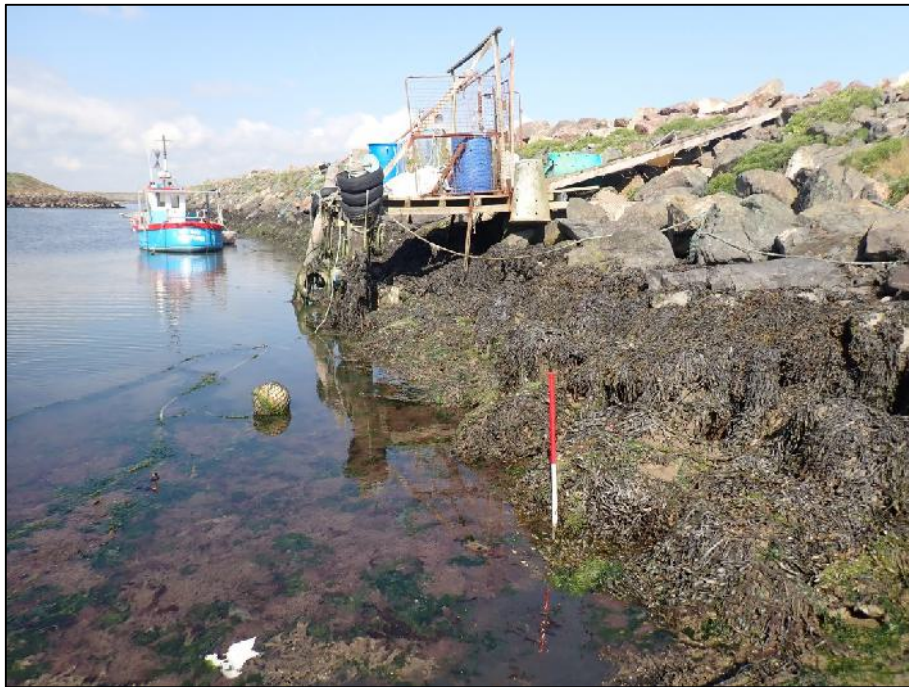
Plate 9: West-facing view of rock-armour revetment forming east side of the northern half (outer part) of the harbour area (1m scale).

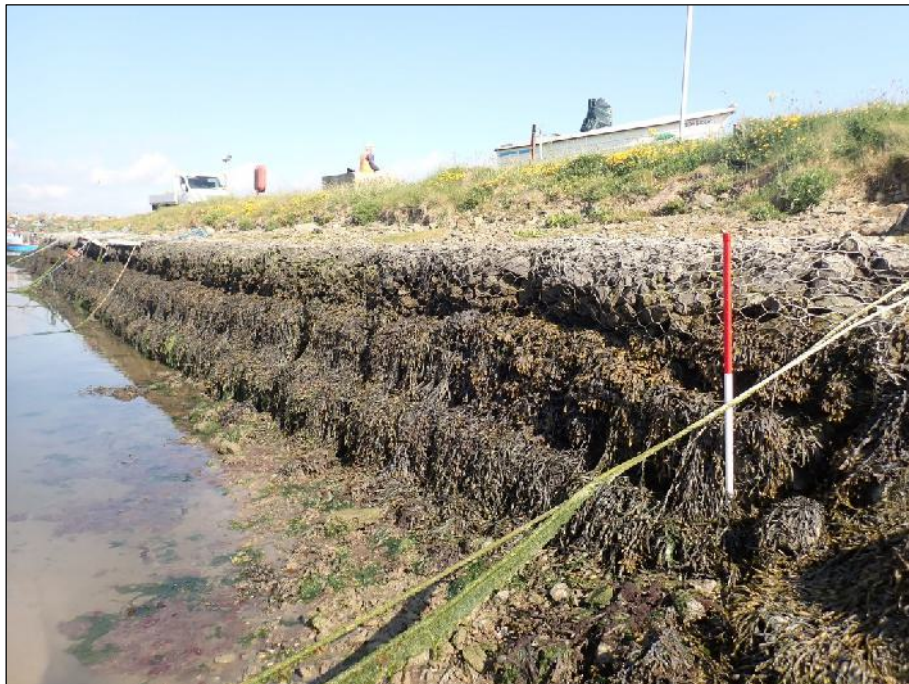
Plate 10: Northwest-facing view of stone filled gabions used to delineate the east side of the inner harbour area (1m scale).

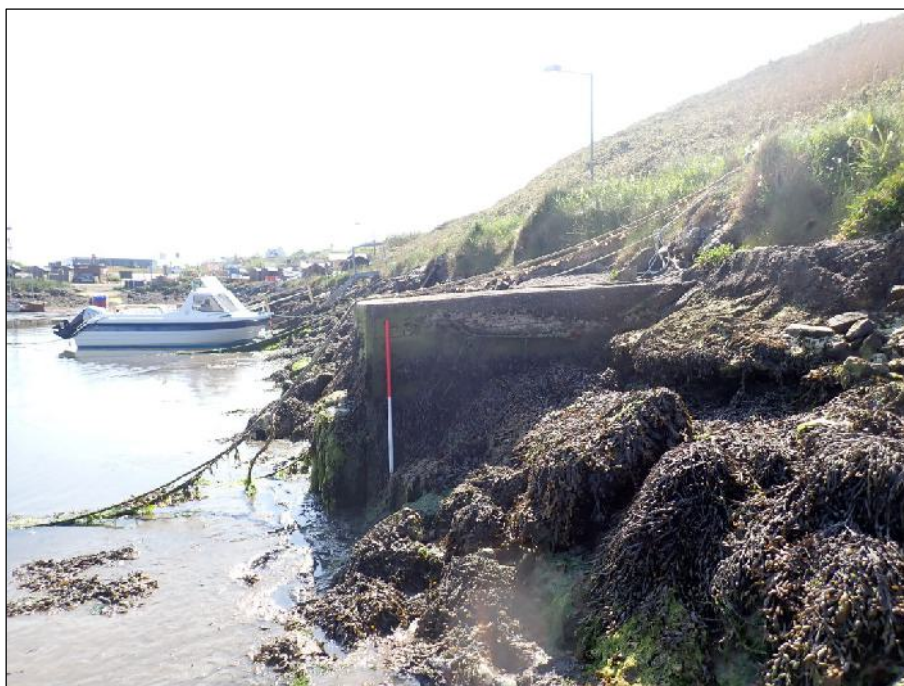
Plate 11: East-southeast view of rubble used to from southwest side of inner harbour area (1m scale).

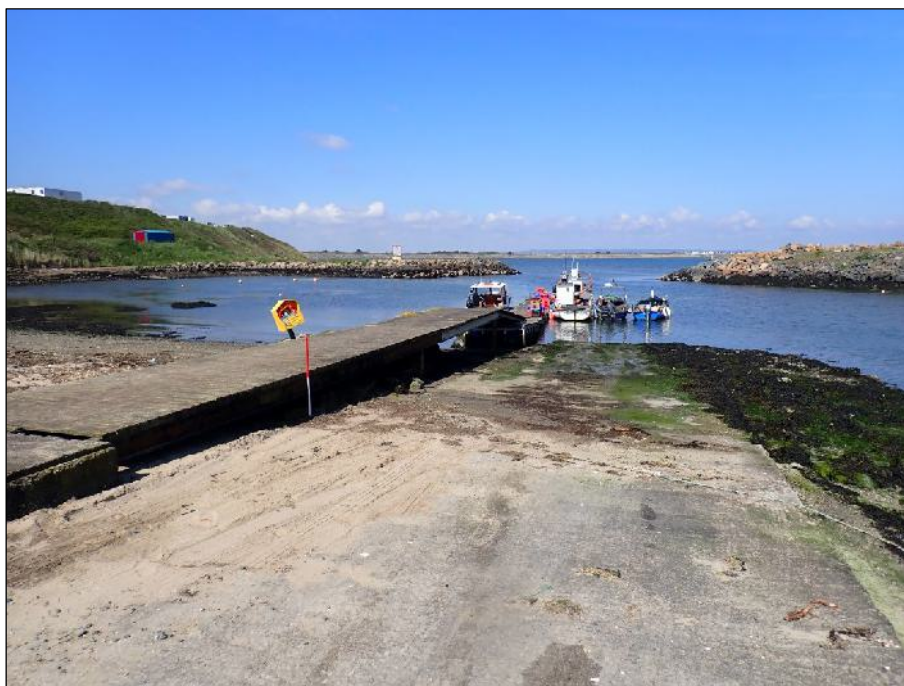
Plate 12: West-northwest view of concrete slip and pontoon structure (1m scale).

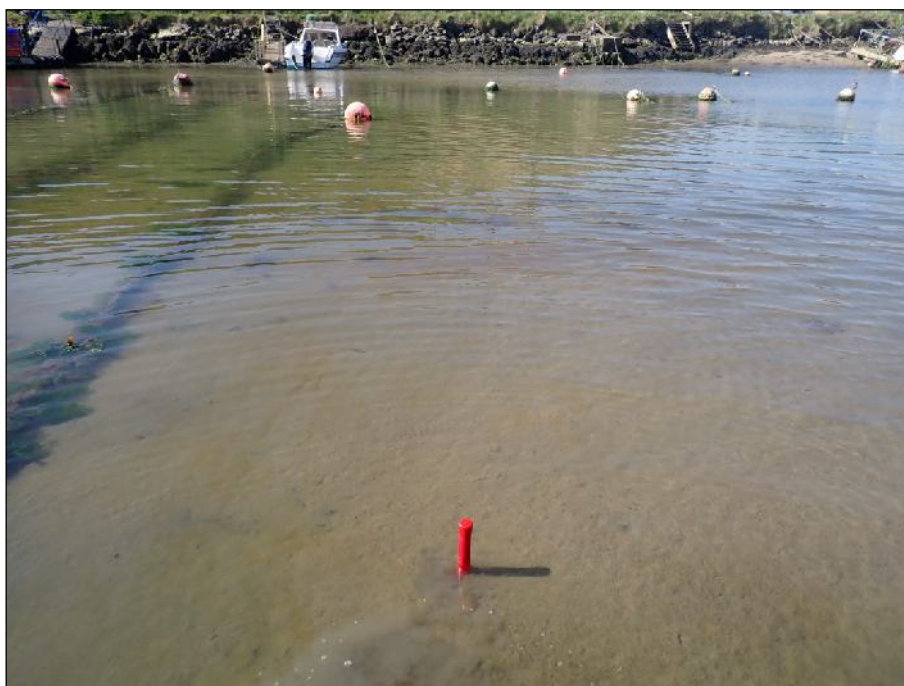
Plate 14: Example shot deep deposit of silt that has built up within the inner harbour area; top of 1m scale protruding from seabed.

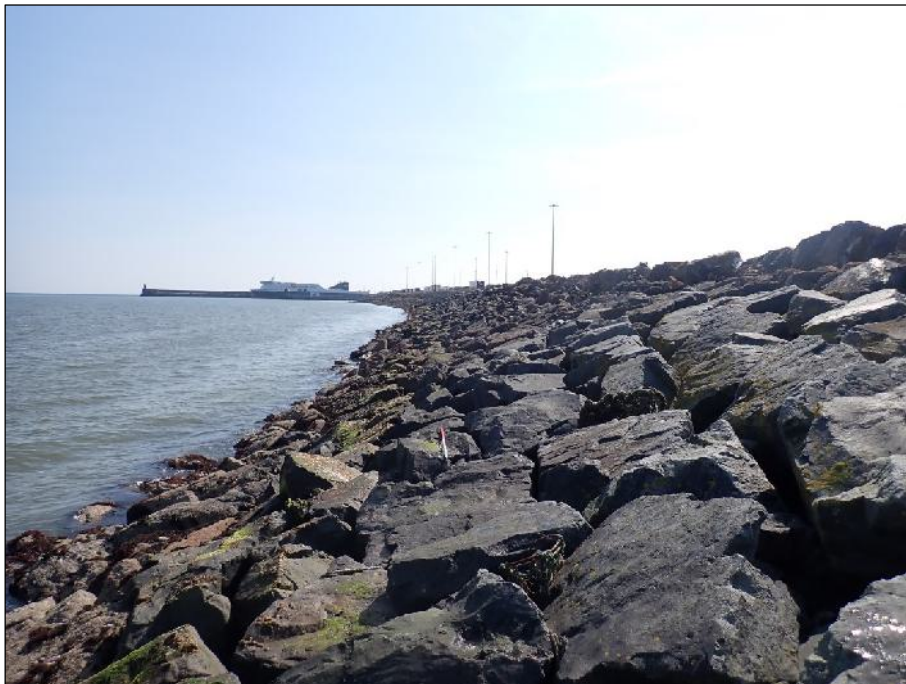
Plate 18: East-facing view along rock-armour revetment forming edge of reclaimed foreshore extending between the Small Boat Harbour and Rosslare Europort (1m scale).

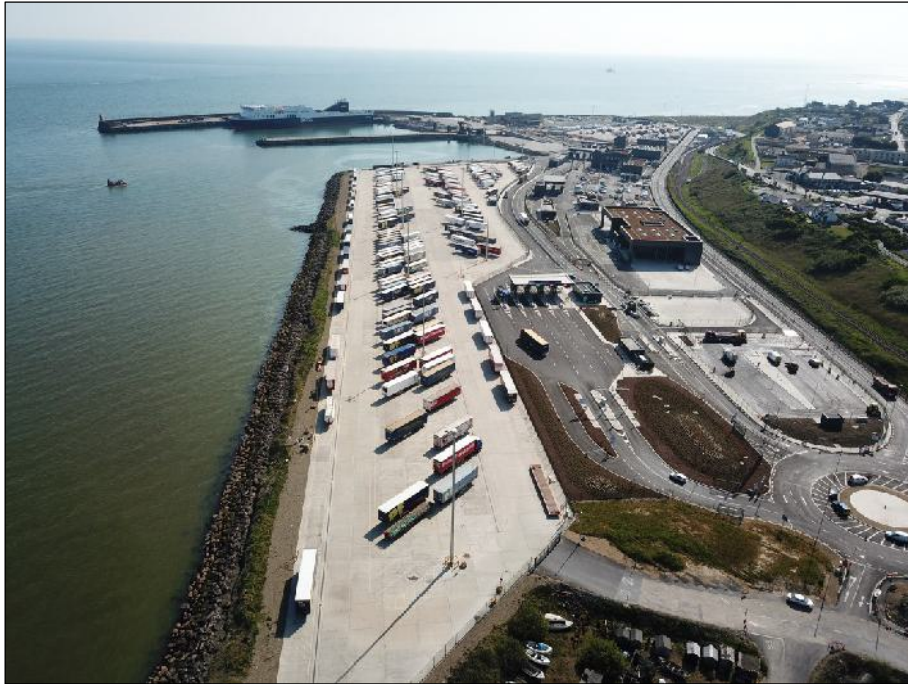
Plate 19: Aerial view of rock-armour revetment forming edge of reclaimed foreshore extending between the Small Boat Harbour and Rosslare Europort. Source: ADCO Drone.

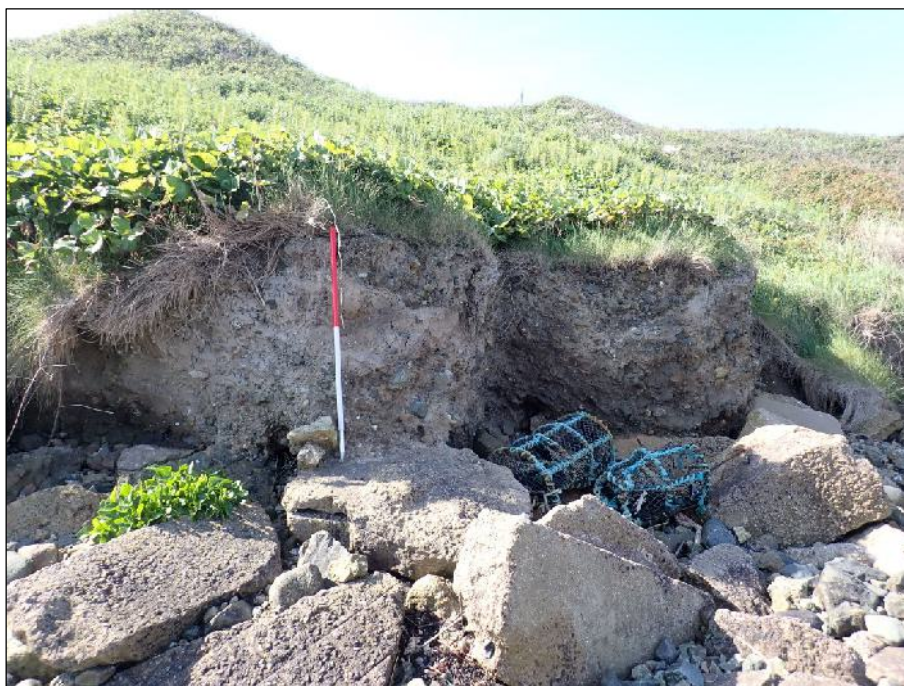
Plate 22: Example shot of exposed section of glacial till along base of low-lying cliff to west of the Small Boat Harbour (1 m scale).
