## **Rosslare ORE Hub**

# **Soils, Geology, Hydrogeology and Contamination**

## **Appendix B: Bathymetry**

# Rosslare Europort Offshore Wind Hub Geophysical Survey Survey Report

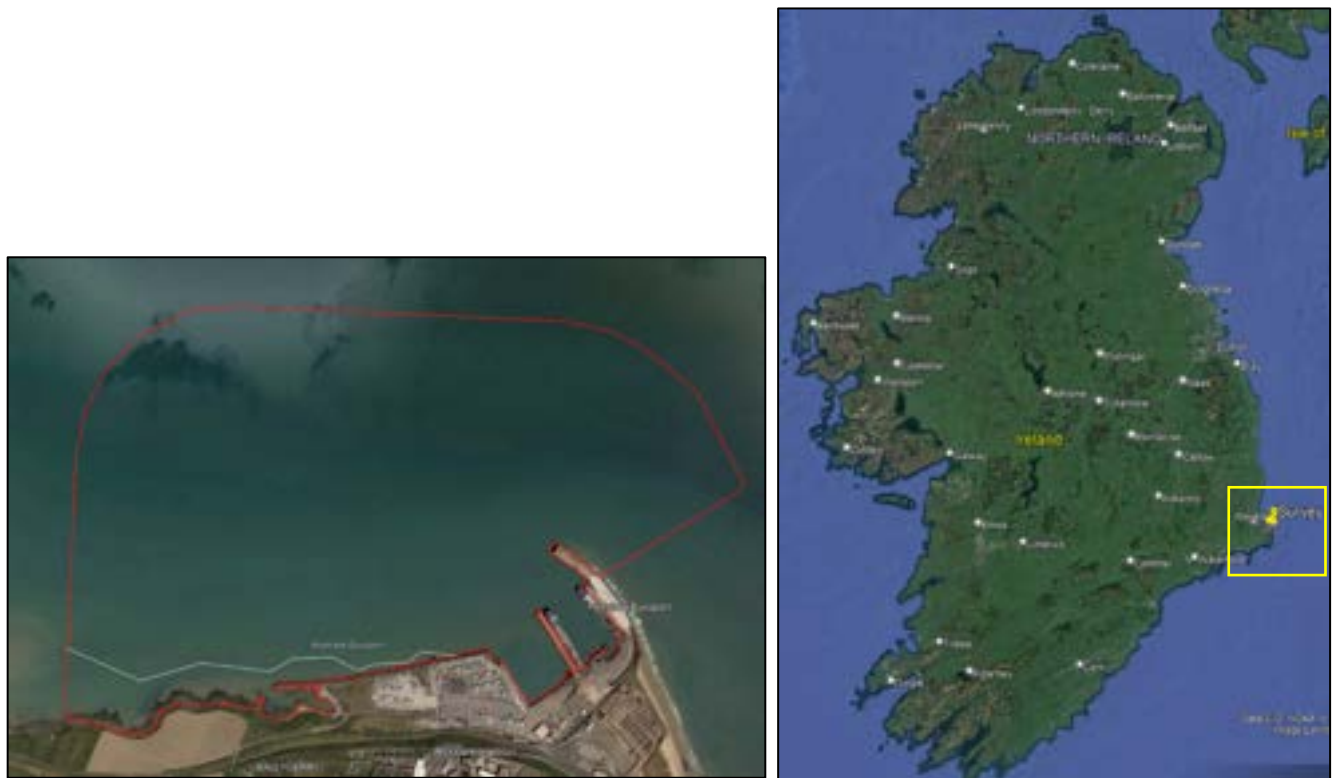
The survey area is located in the south-western area of the Irish Sea, in Rosslare Europort, County Wexford, as shown below with the red polygon. The white line represents the 2m LAT contours line.

Figure 1: Survey area (red polygon)

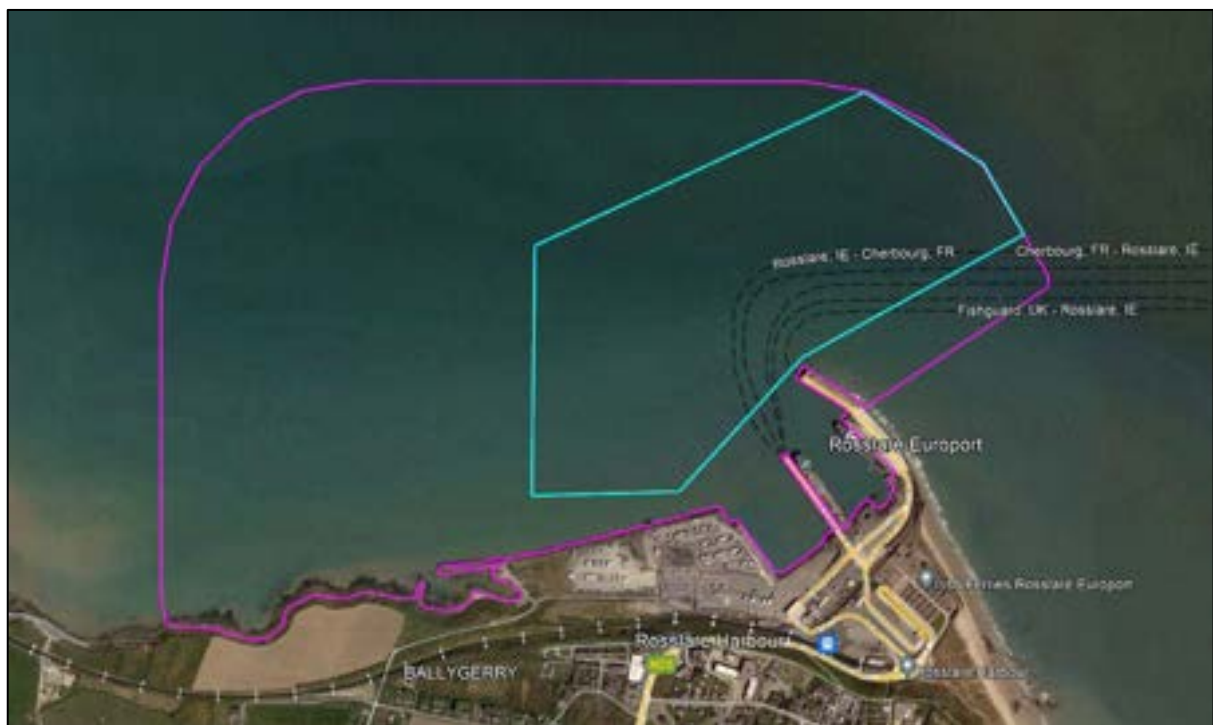
The boomer seismic survey was conducted within a specific area (cyan polygon – figure 2) and with a 50 meters line spacing.

Figure 2: Survey areas showing the boomer survey area in cyan.

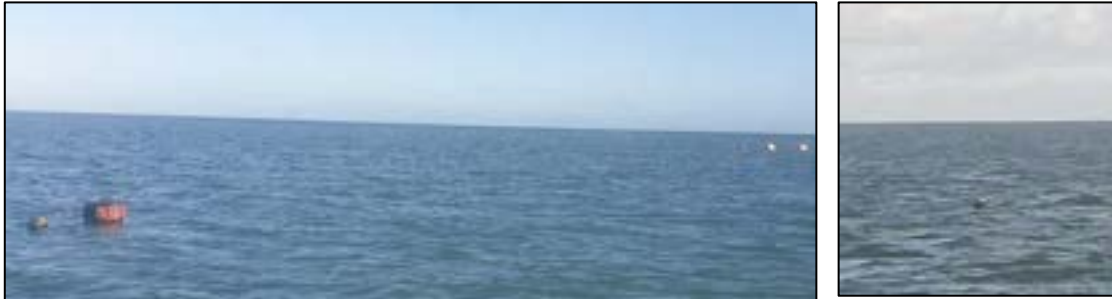
Figure 3: Picture of some of the fishing gear present on site

Figure 3 shows the geophysical survey tracklines. Some of the towed magnetometer survey lines were missed due to difficulty to manoeuvre around jetties and ships and due to fishing gears (figure 3) present on the shallow part of the site (SW).

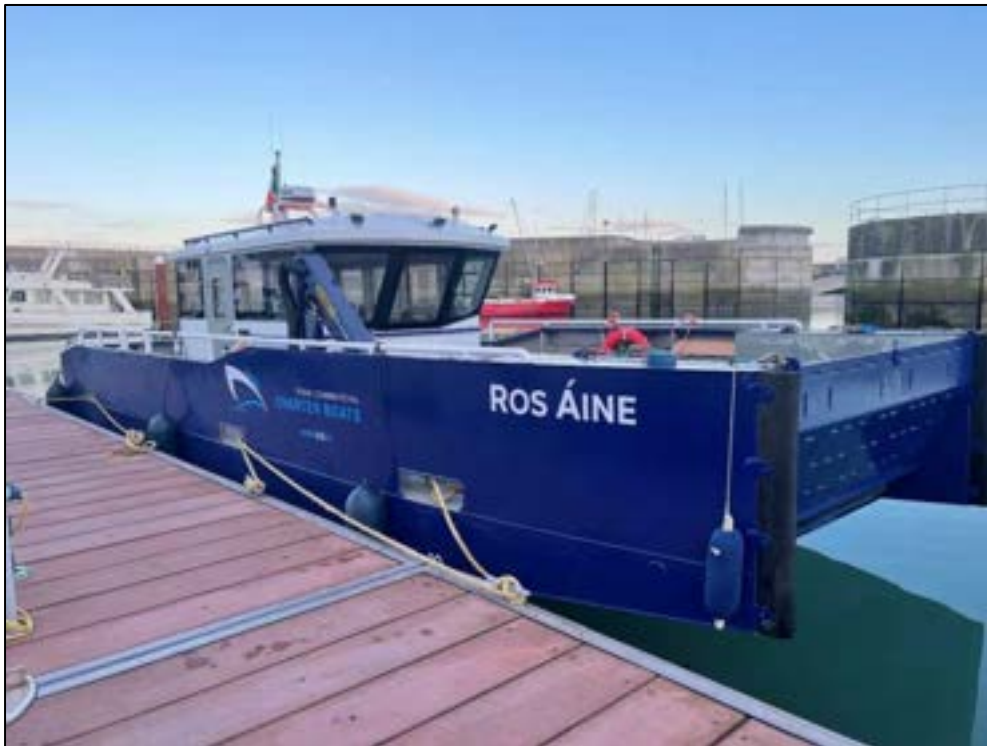
The vessel used for the geophysical survey was the Ros Aine (Figure 5). Summary specifications are listed in Table 2.

Figure 5: Ros Aine, survey vessel.

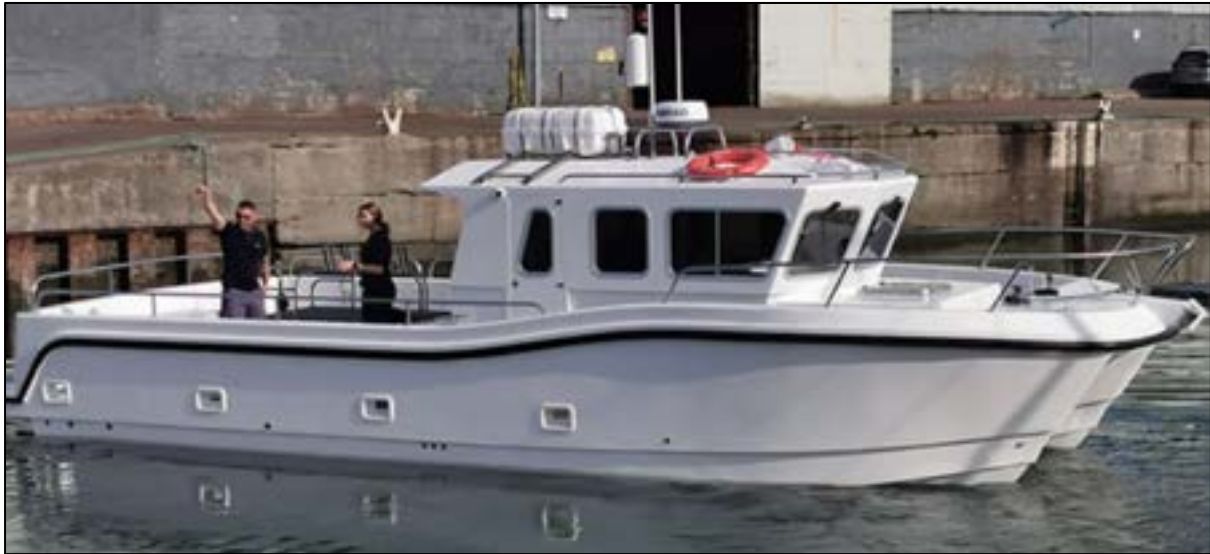
For the MF seismic survey, the Manannan vessel was used (figure 6). Summary specifications are listed in Table 3.

Figure 6: Manannan survey vessel

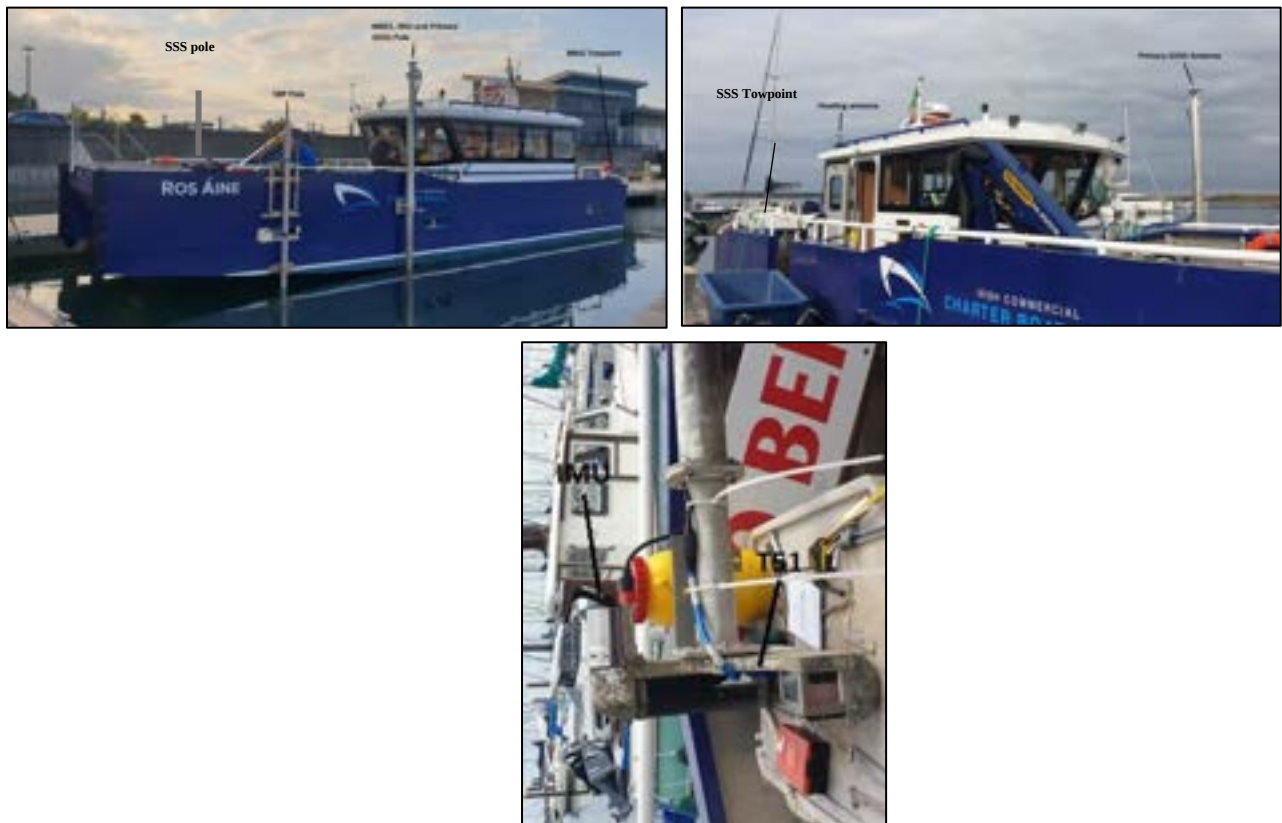
All survey sensors were mounted according to the images shown below. The multibeam sonar, the sub-bottom profiler and one of the side-scan sonars were pole-mounted on the port side of the vessel. Offsets from primary GNSS antenna, sub-bottom profiler and side-scan sonar pole and suitable tow points for the side-scan sonar and magnetometer were measured from the central reference point using a steel tape measure. The central reference point is identified as the reference point on the top of the IMU.

Figure 7: SBP and MBES poles (top left), primary and heading GNSS antennas (top right) and mounting for IMU and MBES (bottom).

The multibeam sonar and IMU are mounted securely together on the same mounting bracket which is fixed to the same pole as the primary GNSS antenna. In essence, the pole becomes the traditional survey vessel in all aspects except for heading. This removes the need for a gyro calibration for the MBES. The remaining heading antenna offsets are determined with a “GAMS” calibration. Note that the heading offsets are related to the primary GNSS antenna and not the IMU reference point in the GAMS calibration.

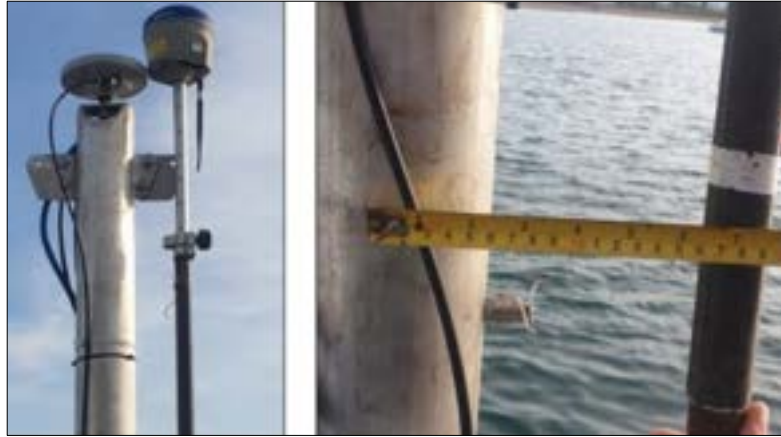
Figure 8: GNSS Rover location (left picture) and offset from primary GNSS antenna and average results (right picture).

The GNSS rover was positioned 0.17m aft of the primary GNSS antenna as shown in Figure 8 and position of both antennas was logged for 300 seconds. The results are shown in Table 10.

A position check of the vessel survey system was completed on 26<sup>th</sup> October 2023 with the vessel alongside the quay wall in Malahide marina, using a GNSS rover connected to RTK corrections. For the verifications, Trimble VRSNow network RTK corrections were used.

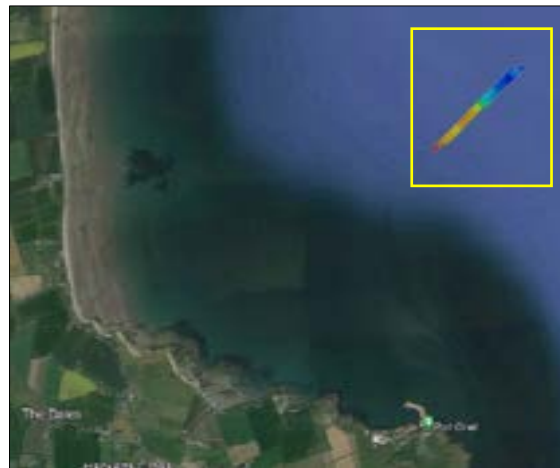
Figure 9: MBES Patch Test Location.

A patch test was completed before the survey. The patch test was conducted in a suitable area of similar water depths expected on site, north-east of Port Oriel, Ireland (figure 9).

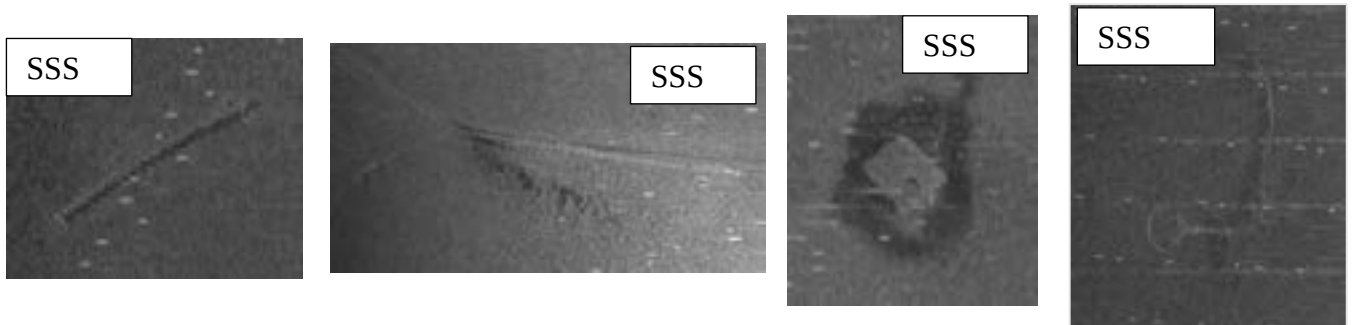
Figure 20: Sidescan sonar contact examples

Figure 20 below is showing a few of the identified contacts. Appendix 2 shows all the sonar contacts.
