Rosslare ORE Hub

EIAR Technical Appendixes

Soils, Geology, Hydrogeology and Contamination

Geotechnical Interpretive Report

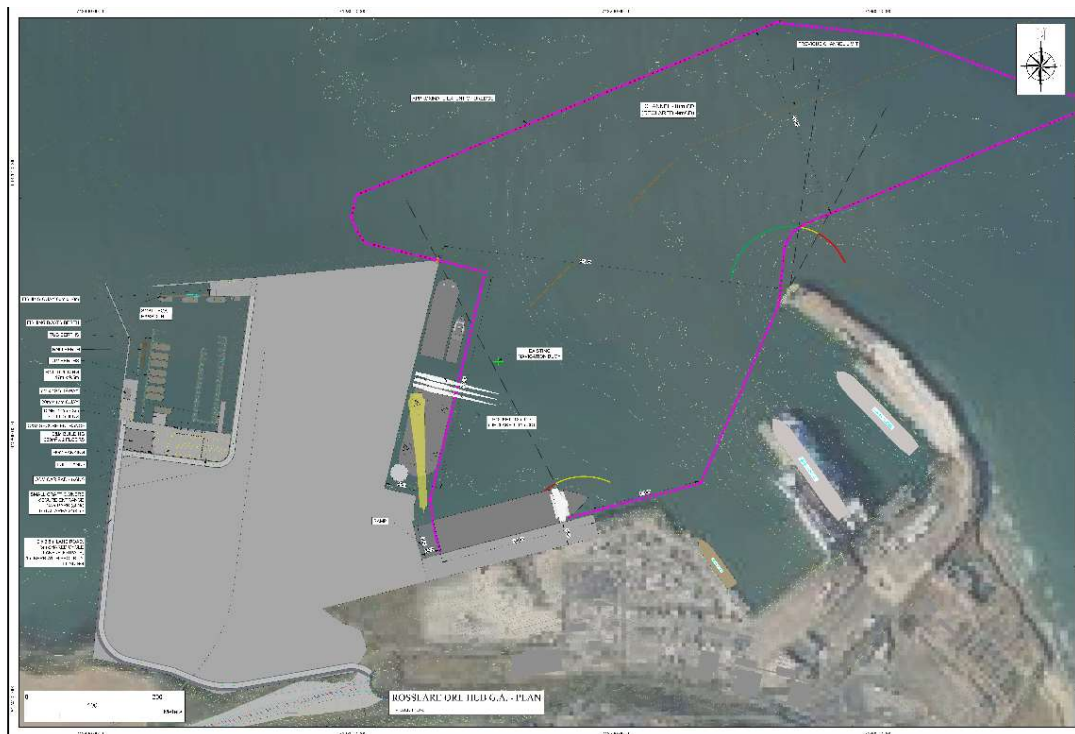
Figure 3-1 Rossclare Europort ORE Design Layout

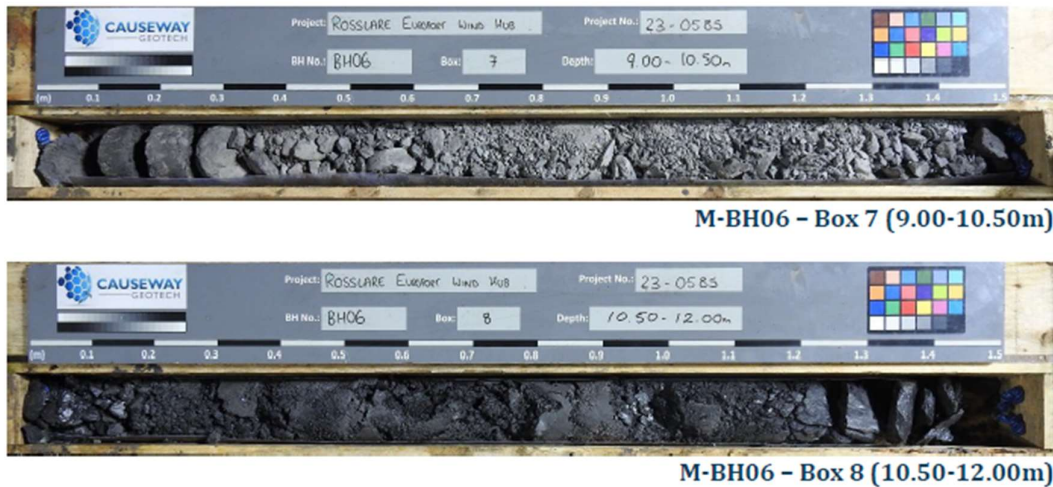
The recovered core samples are of poor quality with a typical core recovery (TCR) typically ranging from 1.5% to 100%, and an average of 81%. The solid core recovery (SCR) defined as the percentage of the recovered core run which contains solid cylindrical pieces of core with their full diameter, is highly variable, typically ranging from 0-71%, with an average of 26% recorded. The rock quality designation (RQD), measured as a percentage of the drill core in lengths of 10 cm or more, typically ranges from 0-46%, with an average of 10% recorded, indicating a high degree of discontinuities. Typical core recovery of the weathered mudstone can be seen in Figure 5-3.

Figure 5-2: Weathered mudstone recovered from M-BH06.

Due to the highly fractured and blocky nature of this material, recovery of full-diameter core samples was difficult, and samples often became friable when recovering from the core liner. This led to difficulties in obtaining samples for point load and uniaxial compression testing.

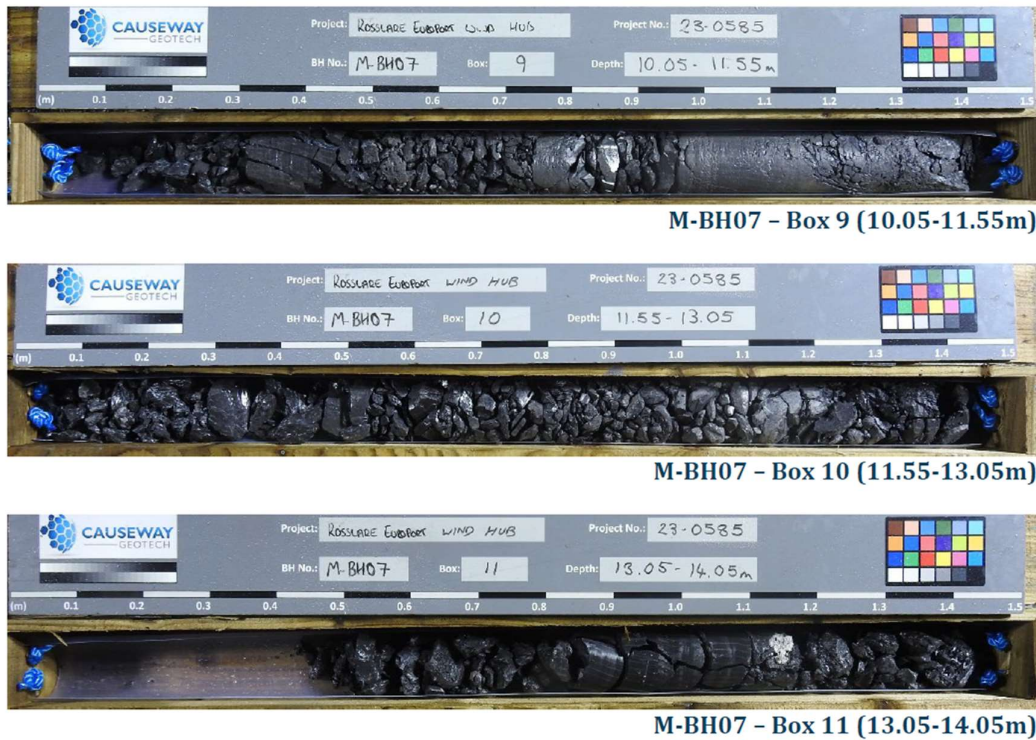
Due to the highly fractured and blocky nature of this material, recovery of full diameter core samples was difficult, and samples often became friable when recovering from the core liner. This led to difficulties in obtaining samples for point load and uniaxial compression testing.

Figure 5-4: Highly fractured and fissile mudstone recovered from M-BH07, illustrating the poor recovery prevalent within the mudstone strata.

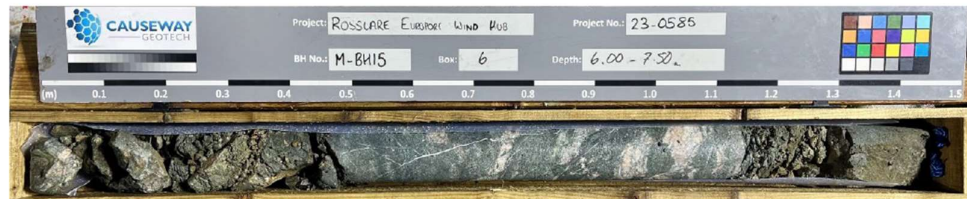
M-BH15 – Box 6 (6.00-7.50m)

The recovered core samples are variable, but generally of good quality with a TC typically above 90%. The SCR is variable, typically ranging from 0-100%, with an average of 71.3% recorded. The RQD typically ranges from 0-98.5%, with an average of 36.6% recorded, indicating a high degree of discontinuities. Highly fractured sections of core made recovery of whole core samples difficult in some localised areas. Examples of amphibolite core recovery can be seen in Figure 5-6, and gneiss core recovery can be seen in Figure 5-7.

Figure 5-7: Gneiss core recovery from M-BH15, illustrating competent core alongside highly fractured, poorly recovered core runs.

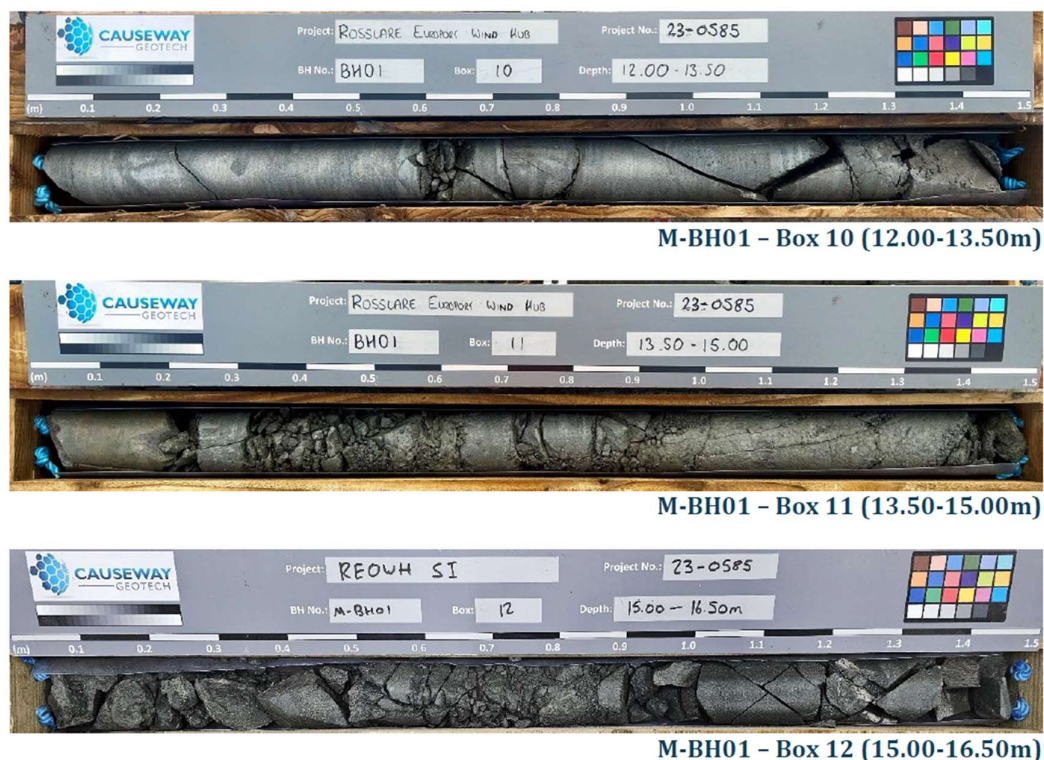
The recovered core samples are of good quality with a TC typically above 90%. The SCR is variable, typically ranging from 12-100%, with an average of 68.8% recorded. The RQD typically ranges from 0-98.5%, with an average of 18.7% recorded, indicating a high degree of discontinuities. An example of dolerite core recovery can be seen in Figure 5-8.

Figure 5-8: Dolerite core recovery from M-BH01.

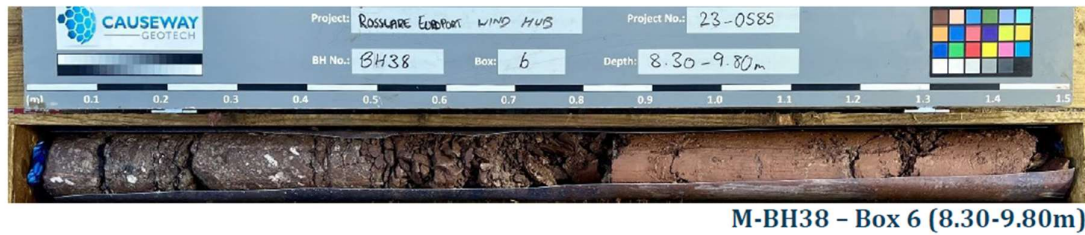
In M-BH38, mylonite was encountered between 8.8 and 11.3m BGL. This unit was described as extremely weak to medium strong narrowly foliated light grey highly fractured MYLONITE, highly reduced in strength. One highly closely spaced foliation fracture set at 60-65° is noted, described as planar, smooth, with light grey clay smear on the fracture surfaces. This is interpreted in the Causeway report as possible fault gouge. An example of the mylonite core recovery can be seen in Figure 5-9.

Figure 5-9: Mylonite (possible fault gouge) recovery from M-BH38.

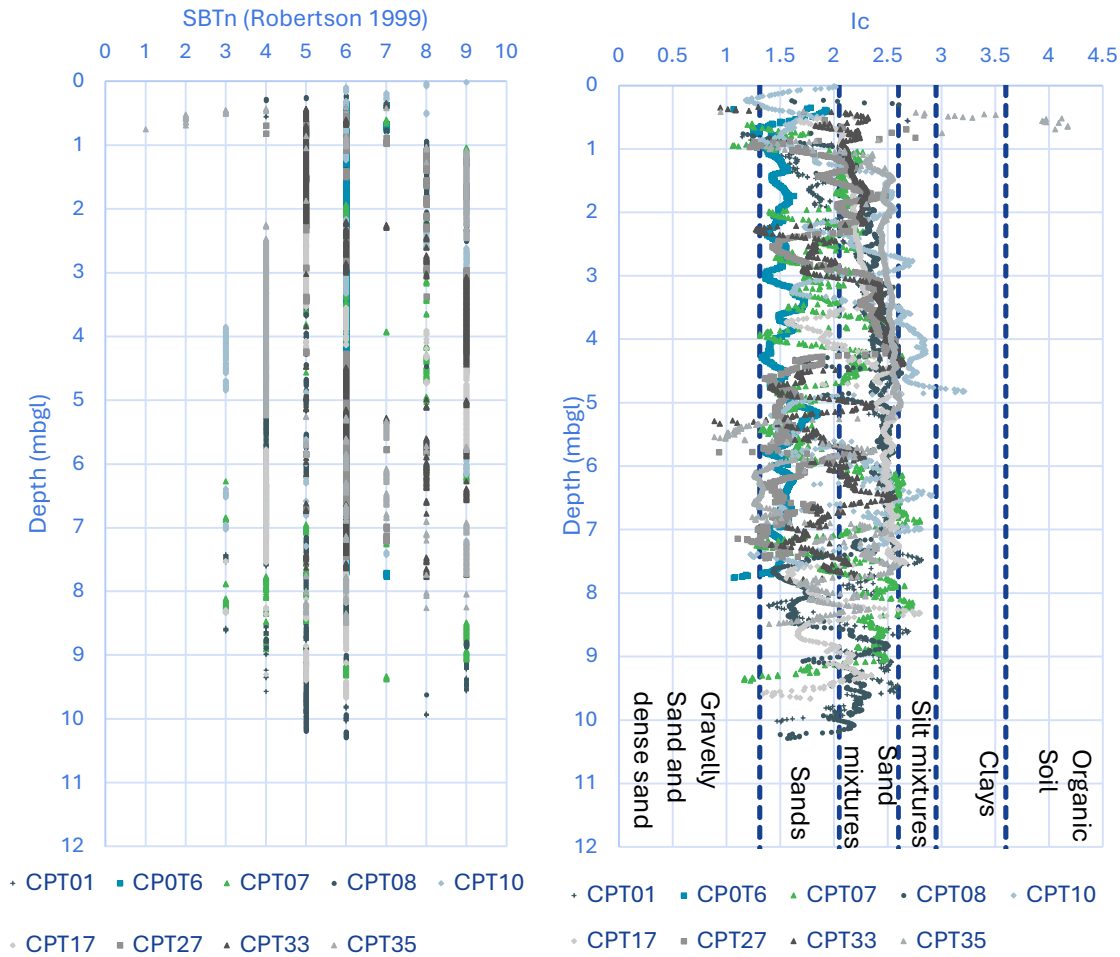
The soil behaviour types (SBT) as derived from Robertson (1999) and a soil behaviour parameter (I_c) adapted for SBT by Jefferies and Davies (1993) for location CPT01, 06, 08, 10, 17, 27, 33 and 35 are outlined in Figure 5-10.

Zone	Soil Behavior Type	I_c
1	<i>Sensitive, fine grained</i>	N/A
2	<i>Organic soils – clay</i>	> 3.6
3	<i>Clays – silty clay to clay</i>	2.95 – 3.6
4	<i>Silt mixtures – clayey silt to silty clay</i>	2.60 – 2.95
5	<i>Sand mixtures – silty sand to sandy silt</i>	2.05 – 2.6
6	<i>Sands – clean sand to silty sand</i>	1.31 – 2.05
7	<i>Gravelly sand to dense sand</i>	< 1.31
8	<i>Very stiff sand to clayey sand*</i>	N/A
9	<i>Very stiff, fine grained*</i>	N/A

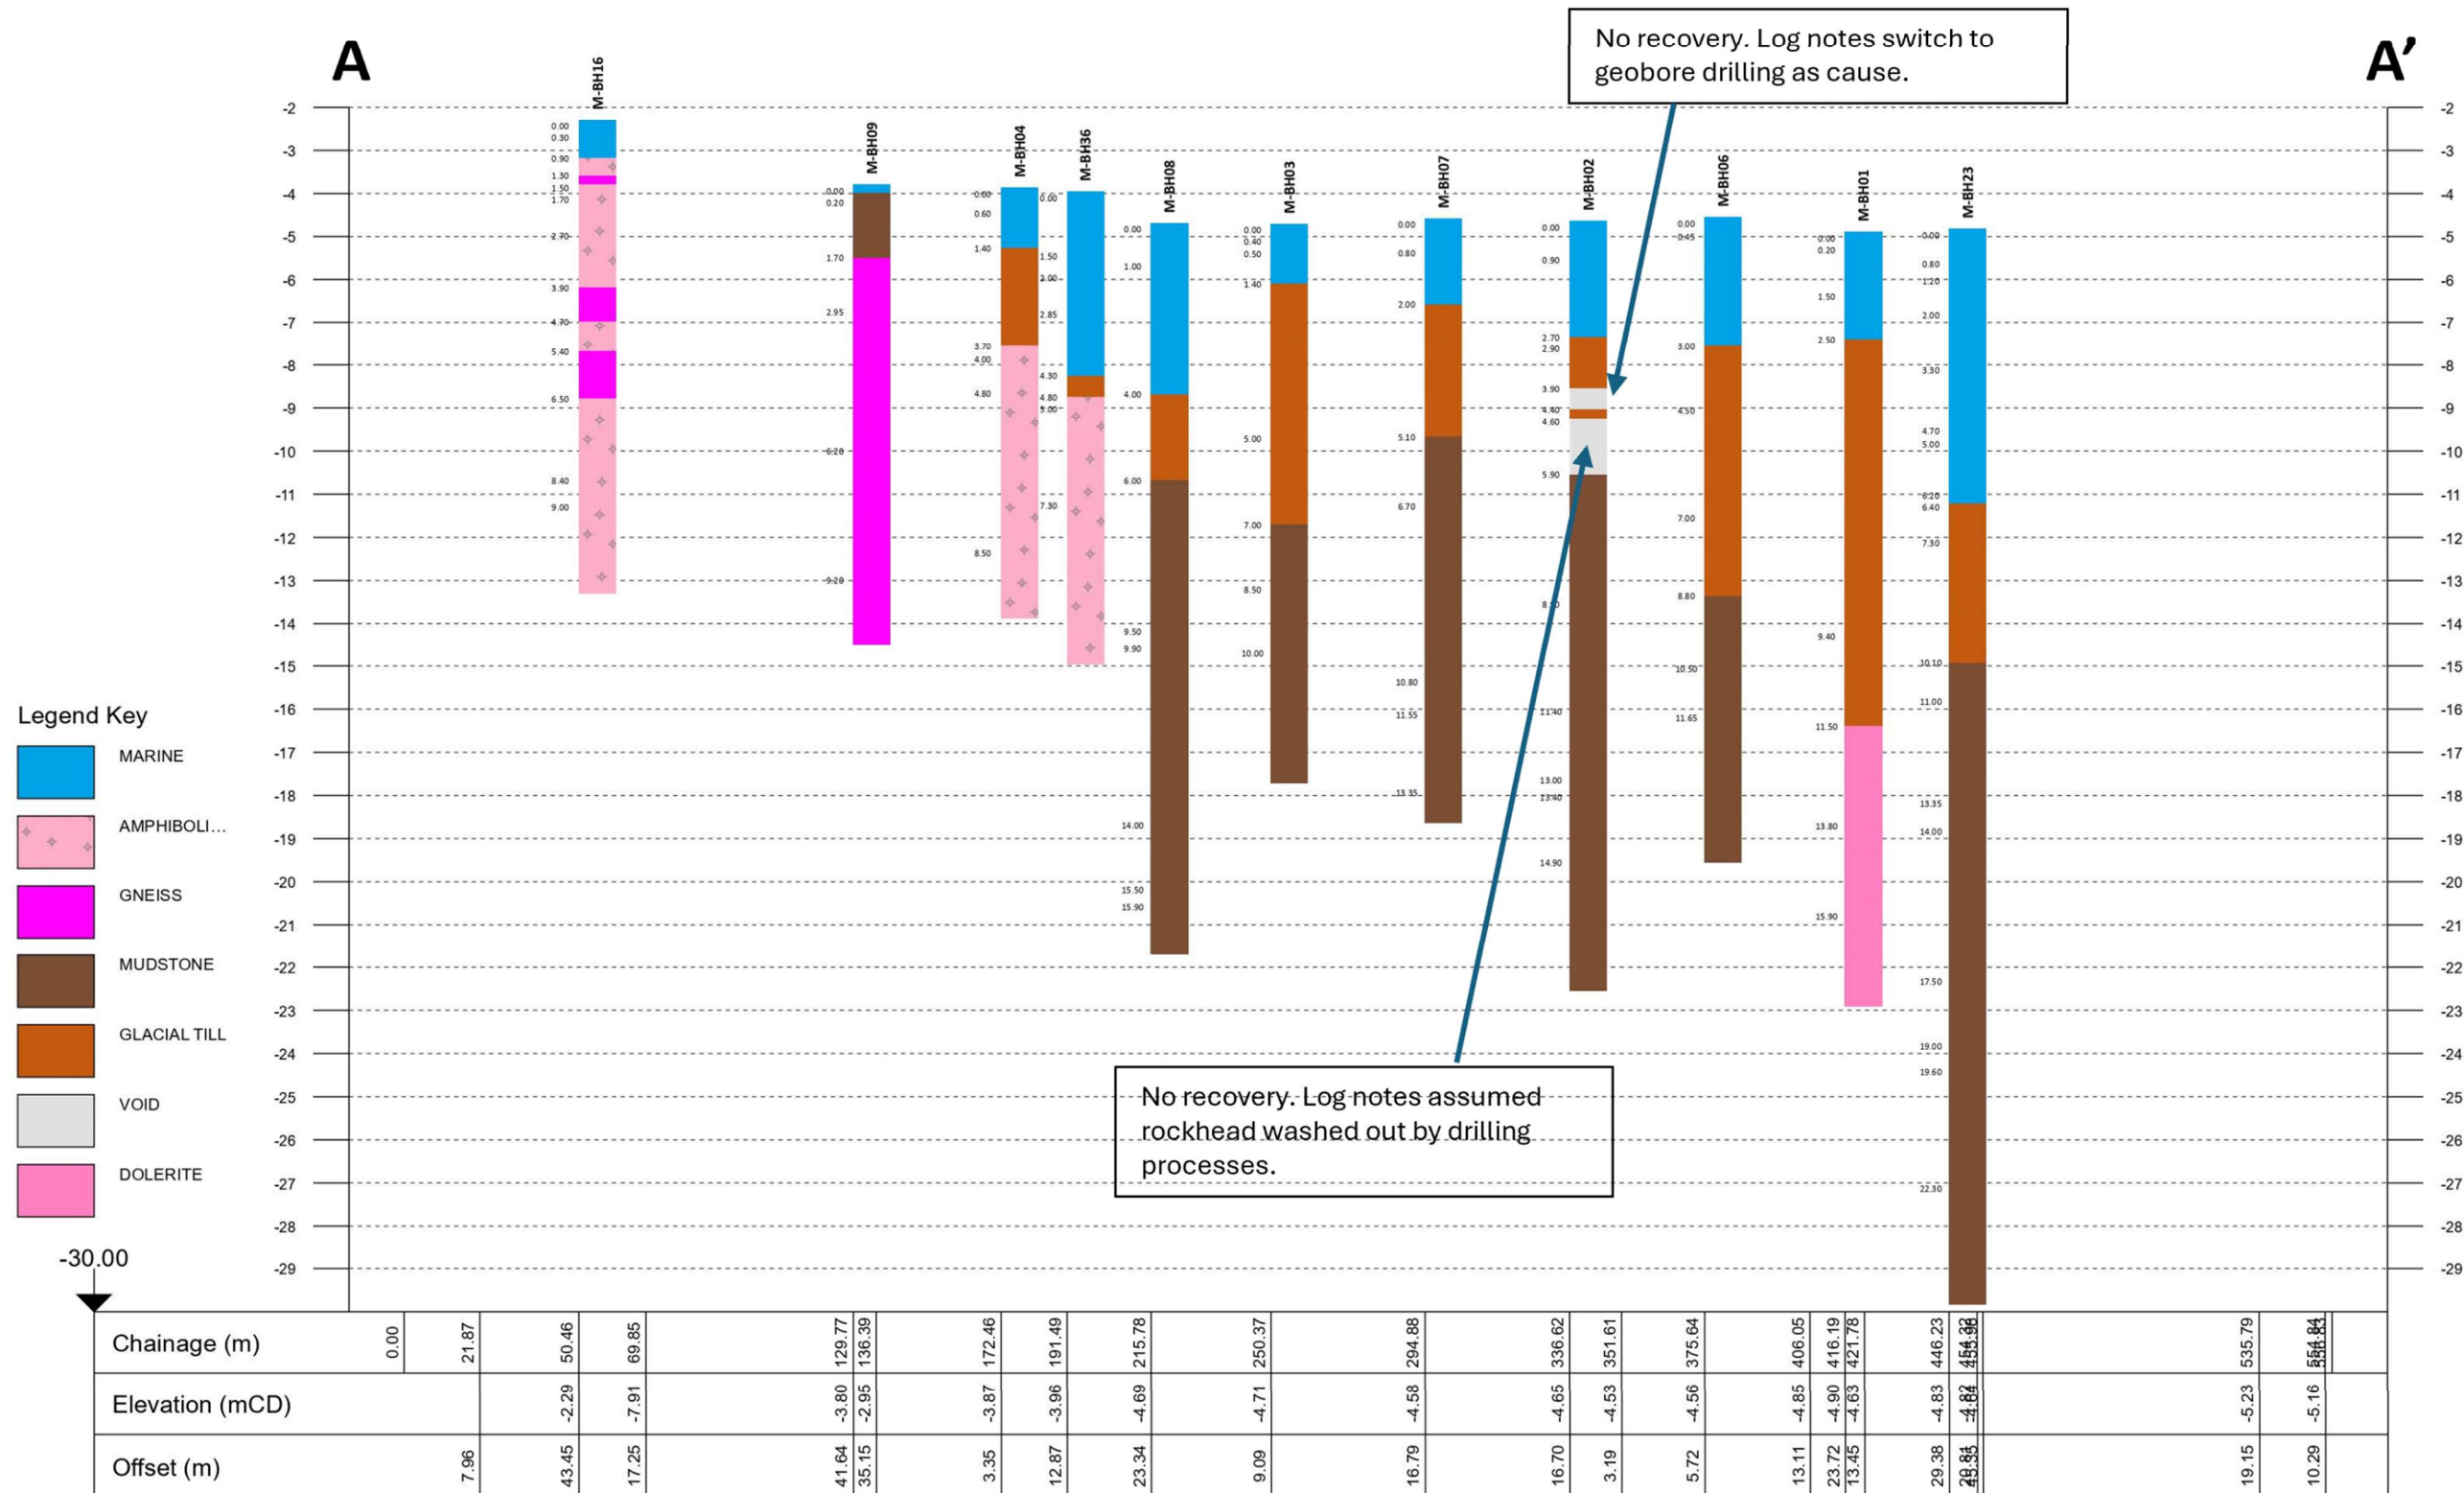
Figure 5-12: Cross Section based on the marine boreholes at the proposed quay wall.

A series of geological cross-sections based on the ground model outlined in Section 5.4 are illustrated in Figure 5-12 to Figure 5-17. A location plan is shown in Figure 5-11.

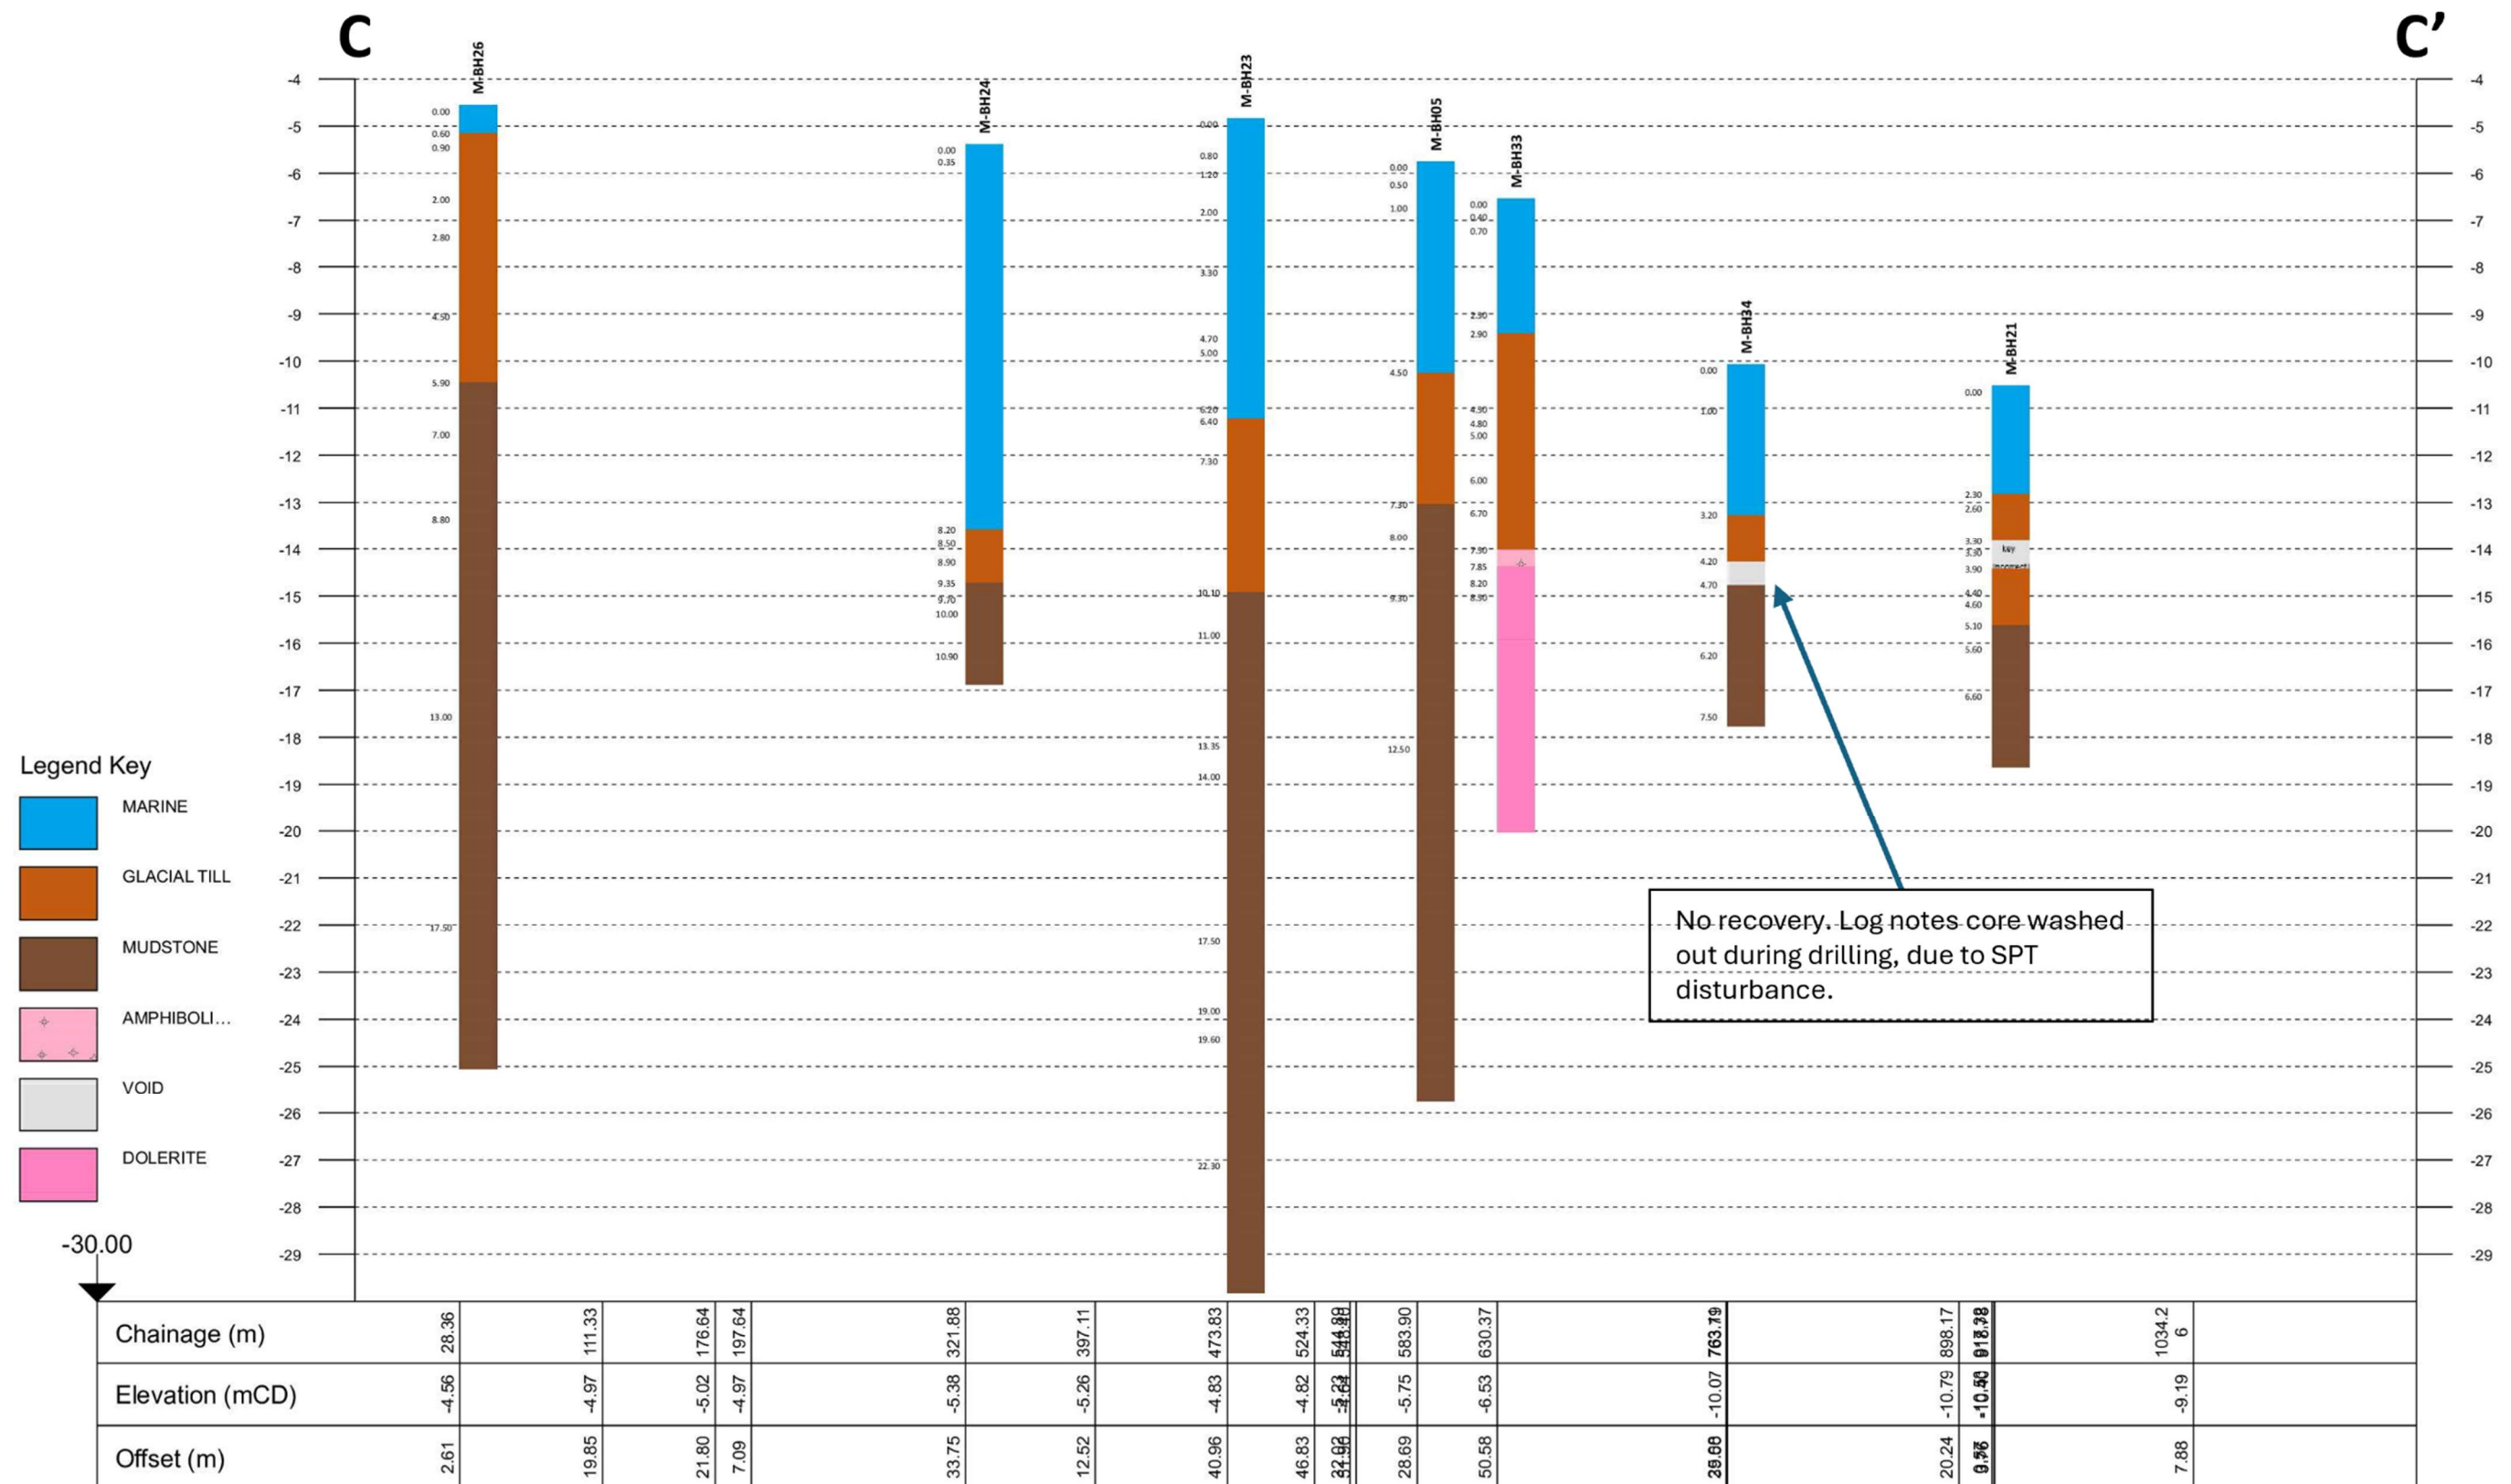
Figure 5-14: Cross-section based on the marine boreholes (far offshore).

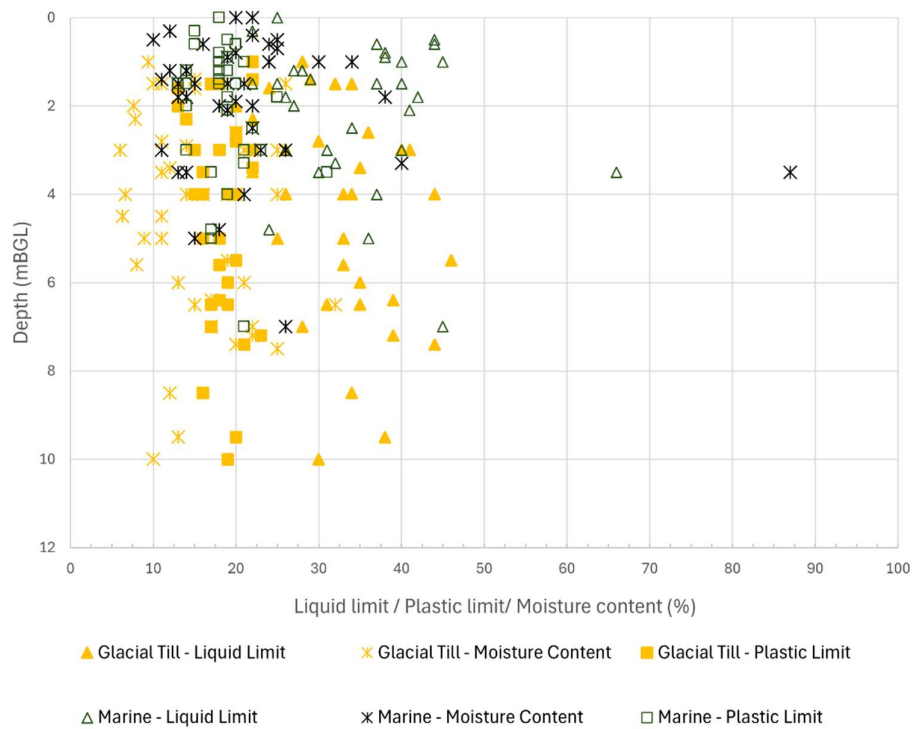
The results of the Atterberg limit and moisture content tests are shown in Figure 5-19. The liquid limit (LL) values of the cohesive marine material varied between 22% and 66% and the plastic limit (PL) results varied between 13% and 31%. The plasticity index (Ip) results for the cohesive marine material range between 7% and 35%. In the cohesive glacial till material, the LL range between 20% and 46%, while the PL results vary between 13% and 23%, with a Ip ranging between 6% and 26%. The plasticity index results are shown in Figure 5-20.

Figure 5-19: Atterberg limit results vs depth (liquid limit, plastic limit and moisture content).

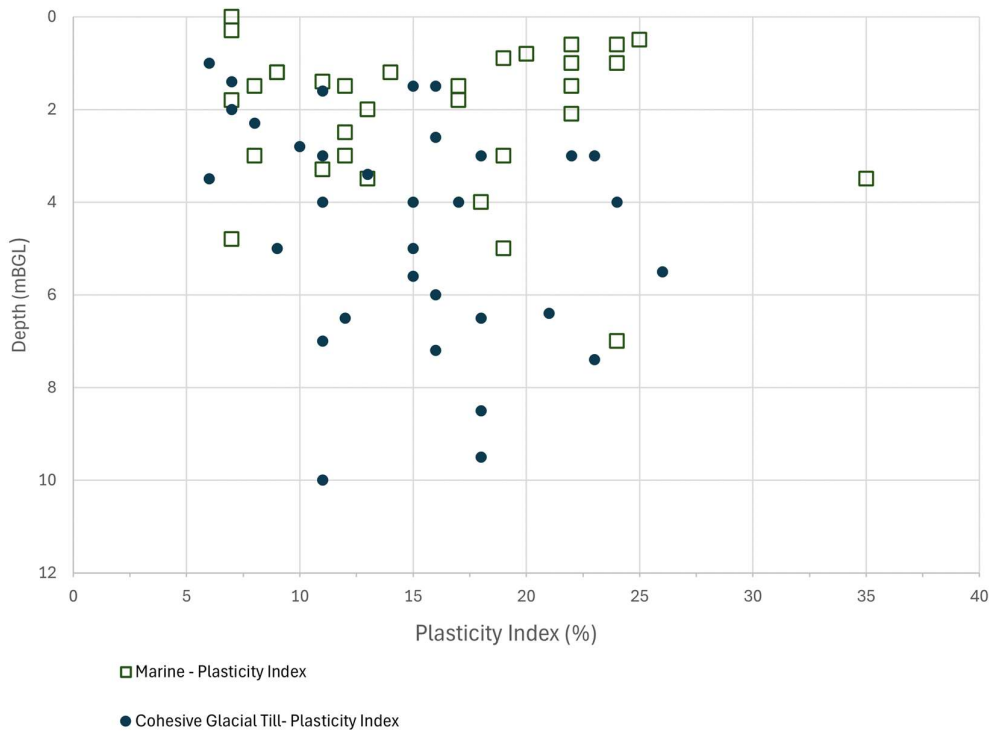
Figure 5-20: Plasticity index results vs depth (m bgl).

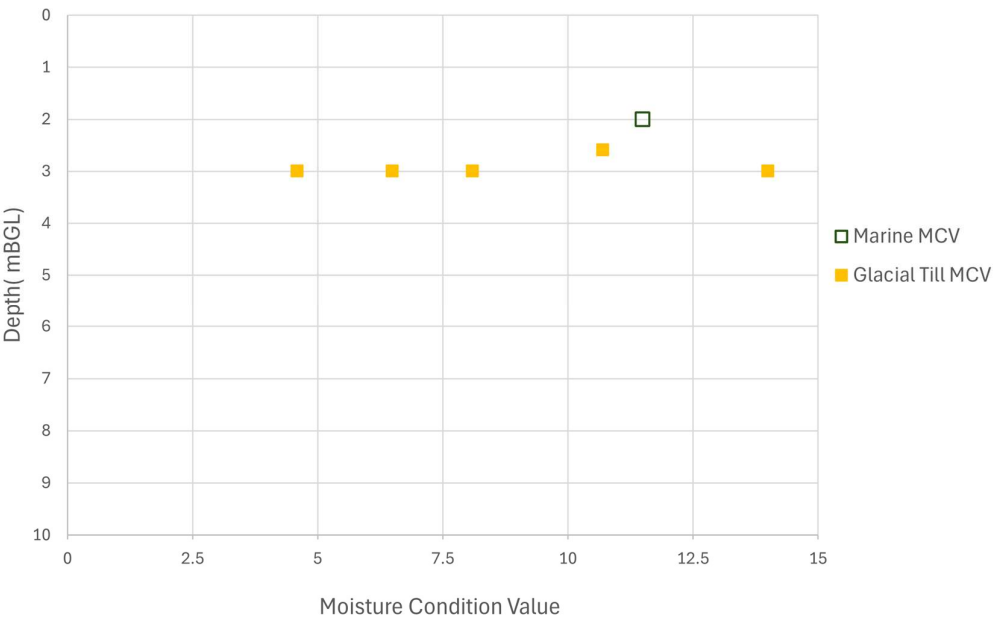
The moisture content results in the cohesive marine material vary between 10% and 85% with no clear trend in the results. Moisture content results in the glacial till vary between 6% and 32%, with no clear trend observed. In addition to moisture content testing, moisture condition value (MCV) tests were carried out on 3 samples- 1 within the cohesive marine stratum, and 2 within the cohesive glacial till. The MCV values are shown in Figure 5-21.

Figure 5-21: MCV vs depth.

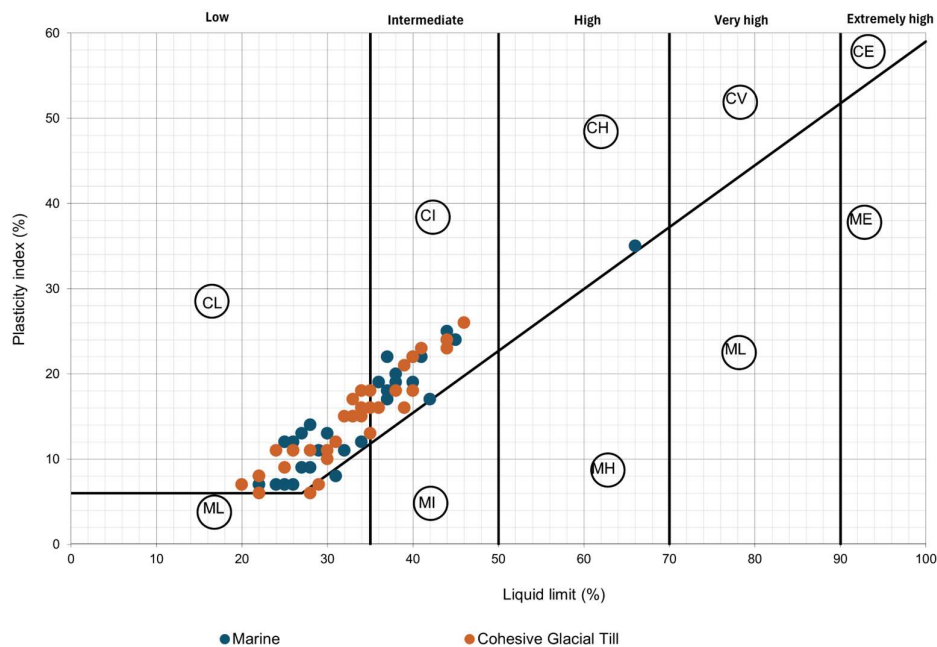
The Casagrande (1948) A-line plasticity chart is shown in Figure 5-22. The combination of LL and PI results in both of the cohesive marine material and the cohesive glacial till vary between low plasticity CLAY and intermediate plasticity CLAY material.

Figure 5-22: Plasticity index vs liquid limit, after Casagrande (1948): C = clay. M = silt. L = low plasticity. I = intermediate plasticity. H = high plasticity

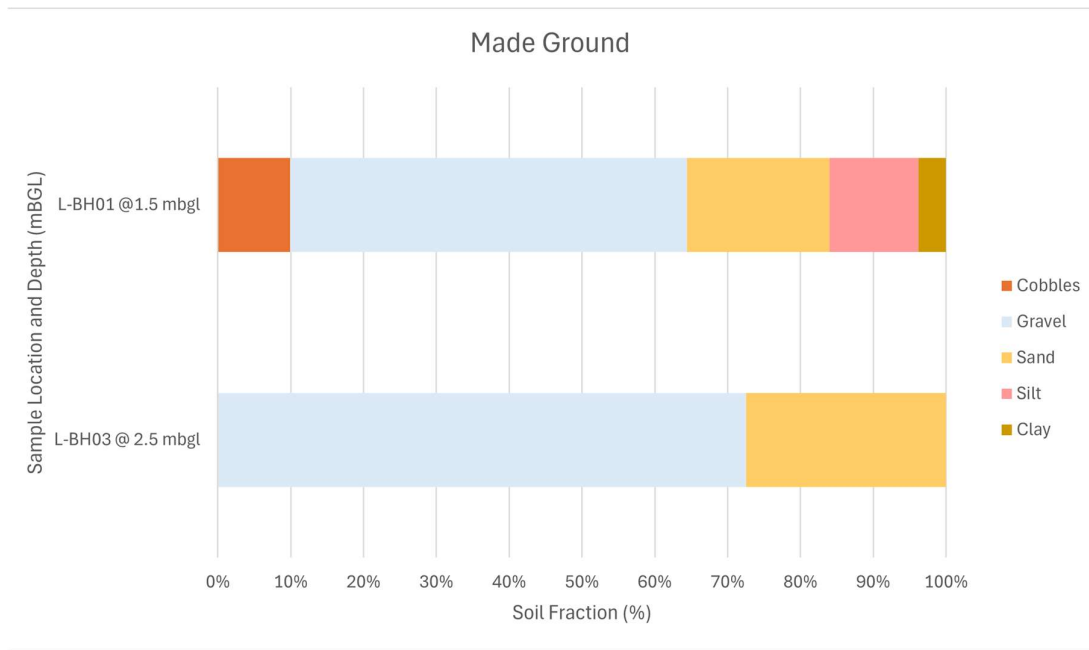
Figure 5-27: Soil fraction results for the Made Ground.
