Re: FOI request IE_FOI_377

Report of Investigation:

**Train A708 collided with cattle on approach to the 55 MP
Portarlinton/Tullamore, near Level Crossing XA043,
28th of June 2018**

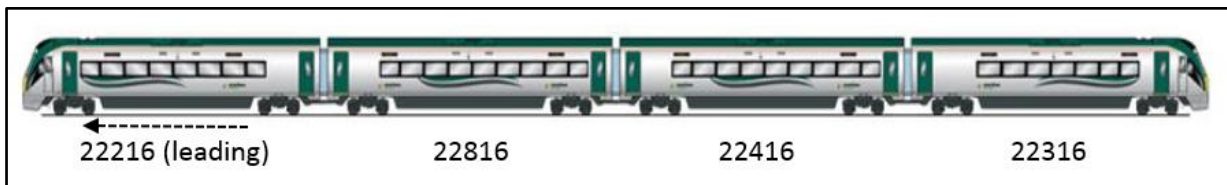
Figure 4: Consist of the 22000 Class ICR (set 16) involved in the occurrence.

- 7.3 There were 185 passengers on board the train at the time of the occurrence. There were no injuries reported. There was extensive damage caused to the front of train and the underframe of the coaches to various electrical components and air systems as a result of the collision.

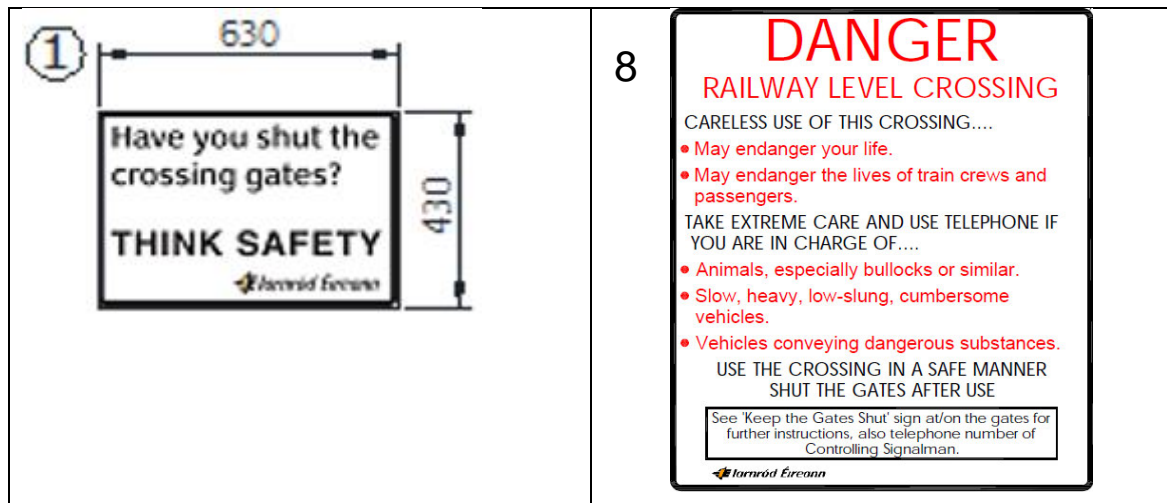
10.2.1 The user is responsible for using the level crossing safely, which includes securing the gate properly after use. Signage is the primary means of communication between IÉ and the user. The signage displayed at XA043 was compliant with Technical Management Standard, CCE-TMS-380 'Technical Standard for the Management of User Worked Unattended Level Crossings'. The signs (numbered in figure 13 below) include statutory signage to remind the user of their responsibility to keep the gates shut (No. 4 below) as well as warning signage about safety (No. 1 and 8 below).

2. PENALTIES: Any person omitting to shut and fasten these gates after using this crossing is liable to prosecution. You are liable to a fine in excess of €600 and / or 6 months Imprisonment.

Figure 13: Statutory signage and warning signage to remind users of their responsibility to keep gates shut.

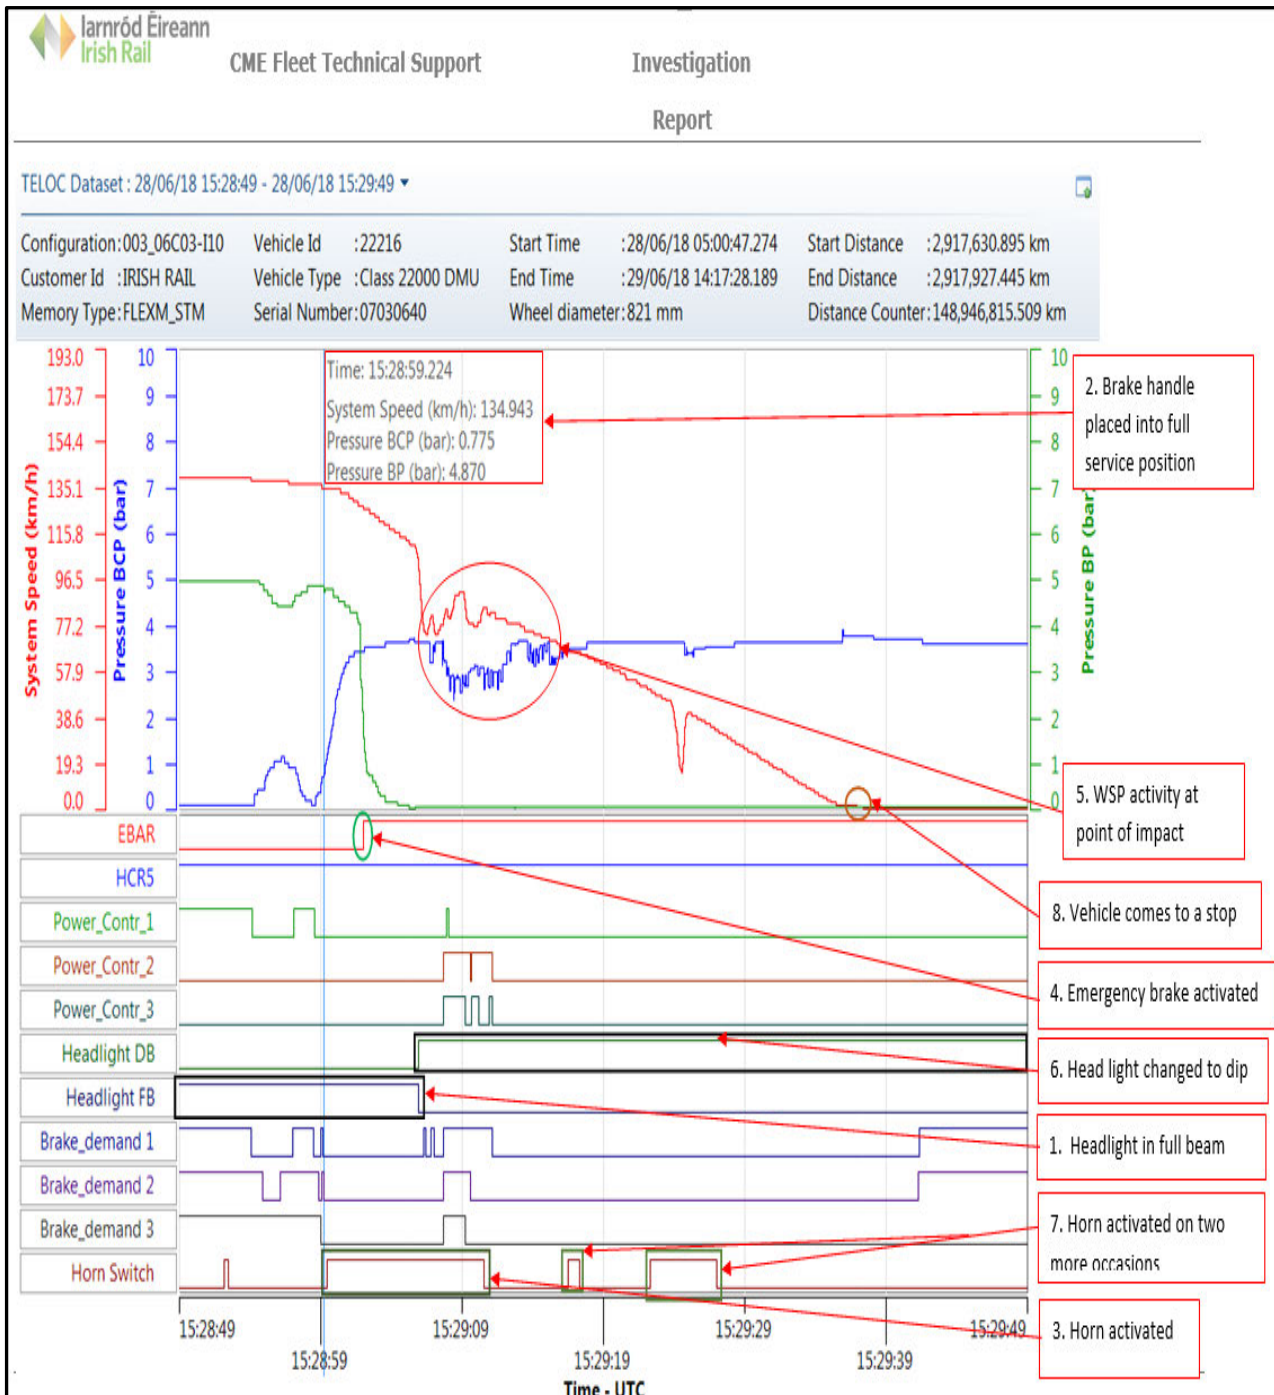
Appendix B – Excerpts from the CME OTDR analysis

Note: This section is from 15:28:49 to 15:29:49 and covers the occurrence. The hour difference in time is due to the event recorder time being set to winter time i.e. GMT. During summer time the event recorder time is 1 hour subtracted from normal time.
